THE RICHARD STOCKTON COLLEGE OF NEW JERSEY

**Beach-Dune Performance Assessment of  
New Jersey Beach Profile Network (NJBPN) Sites at  
Long Beach Island, New Jersey  
After Hurricane Sandy**

November 13, 2012

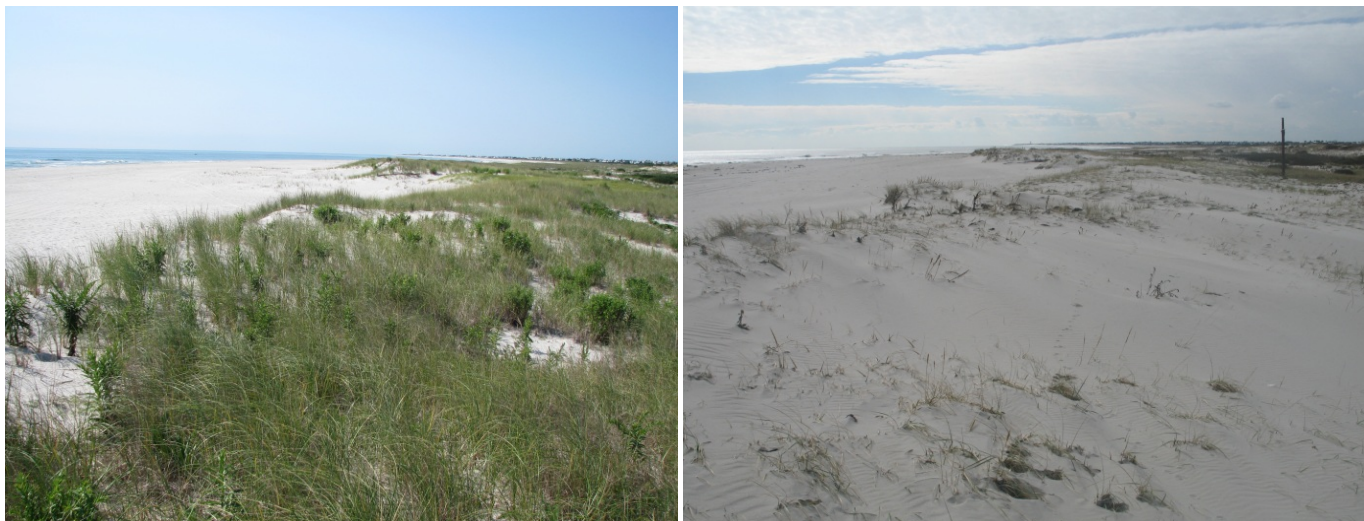
## NJBPN 245 – 10<sup>th</sup> Street, Barnegat Light

The photo on the left was taken on September 12, 2012 and shows the dune and beach conditions before Sandy. Note the flourishing dense vegetation along the landward dune slope. In the photo on the right taken on November 2, 2012 from the same location looking south post Sandy shows the impact of the storm which is evident from the sand overwashed and blown landward across the dune burying but not killing the dense vegetation seen in the September picture.

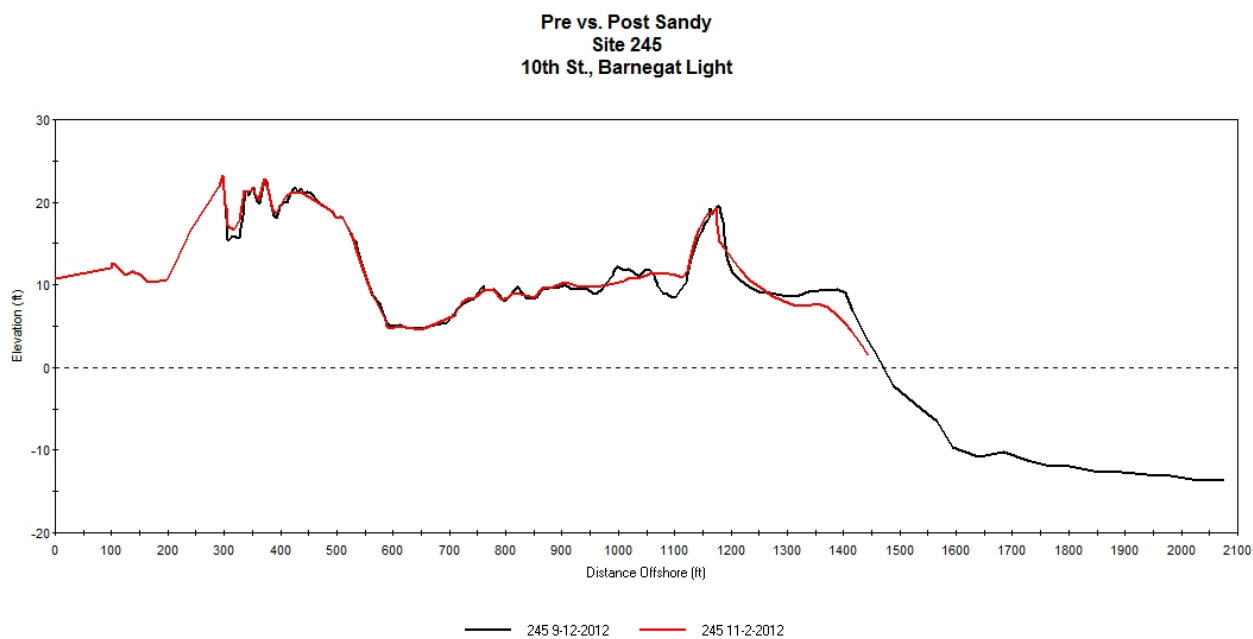
Figure 2. Above is a comparison plot between two surveys taken pre-storm on September 12, 2012 and the post-storm survey of November 2, 2012. The plot depicts the modest changes caused by the storm were limited to the berm crest and foredune ridge where 6.21 yds<sup>3</sup>/ft. of sand was removed during the storm. The massive dune system landward was essentially unaffected by Sandy. This region benefits from the shelter effect of the Barnegat Inlet jetty which protects this region from northeast wave approach, trapping and retaining sand south of the structure. This entire cross section developed following the completion of the replacement south jetty in 1991.

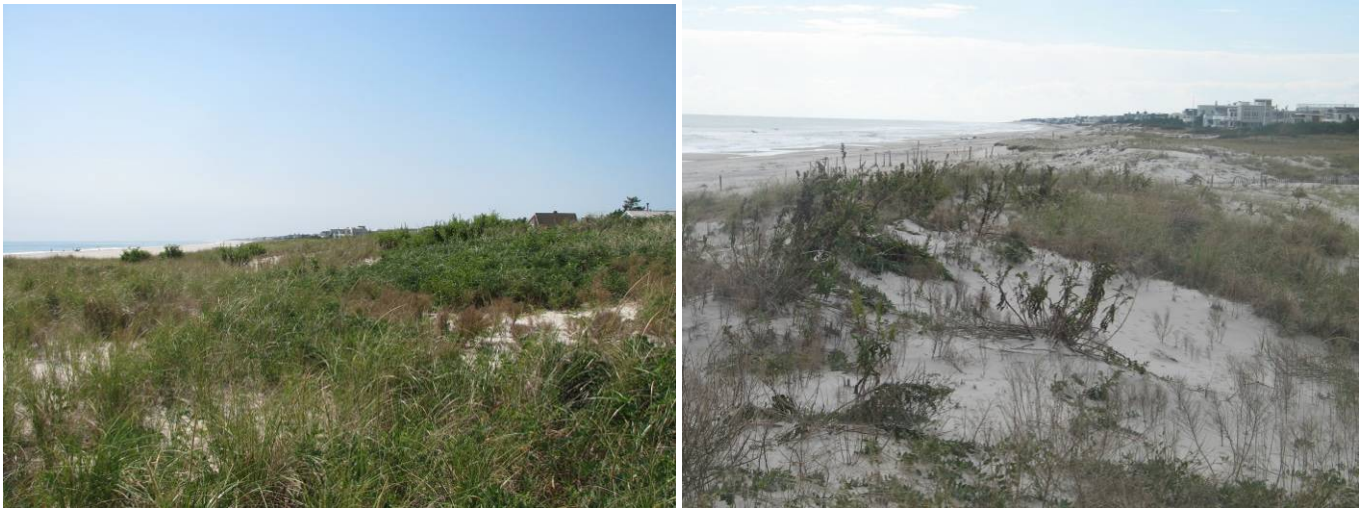
## NJBPN 145 – 26<sup>th</sup> Street, Barnegat Light

The photo on the left was taken on September 12, 2012 and shows the dune and beach conditions before Sandy. Again note the flourishing dense vegetation along the seaward dune slope. In the photo on the right taken on November 2, 2012 from a similar location looking south post-Sandy the impact of the storm is evident from the sand overwashed and blown landward across the dune burying the dense vegetation seen in the September picture and by the narrower beach width.

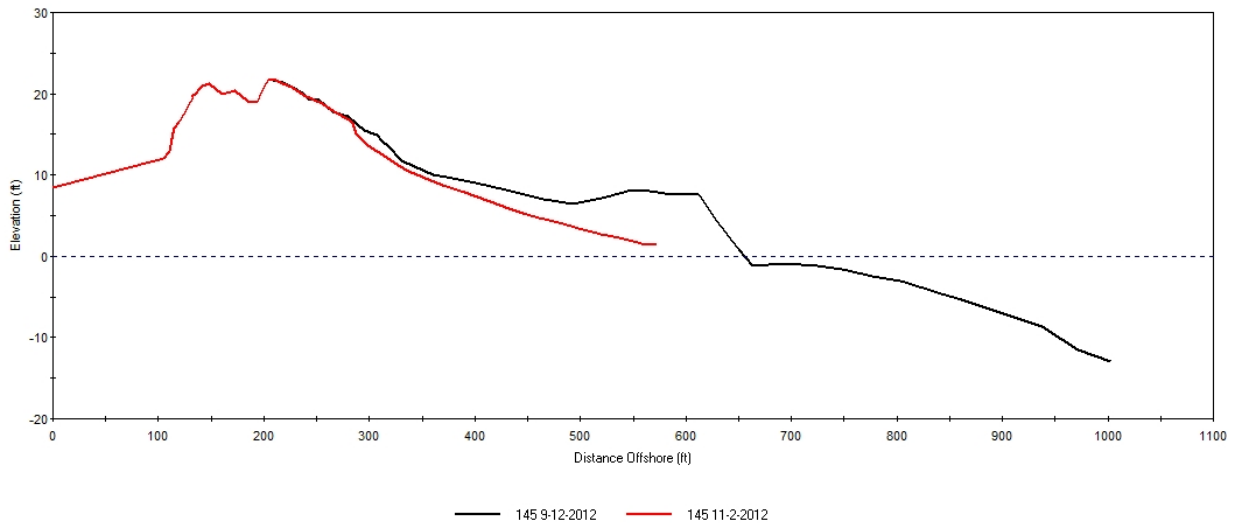
Pre vs. Post Sandy  
Site 145  
26<sup>th</sup> St., Barnegat Light

Figure 3. The above comparison plot between two surveys taken pre-storm on September 12, 2012 and the post-storm survey of November 2, 2012 shows significant beach erosion. At 26<sup>th</sup> Street the berm was removed, beach flattened and elevations lowered along with a cut that removed about 25 feet of the seaward dune slope leaving a 3-foot high modest scarp along the seaward dune toe. The 200-foot wide dune remained largely intact preventing major overwash into the street and damage to oceanfront property. The modest dune and moderate beach erosion caused by Sandy here removed 28.62 yds<sup>3</sup>/ft. of sand from this site but the lack of property damage and overwash demonstrates the value of wider beaches and a well-developed dune system. Data gathered over time shows that 75% of the sand now in the dune arrived on this shoreline following the construction of the new jetty.

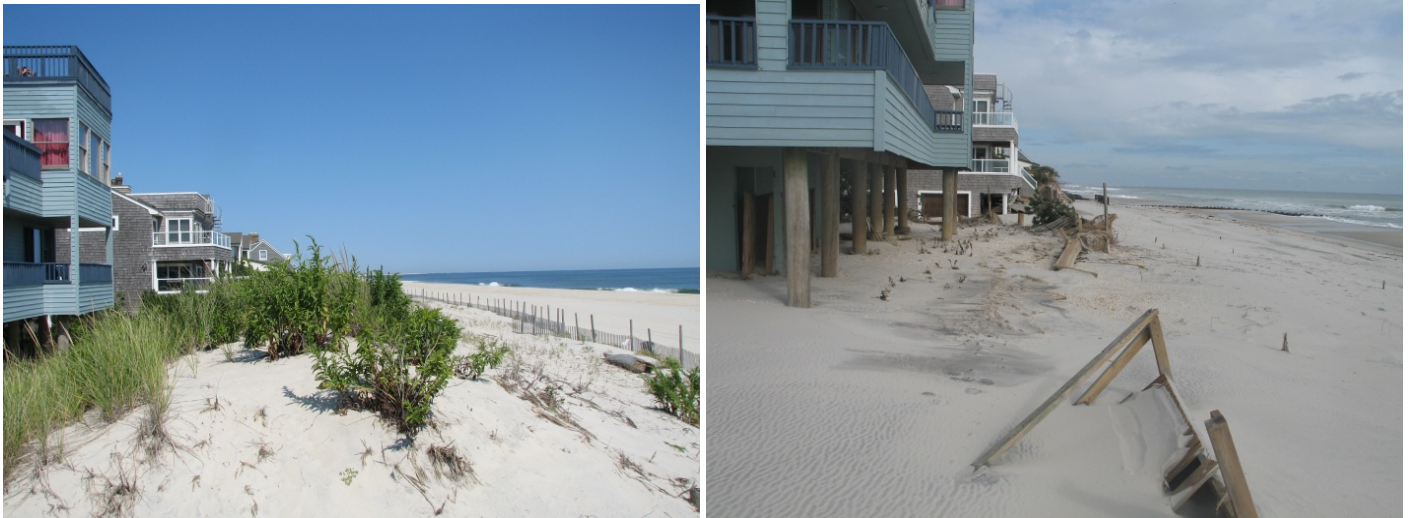
## NJBPN 144 – La Baia Street, Loveladies

Above are two photos taken at La Baia Street before and after Sandy. The photo on the left was taken on September 12, 2012 and shows the dune and beach conditions before Sandy. In the photo on the right taken on November 2, 2012 from a similar location looking south post Sandy the impact of the storm is evident the dune seaward of the homes is obliterated the beach is lower in elevation and narrower in width. Sand was overwashed between the oceanfront homes, carried landward to the road.

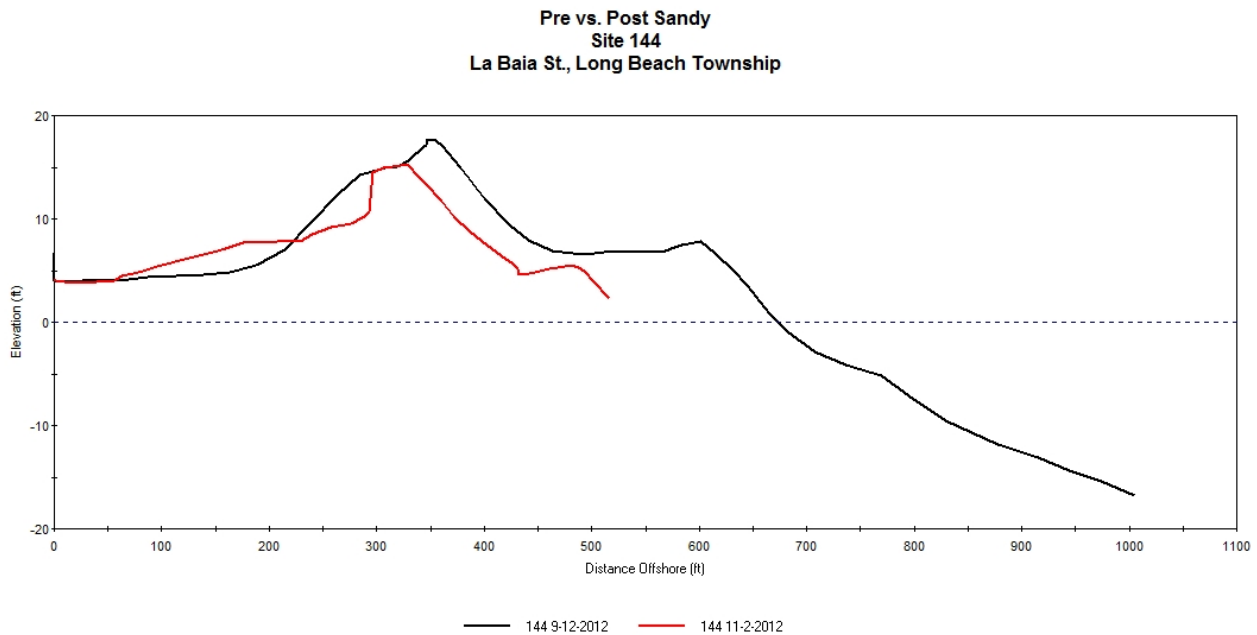
**Figure 4.** The comparison plot above for surveys taken on September 12, 2012 and the post-storm survey of November 2, 2012 shows major beach erosion, significant dune failure and sand overwash landward to the reference location. The dune width is narrower seaward of the oceanfront properties than in Barnegat Light and provided less storm protection for the structures. The net volume change was fairly moderate with 21.63 yds<sup>3</sup>/ft. of sand lost but a significant volume of sand has been relocated to the landward toe and no longer providing storm protection for the seaward homes. The volume loss seaward of the properties was much more significant with a loss of about 125 feet of retreat in the beach width. A final volume total will require an offshore survey to assess losses below the zero elevation datum. A significant contributor to the damage at this location was the presence of a beach access pathway constructed at least 6 feet lower than the dune crest on either side of the pathway. The wave forces created the “Grand Canyon” of Long Beach Island in carving a two-house wide gap in the dunes. Fixing the problem seen at pathways can be a near cost-free means of reducing potential wave damages in the future.

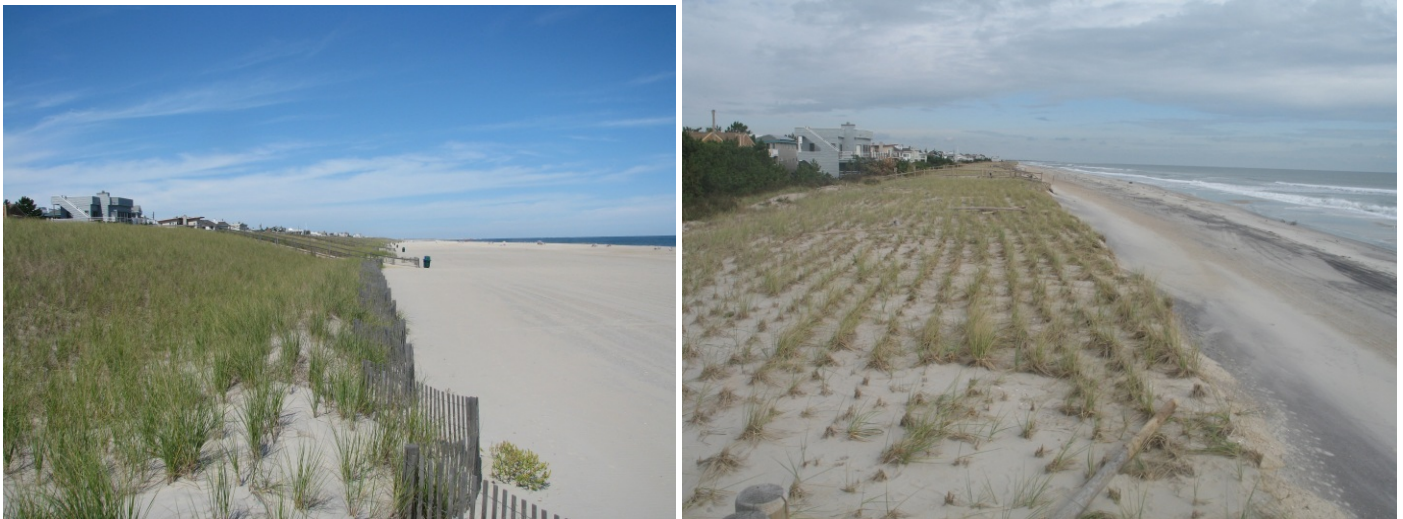
**NJBPN 143 – 73<sup>rd</sup> Street, Harvey Cedars**

The two photos above taken at 73<sup>rd</sup> Street before and after Sandy show the dune and beach changes resulting from the storm. The photo on the left was taken on September 11, 2012 while the photo on the right was taken on November 2, 2012 from a similar location looking north. This site had recently received sand as part of the USACE beach restoration program for Long Beach Island. The project provided ample dune and beach width enhancement and storm protection for the oceanfront properties. Post-Sandy shows the impact of the storm with a significant dune scarp at the seaward crest and a narrow, lower elevation beach remaining. However there was no evidence that sand has overwashed the dune at this location.

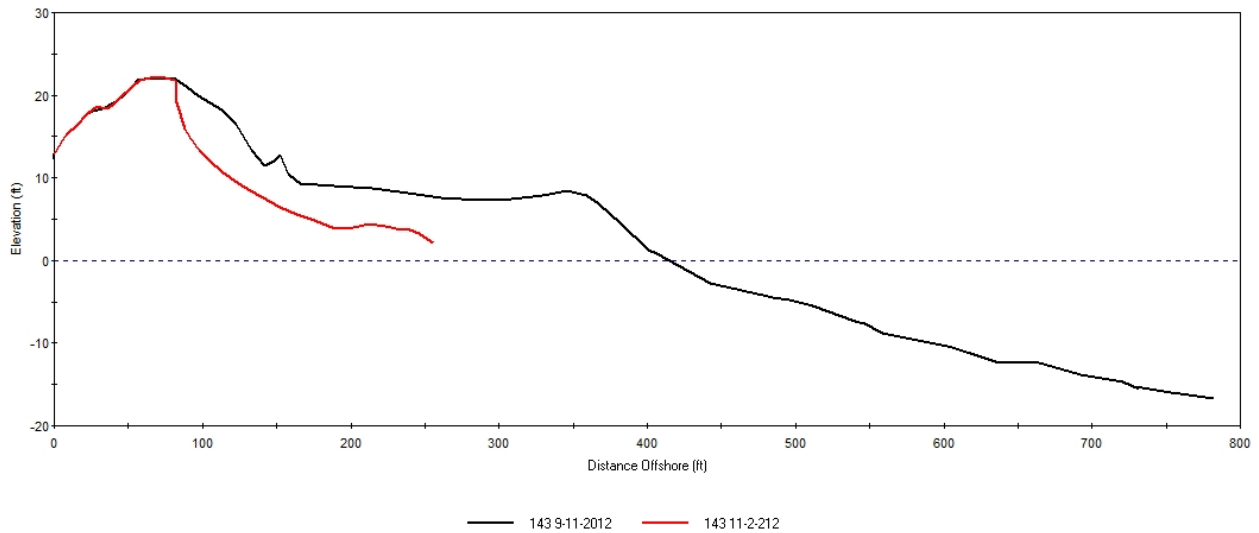
**Pre vs. Post Sandy  
Site 143  
73rd St., Harvey Cedars**

Figure 5. The above comparison plot between two surveys taken pre-storm on September 11, 2012 and the post-storm survey of November 2, 2012 shows significant dune and beach erosion. At 73<sup>rd</sup> Street the berm was removed, beach flattened and elevations lowered along with a cut that removed nearly the entire seaward dune slope leaving a steep 6-8 foot high scarp along the seaward dune crest. The 22-foot high dune remained intact from the seaward crest landward preventing major overwash into the street and damage to oceanfront properties. The significant dune and beach erosion caused by Sandy removed 32.95 yds<sup>3</sup>/ft. of sand from this site and about 125 feet of beach width.

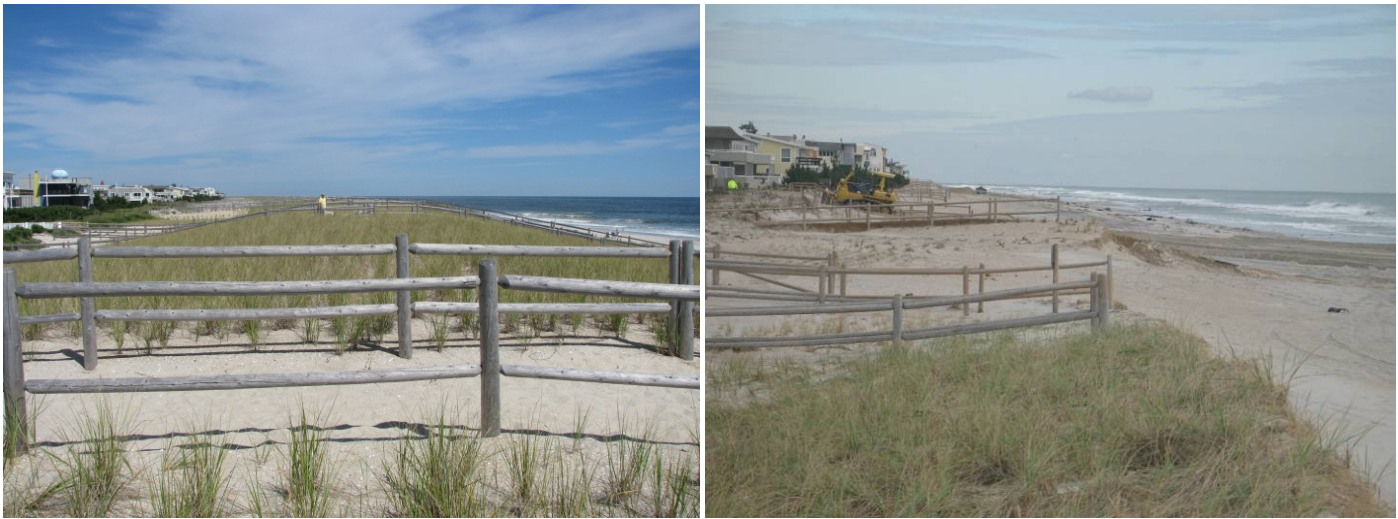
**NJBPN 142 – Tranquility Drive, Harvey Cedars**

Above are two photos taken at Tranquility Drive before and after Sandy. The photo on the left was taken on September 11, 2012 and shows the dune and beach conditions of the USACE engineered beach before Sandy. On the right the photo taken on November 2, 2012 from a similar location looking north post-Sandy shows the impact of the storm evident the significant loss of dune seaward of the homes, the beach is lower in elevation and narrower in width. Despite the significant loss of dune to the landward crest of the engineered dune, overwash did not occur and the oceanfront property was protected from wave damages.

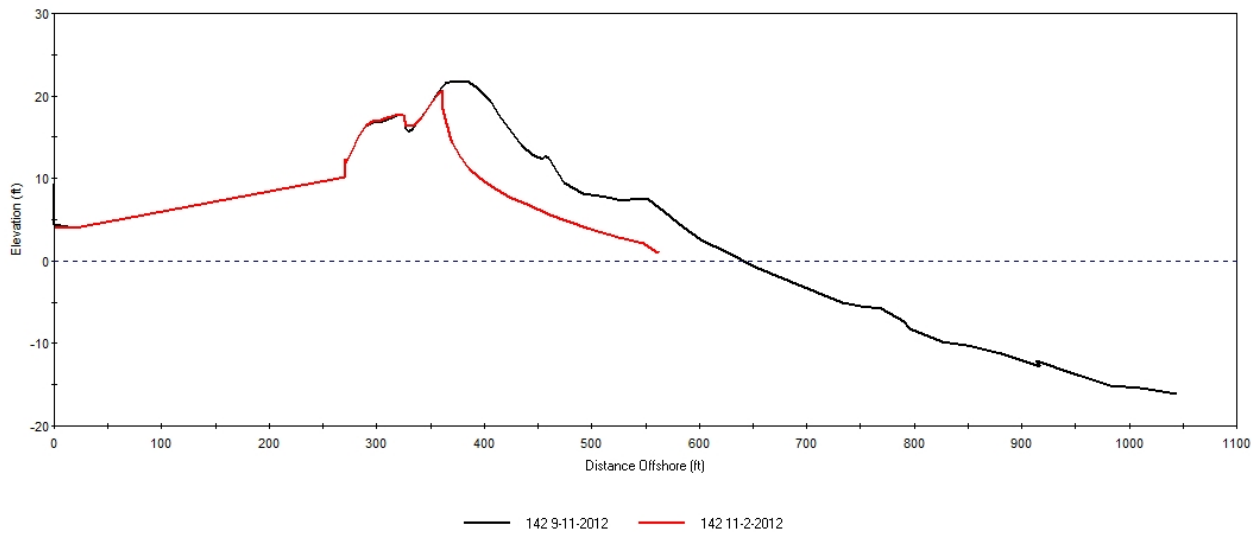
**Pre vs. Post Sandy  
Site 142  
Tranquility Dr., Harvey Cedars**

Figure 6. Above is a comparison plot between two surveys taken pre-storm on September 11, 2012 and the post-storm survey of November 2, 2012. Despite the significant loss of beach width and dune to the landward crest of the engineered project dune, overwash did not occur, prevented by the remaining project dune and the pre-construction dune remnants along the landward slope. The beach was flattened and lowered in elevation with significant shoreline retreat of between 75-100 feet. Sandy caused major erosion at this site with a loss of 48.19 yds<sup>3</sup>/ft. of sand but the USACE project provided the protection needed to prevent serious property damage for the oceanfront homes and public infrastructure.

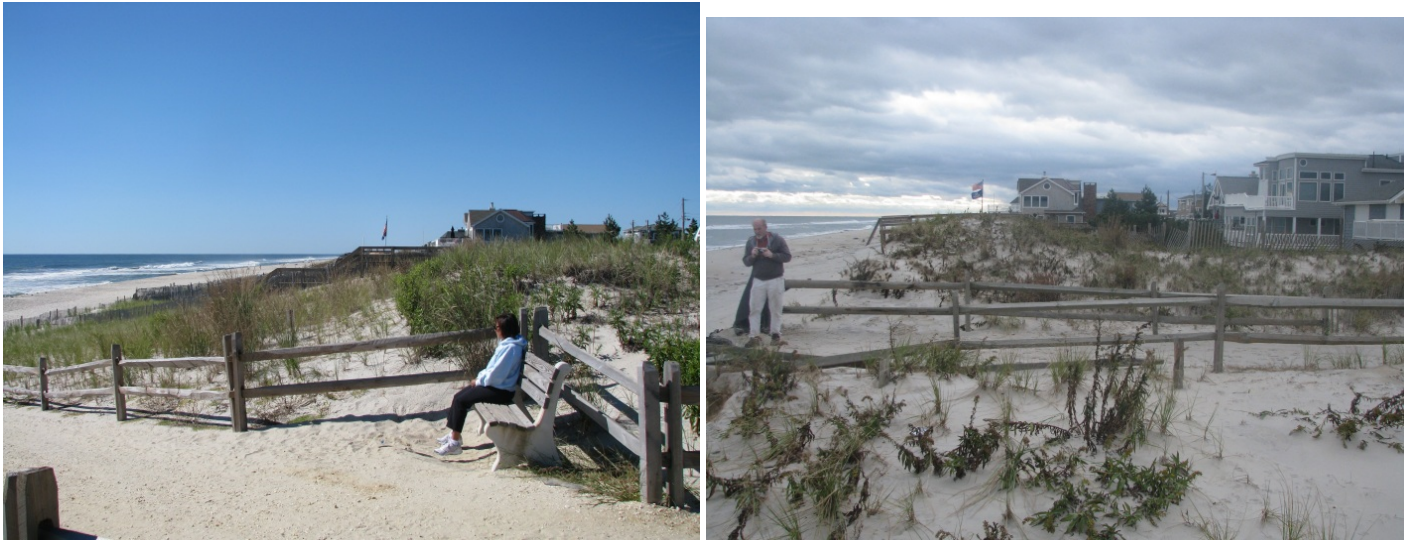
## NJBPN 241 – 20<sup>th</sup> Street – Surf City

The photographs above were taken on September 11<sup>th</sup>, 2012 (left) and November 1<sup>st</sup>, 2012 (right). Both images show the view of 20<sup>th</sup> Street (site 241) looking south. This location Surf City received a beach replenishment in 2007, which increased the sand volume and width of the dune and berm. The dune and berm both experienced substantial erosion; however no overwash occurred at this location.

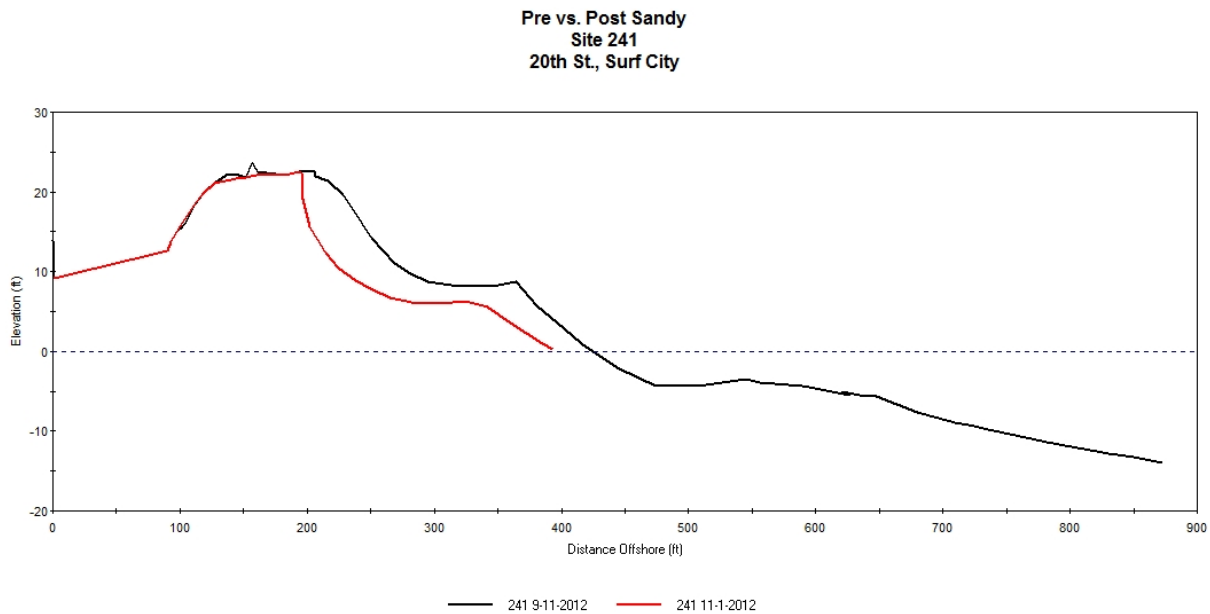
Figure 7. Between September 11<sup>th</sup> and immediately following Hurricane Sandy on November 1<sup>st</sup>, site 241 had a sand volume loss of 36.4 yds<sup>3</sup>/ft. This site received beach replenishment in 2007 as part of the US Army Corps Long Beach Island Shore Protection Project. The engineered beach and dune suffered substantial retreat at the foredune slope, but dune remains intact and was not breached. The engineered berm was also substantially eroded, with that sand most likely being transported into the nearshore at this location.

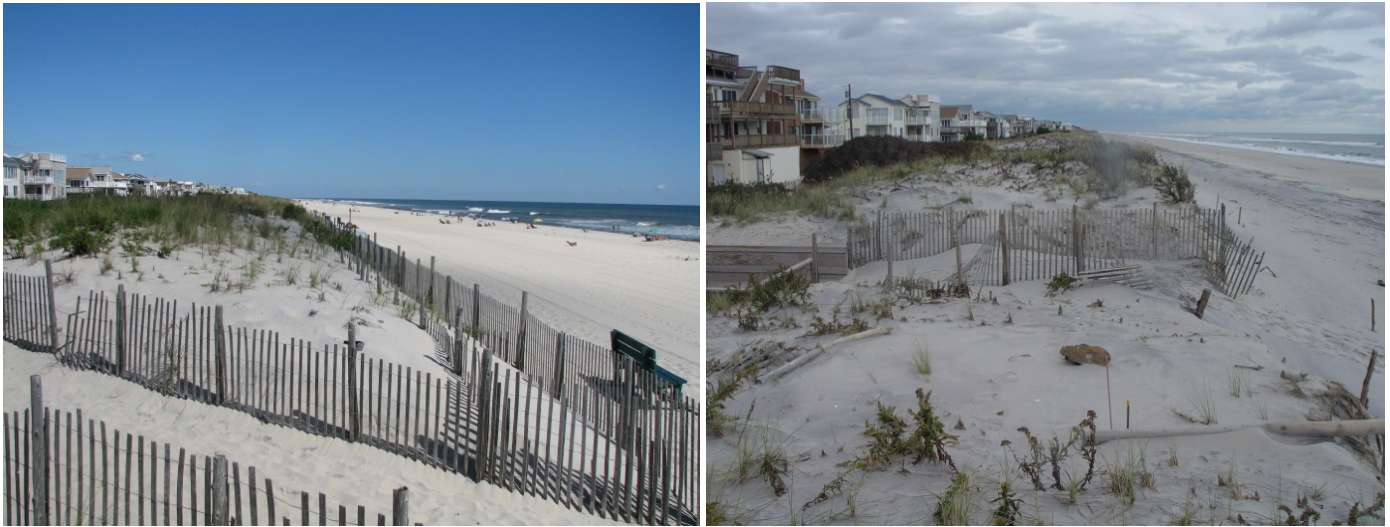
## NJBPN 141 – 8<sup>th</sup> Street, Ship Bottom

The photographs above were taken on September 10<sup>th</sup>, 2012 (left) and November 1<sup>st</sup>, 2012 (right). Both images show the view of 8<sup>th</sup> street (site 141) looking north. This location in Ship Bottom experienced erosion of the beach and dune, however the dune was not breached and no overwash occurred at this location.

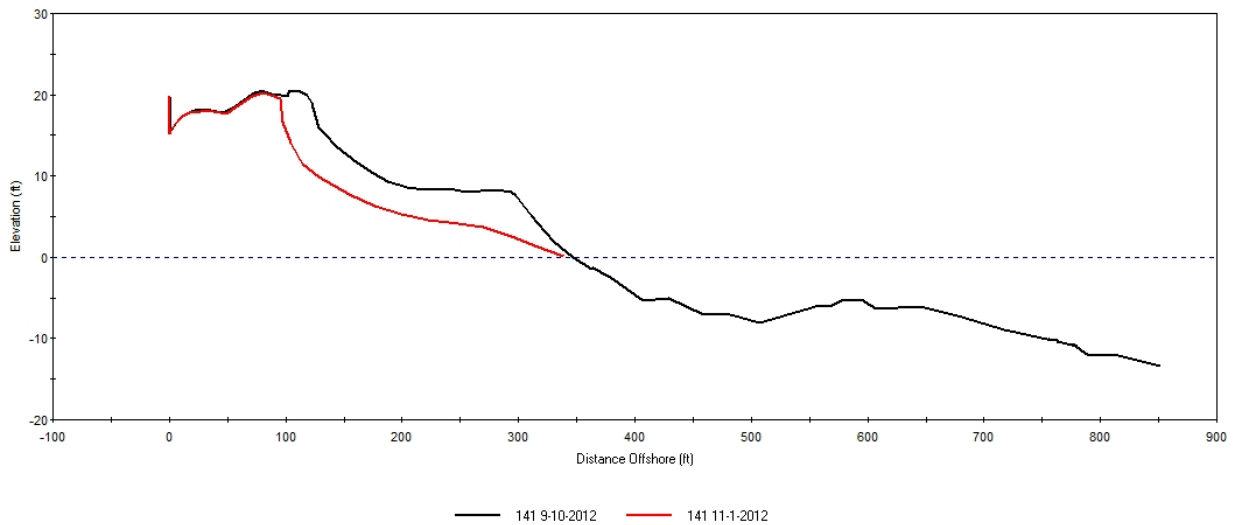
**Pre vs. Post Sandy  
Site 141  
8th St., Ship Bottom**

Figure 8. Between September 10<sup>th</sup> and immediately following Hurricane Sandy on November 1st, site 141 had a sand volume loss of 40.3 yds<sup>3</sup>/ft. The foredune and berm experienced substantial losses in sand volume, but over half of the dune remains intact and was not breached. The elevation of the beach berm has been lowered and the majority of sand was most likely transported into the nearshore at this location.

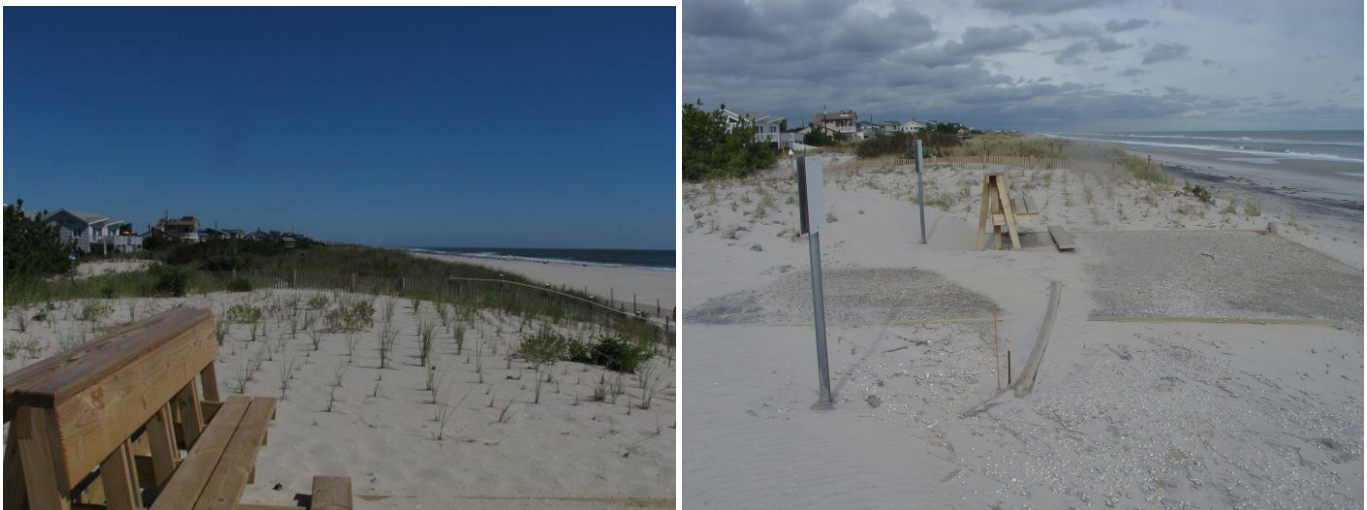
## NJBPN 140 – 32<sup>nd</sup> Street, Long Beach Township

The photographs above were taken on September 10<sup>th</sup>, 2012 (left) and November 1<sup>st</sup>, 2012 (right). Both images show the view of 32<sup>nd</sup> street (site 140) looking north. This location in the Brant Beach section of Long Beach Township received beach replenishment in spring 2012, which increased the sand volume and width of the dune and berm. The foredune slope experienced minor erosion, while the berm was severely eroded. No overwash occurred at this location. The park bench remained in its original position.

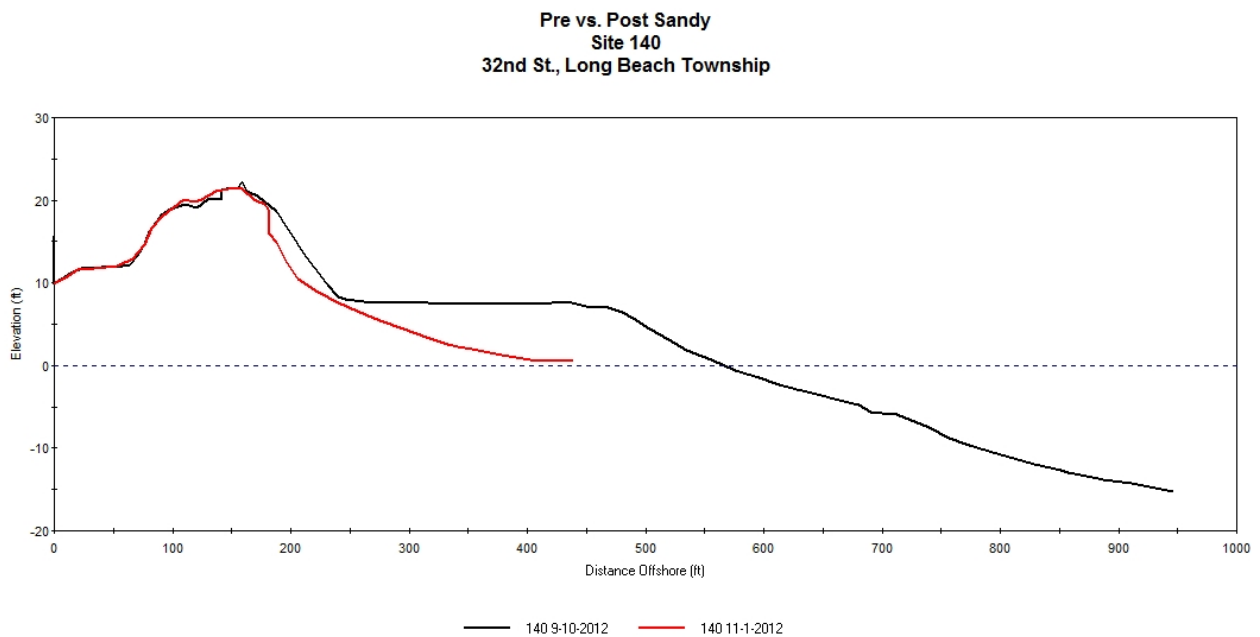
Figure 9. Between September 10<sup>th</sup> and immediately following Hurricane Sandy on November 1st, site 140 had a sand volume loss of 40.4 yds<sup>3</sup>/ft. This site received beach replenishment in spring 2012 as part of the US Army Corps Long Beach Island Shore Protection Project. The engineered dune experienced a minor retreat at the foredune slope, but dune remains intact and was not breached. The majority of erosion at site 140 occurred on the berm, with that sand most likely being transported into the nearshore at this location.

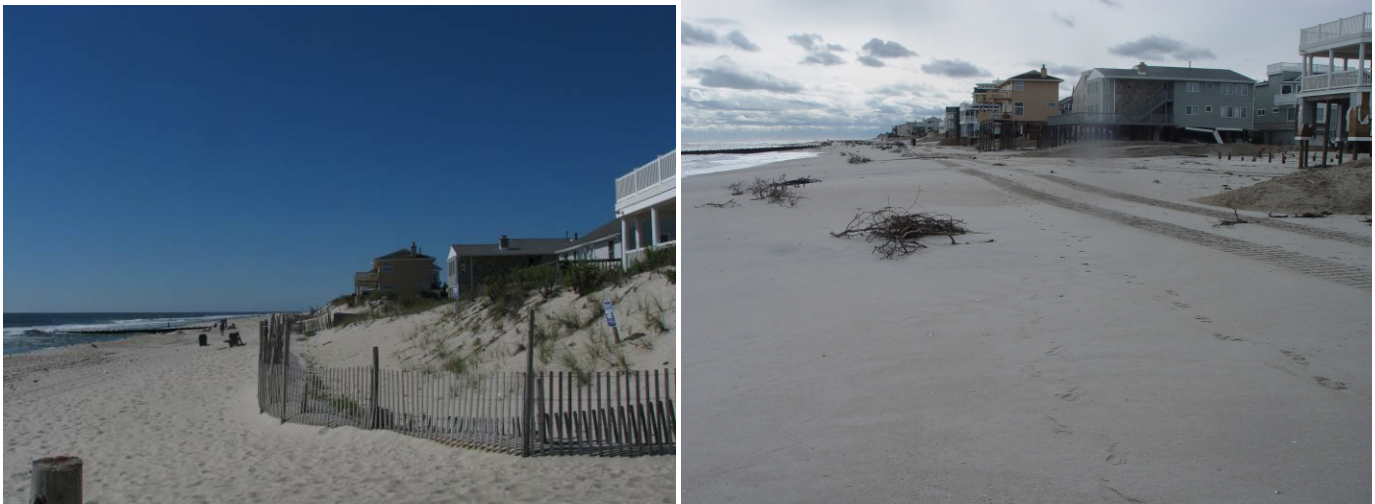
## NJBPN 139 – 81<sup>st</sup> Street, Long Beach Township

The story was different at Beach Haven Crest where the dune failed at 81<sup>st</sup> Street. The pre-Sandy photograph depicts a narrow dune with a 16-foot crest elevation. This proved insufficient to stop the wave assault and extensive damage resulted. Both beach width and dune mass are essential as a team to protect from wave damage because both are essentially piles of sand which do erode at fairly rapid rates. If a dune were to erode at a 10 feet per hour rate, then it would need to be 100 feet thick to withstand a 10 hour duration of a steady intensity storm. This approximates Sandy's level of violence over two high tide intervals on Monday October 29<sup>th</sup>.

The photographs above were taken on September 10<sup>th</sup>, 2012 (left) and November 1<sup>st</sup>, 2012 (right). Both images show the view of 81<sup>st</sup> street (site 139) looking south. It is evident in the photographs that the existing dune was completely eroded away and overwash occurred, with waves pushing water and sand under the oceanfront homes and into the streets landward of them. The dune elevation was about 16 feet.

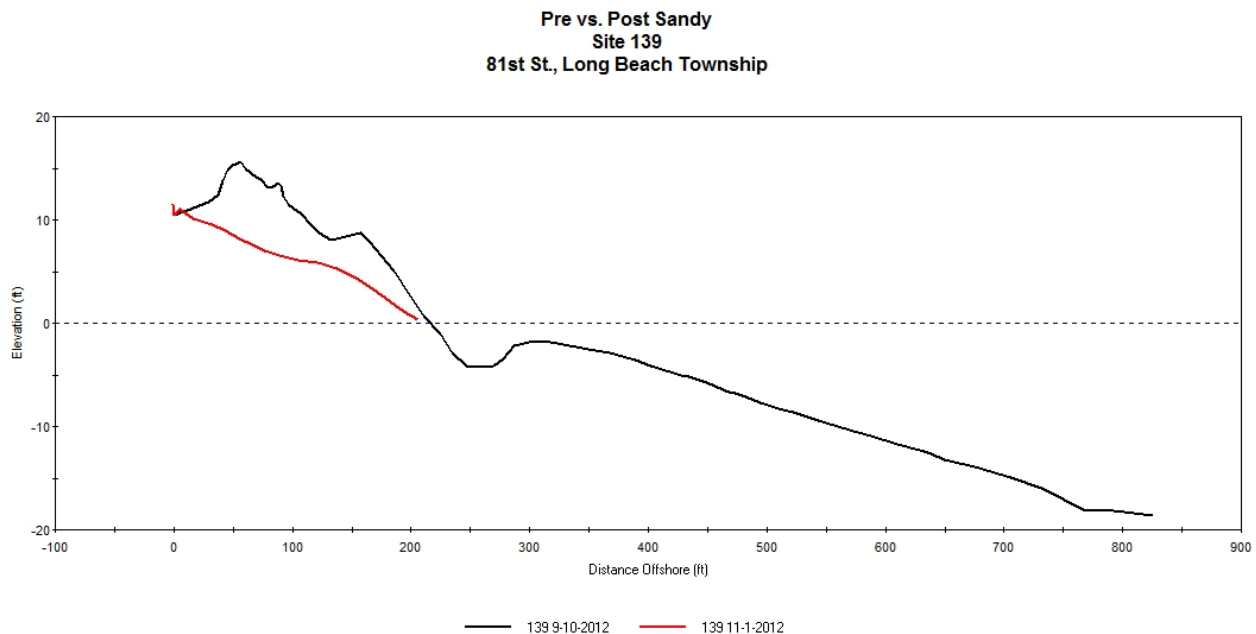
Figure 10. Site 139 experienced severe erosion and overwash between September 10<sup>th</sup> and immediately following Hurricane Sandy on November 1<sup>st</sup>, which resulted in a sand volume loss of 29.5 yds<sup>3</sup>/ft. The entire dune has been removed with the majority of sand being transported by waves landward of the profile and offshore. Damage occurred as waves swept any and all appliances, water heaters, air conditioner compressors, barbecue grills etc landward from under each of the homes on pilings. Piling supported structures fostered by FEMA back in 1968 at its onset did pay dividends since those homes on pilings were not destroyed completely.

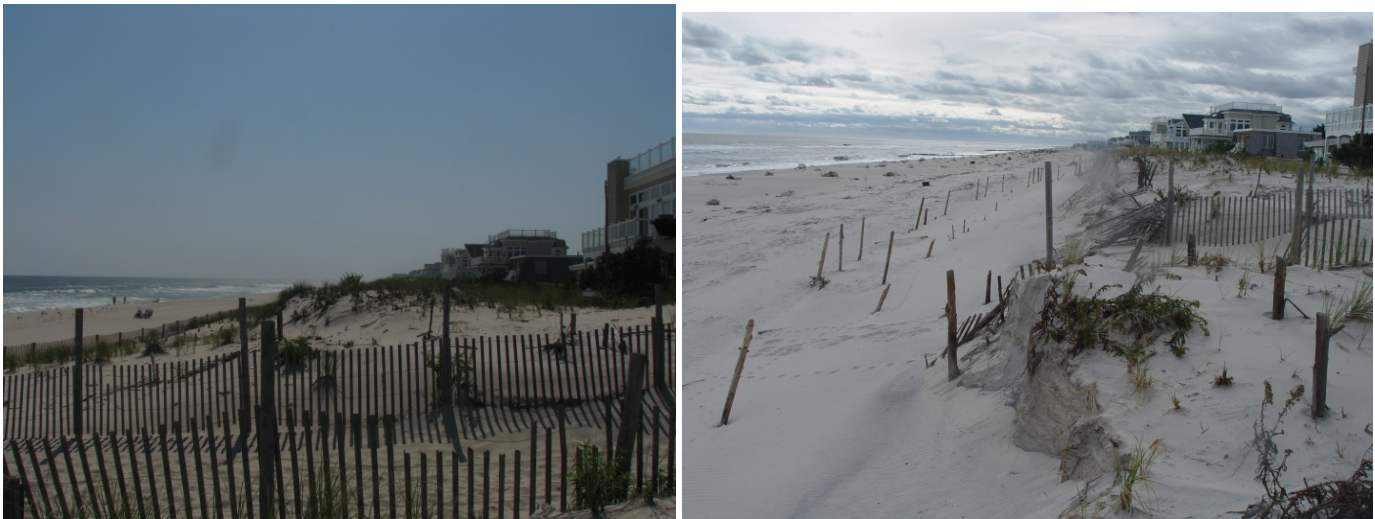
**NJBPN 138 – Old Whaling Road (124<sup>th</sup> Street), Long Beach Township**

The site at Old Whaling Road was different in Spray Beach due to a wider, higher dune. About a third of the dune was eroded taking all of the seaward slope, but the height prevented overwash and the properties landward were spared.

The photographs above were taken on September 7<sup>th</sup>, 2012 (left) and November 1<sup>st</sup>, 2012 (right). Both images show the view of Old Whaling Road (site 138) looking south. The existing dune experienced erosion, however it was not completely removed and no overwash occurred at this location. Surprisingly, two blocks to the north a dune of comparable size and shape was eroded away and overwash occurred.

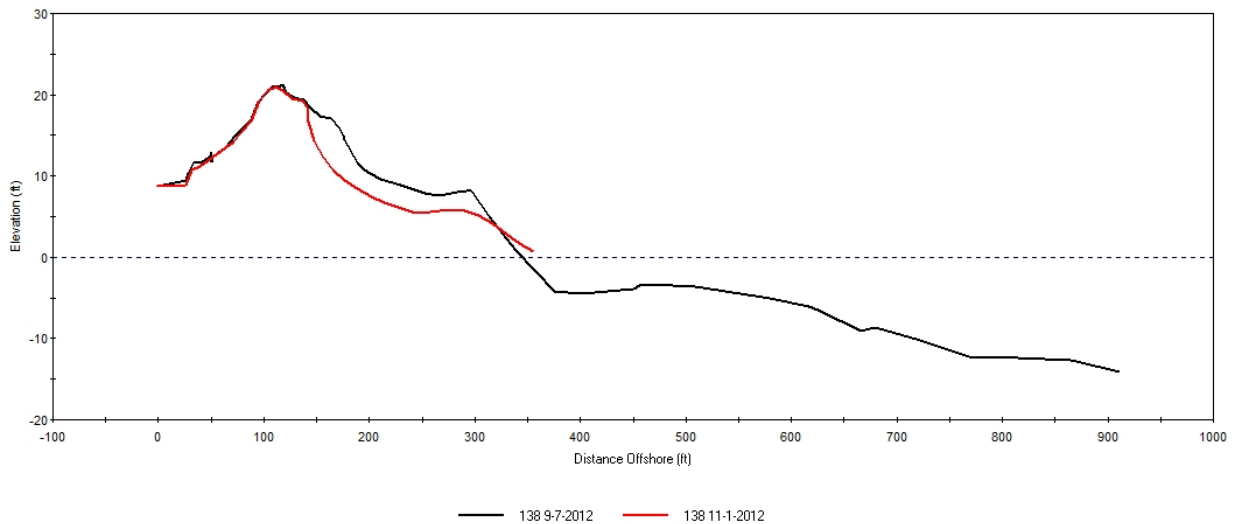
**Pre vs. Post Sandy  
Site 138  
Old Whaling Rd., Long Beach Township**

Figure 11. Between September 7<sup>th</sup> and immediately following Hurricane Sandy on November 1<sup>st</sup>, site 138 had a sand volume loss of 19.1 yds<sup>3</sup>/ft. The seaward dune toe experienced a modest retreat, but over half of the dune remains intact and was not breached. The elevation of the beach berm has been lowered. The majority of erosion at site 138 occurred in the foredune slope and berm, while the majority of sand was most likely transported into the nearshore at this location. This location was NOT in a ACOE project beach zone, but it did have a wider and higher elevation dune than most of the non-Federally managed beaches.

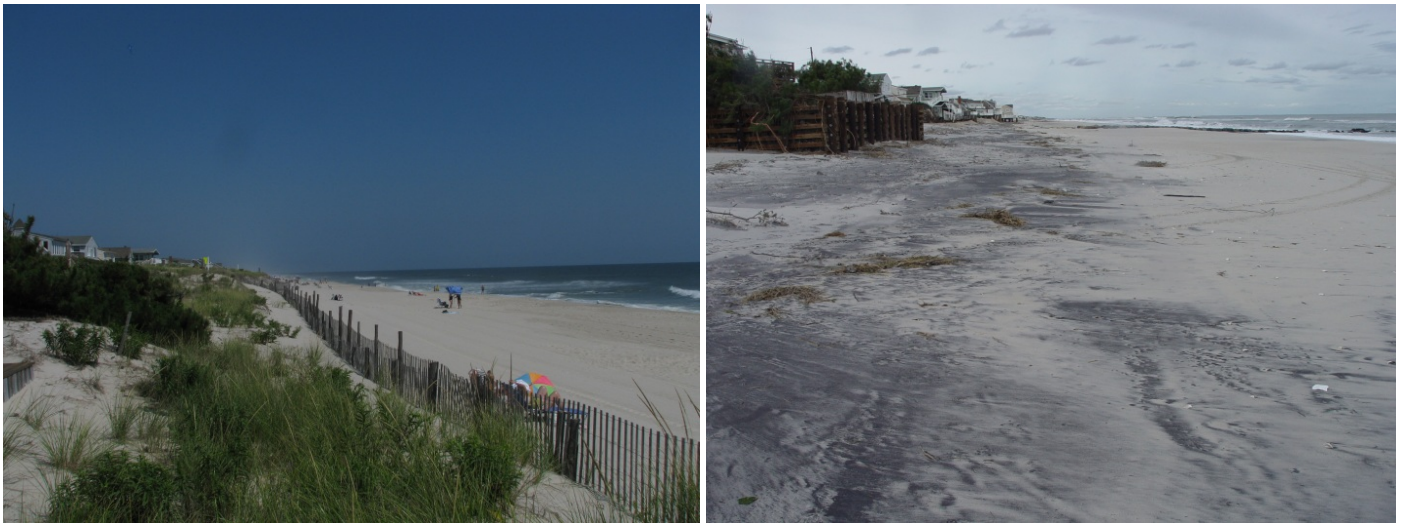
## NJBPN 137 – Taylor Avenue, Beach Haven

The photographs above were taken on September 7<sup>th</sup>, 2012 (left) and November 1<sup>st</sup>, 2012 (right). Both images show the view of Taylor Avenue (site 137) looking north. It is evident in the photographs that the existing dune was completely eroded away and overwash occurred, with waves pushing water and sand under the oceanfront homes and into the streets landward of them. The crib timber structure in the above right photograph was instrumental in saving the home from significant damage. The cribbing was back-filled with rocks and masonry debris and provided an effective barrier to direct wave impacts.

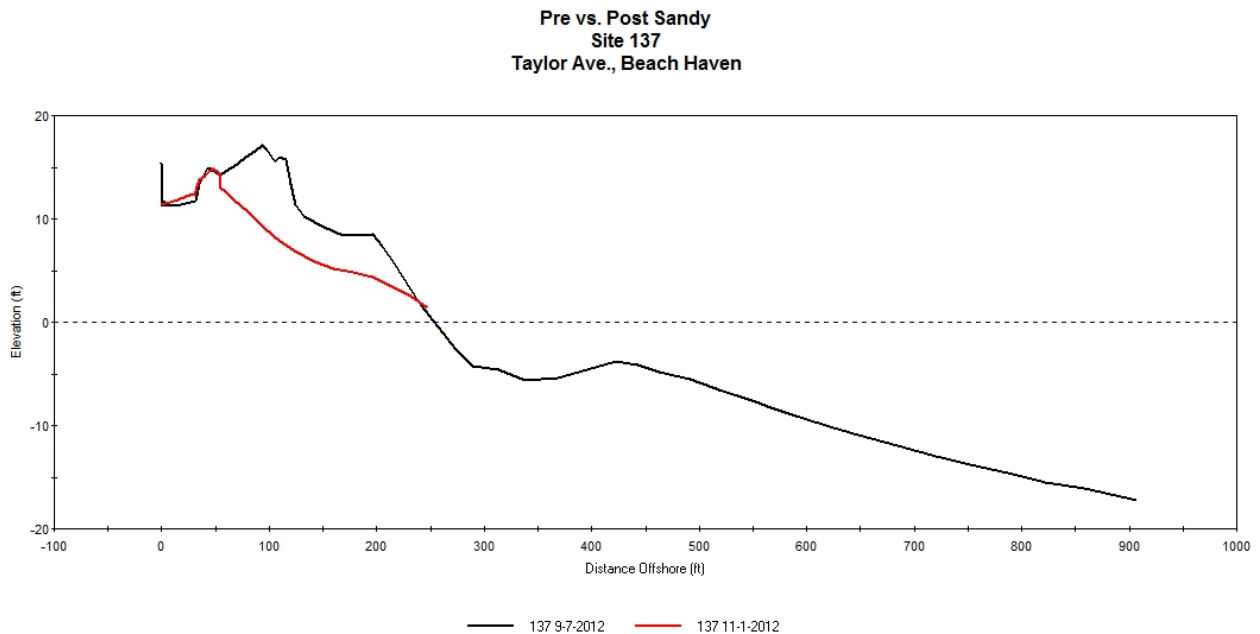
Figure 12. Site 137 experienced severe erosion and overwash between September 7<sup>th</sup> and immediately following Hurricane Sandy on November 1<sup>st</sup>, which resulted in a sand volume loss of 27.3 yds<sup>3</sup>/ft. The entire dune has eroded away, with the majority of sand being transported by waves landward of the profile as well as offshore. The red “bump” on the November cross section was material already hauled back to the beach from the roads inland.

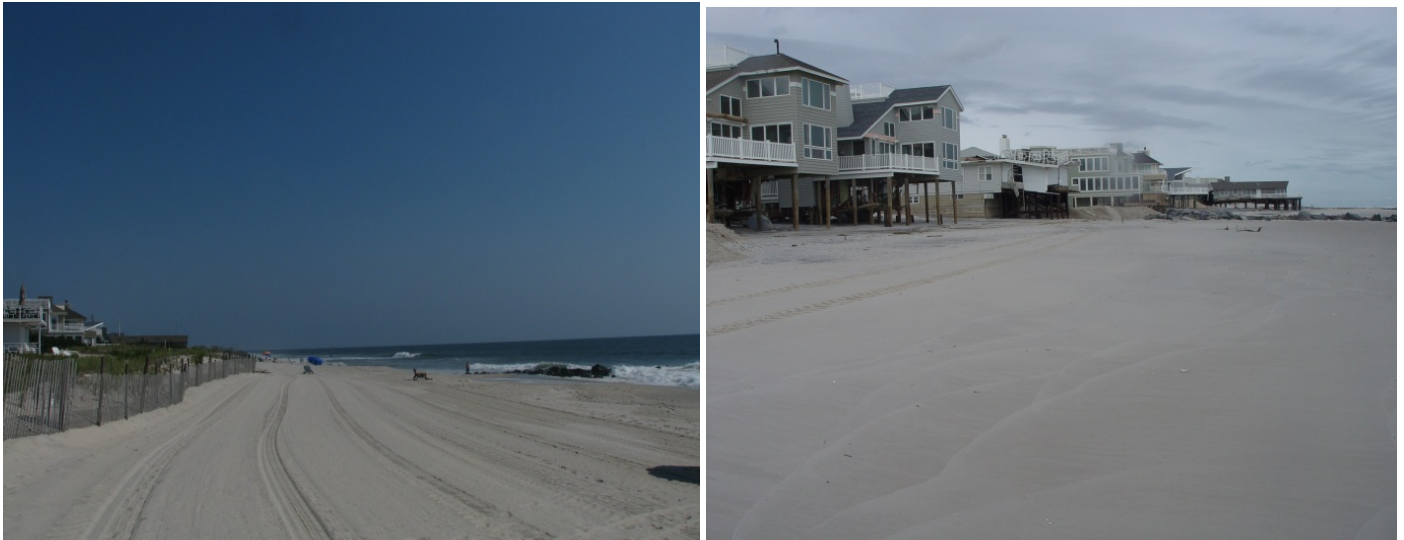
## NJBPN 136 – Dolphin Avenue, Beach Haven

The photographs above were taken on September 6<sup>th</sup>, 2012 (left) and November 1<sup>st</sup>, 2012 (right). Both images show the view of Dolphin Avenue (site 136) looking north. It is evident in the photographs that the existing dune was completely eroded away and overwash occurred, with waves pushing water and sand under the oceanfront homes and into the streets landward of them. Damage was clear and very common.

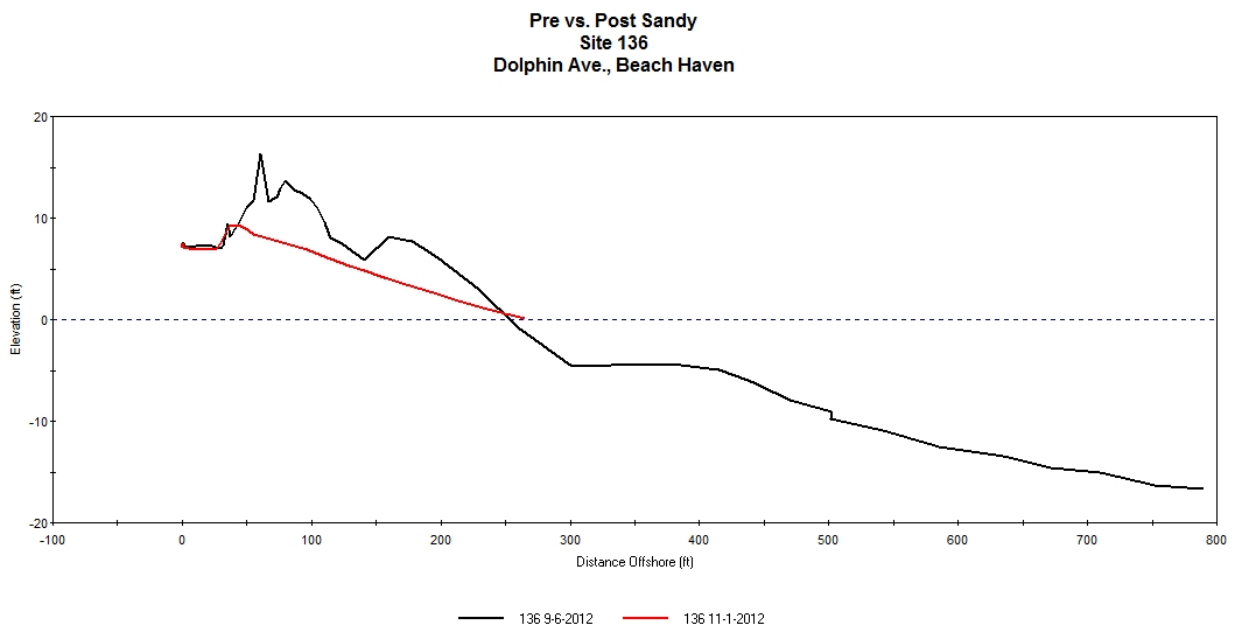
Figure 13. Site 136 experienced severe erosion and overwash between September 6<sup>th</sup> and immediately following Hurricane Sandy on November 1<sup>st</sup>, which resulted in a sand volume loss of 24.1 yds<sup>3</sup>/ft. The entire dune has been removed with the majority of sand being transported by waves landward of the profile and offshore.
