THE RICHARD STOCKTON COLLEGE OF NEW JERSEY

**Beach-Dune Performance Assessment of  
New Jersey Beach Profile Network (NJBPN) Sites at  
Long Beach Island, New Jersey  
After Hurricane Sandy**

November 13, 2012

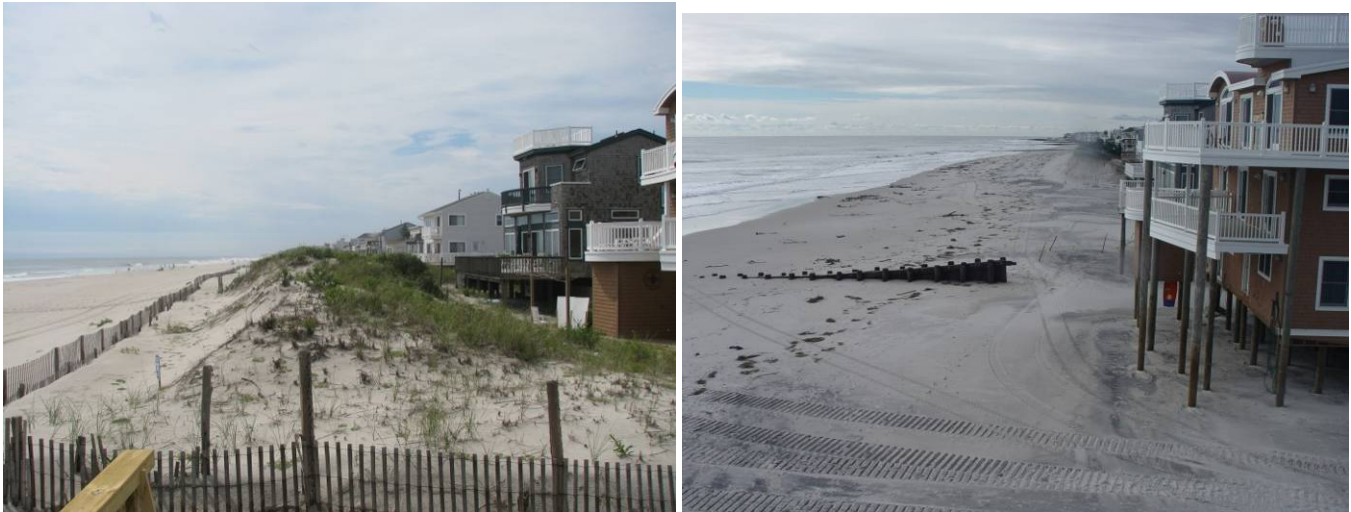
## NJBPN 135 – Webster Avenue, Long Beach Township

The site #135 at Webster Avenue was typical of the wholesale damage done as the dune system was essentially erased and washed across the island into Barnegat Bay in many cases. Sand thickness of 3 to 4 feet were observed on the Boulevard and down the side streets to the bay. Low elevation homes were destroyed and even some larger structures showed serious impacts. The practice of oceanfront owners closing in the ground level area under the first habitable floor level with a concrete floor, insulated walls, and installing the furnace, hot water heater, the air conditioner compressor, and storing a myriad of possessions in an area designated as open space to allow waves to pass under the building with minimal impact, vastly increased the damage to individual properties as the wave of debris piled up against landward structures and penetrated into other ground level spaces. Individuals found that their space under the house now contained an intertwined complex of debris densely filling the entire area under the house. Clearly the dunes were too thin, too low and the beach too narrow to block Sandy in any meaningful way.

The photographs above were taken on September 6<sup>th</sup>, 2012 (left) and November 1<sup>st</sup>, 2012 (right). Both images show the view of Webster Avenue in Beach Haven (site 135) looking south. It is evident in the photographs that the existing dune was completely eroded away and overwash occurred, with waves pushing water and sand under the oceanfront homes and into the streets landward of them exposing the timber section of an old groin long forgotten under the dune.

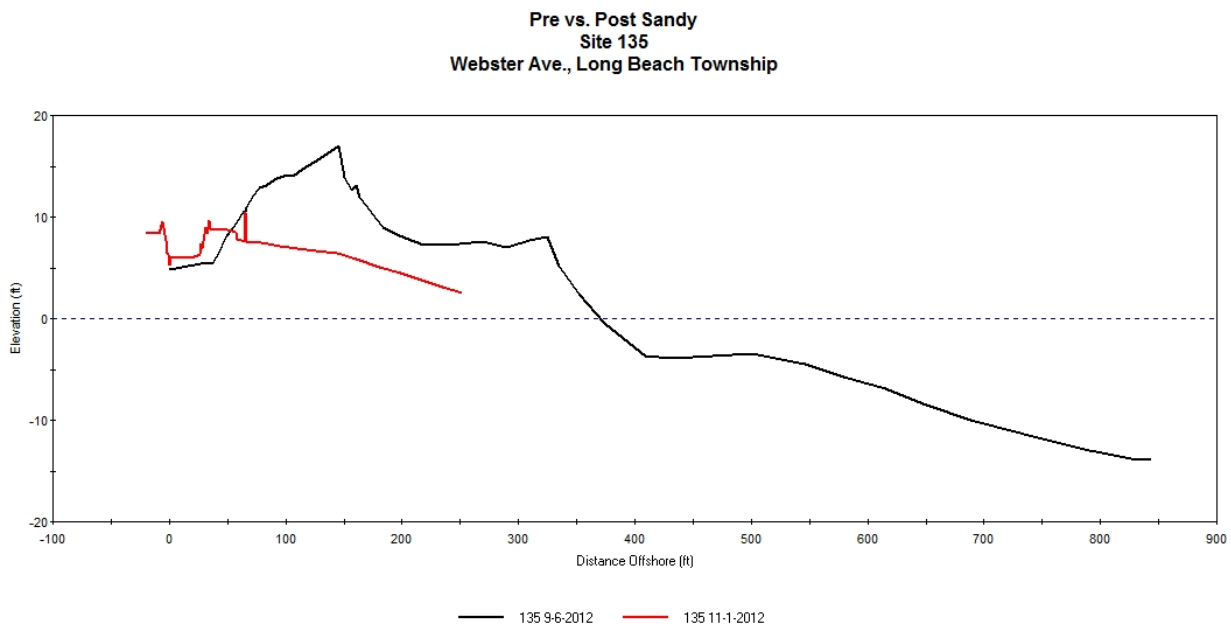
Figure 14. Site 135 experienced severe erosion and overwash between September 6<sup>th</sup> and immediately following Hurricane Sandy on November 1<sup>st</sup>, which resulted in a sand volume loss of 37.9 yds<sup>3</sup>/ft. The entire dune has been removed with the majority of sand being transported landward of the profile and offshore. The cut was the excavation already completed to open the road to travel. Sand was pushed back onto the beach. Occasional dune segments remained seaward of a few homes, which in one case still had intact landscaping unharmed.

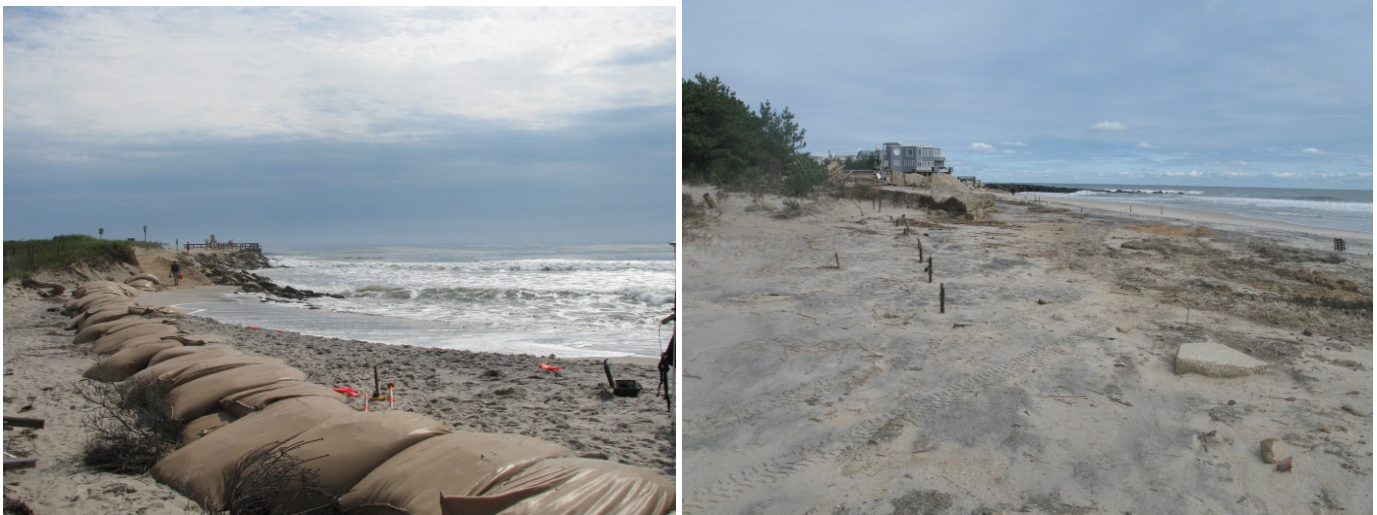
**NJBPN 234 – Forsythe National Wildlife Refuge, Holgate Entrance, Long Beach Township**

The photographs above were taken on September 6<sup>th</sup>, 2012 (left) and November 1<sup>st</sup>, 2012 (right). Both images show the view looking north at the beach-buggy entrance to the Forsythe Refuge (site 234). Wide-scale overwash occurred that extended to Barnegat Bay at this location due to the effect of Hurricane Sandy.

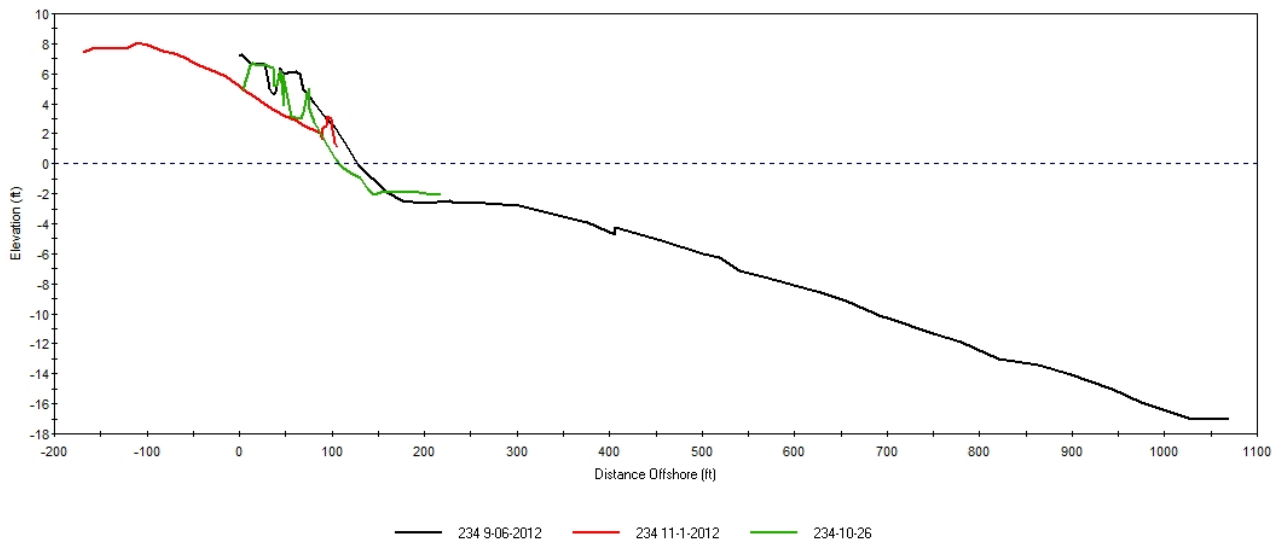
**Pre vs. Post Sandy  
Site 234  
Natural Area, Long Beach Township**

Figure 15. For many years, the natural area Long Beach Island has been experiencing substantial erosion and overwash due to the terminal groin cutting off the natural longshore transport of sand to the south. As a result of Hurricane Sandy, between September 6<sup>th</sup> and immediately following the storm on November 1<sup>st</sup>, site 234 suffered a loss of 7.8 yds<sup>3</sup>/ft. Wave action and overwash removed sand and temporary shore protection features (sand bags) from the refuge entrance roadway (and beach directly east) and added it to the region west of that area (backdune area). The green line represents a pre-Sandy survey done because the crew was in the locality on another mission to see differences between the September survey and an immediately pre-Sandy set of conditions. Some erosion had already made a bad situation worse prior to the hurricane.

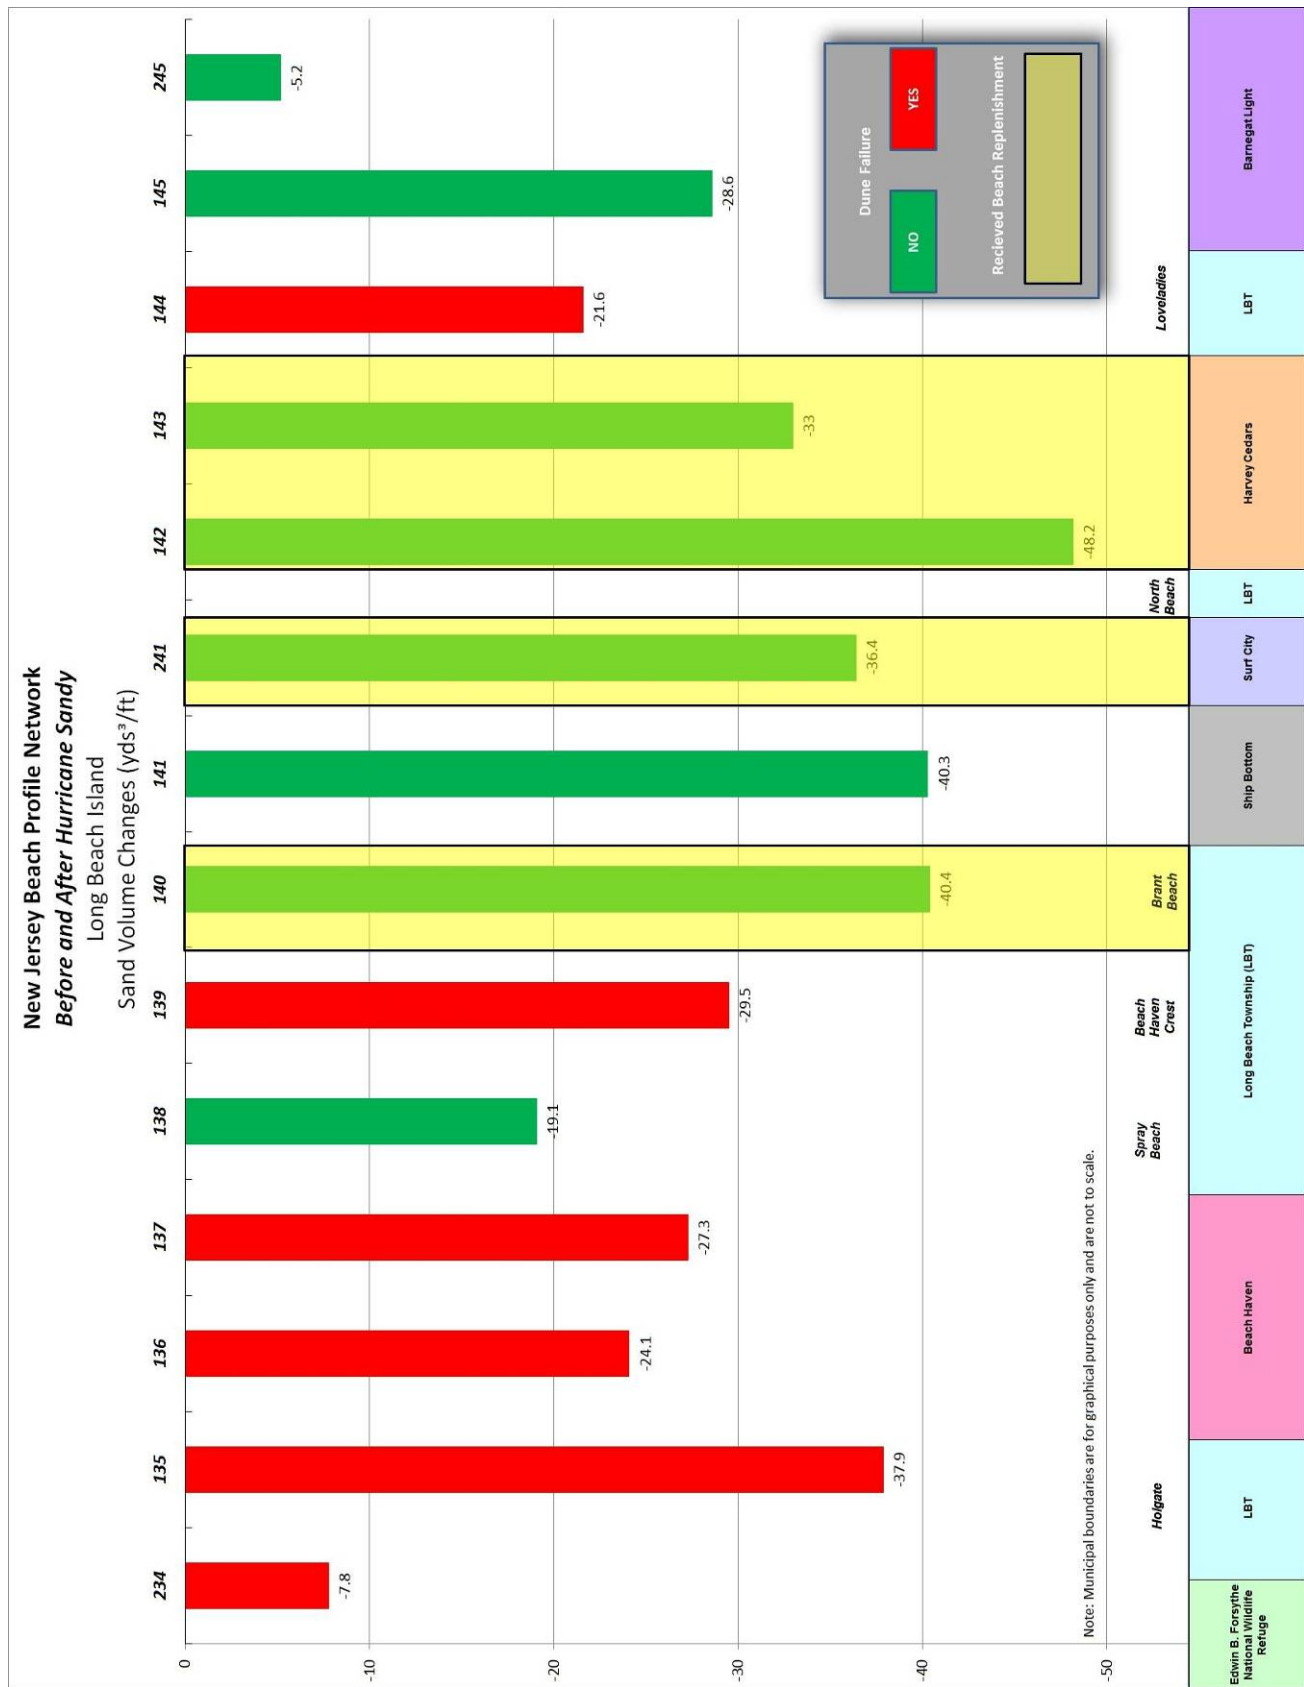
Figure 17. This graphic combines the loss figures with the presence or absence of the Federal Shore Protection Project and the occurrence of dune failure. It became perfectly clear that the ACOE shore protection design was sufficient to preclude structural damage along the extent of the LBI coastal shoreline where it had been completed.
