# FINAL REPORT FOR 2019 ON THE CONDITION OF THE MUNICIPAL BEACHES IN THE CITY OF BRIGANTINE BEACH, ATLANTIC COUNTY, NEW JERSEY

PREPARED BY: THE STOCKTON UNIVERSITY COASTAL RESEARCH CENTER

March 20, 2020

# Annual Report for 2019 to the City of Brigantine Beach on the Condition of Municipal Ocean Beaches

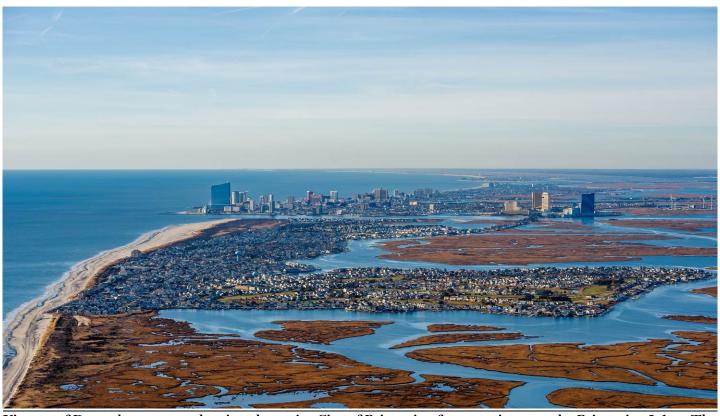
View as of December 8, 2019 showing the entire City of Brigantine from a point over the Brigantine Inlet. The 2018 US Army beach maintenance sand placement is still very evident between the feeder beach north of development and points south of 4th Street North. The expanse of dunes and south of 15th Street South are also readily apparent. (photo by Ted Kingston 2019)

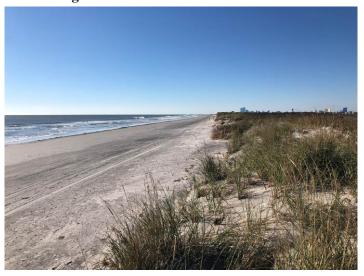
Figure 1a taken on October 30, 2018 looking south along the edge of the dunes: a minor storm on the 28<sup>th</sup> and 29<sup>th</sup> clipped the seaward slope and left debris at the base of the grass. The beach became flatter in profile slope as well.

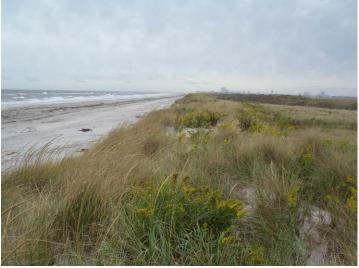
Figure 1b taken October 16, 2019 demonstrates excellent grass recovery from storm damage as growth progressed onto the upper beach by fall 2019.

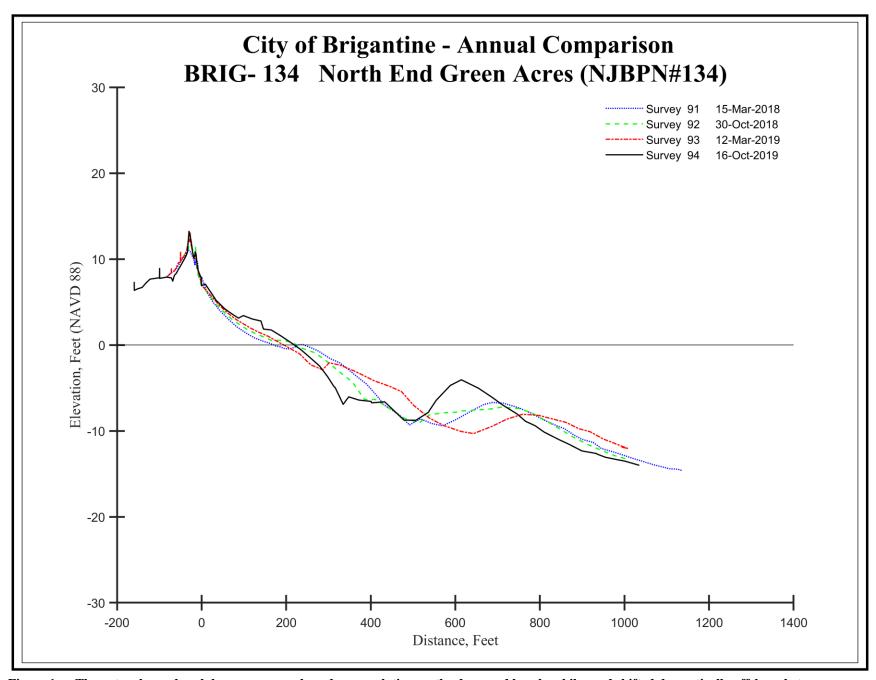
Figure 1c – The natural area beach has seen general sand accumulation on the dune and beach, while sand shifted dramatically offshore between a gentle slope into deeper water to a cross section with a deep trough seaward of the beach and a very large offshore bar that generated  $28.32 \text{ yds}^3$ /ft. in added sand.

The dune has naturally been restored since Sandy as material has slowly increased the dune elevation and grasses have propagated on the ridge generated. The beach remained quite stable with the greatest shifts in elevation occurring offshore as the bar trough deepened and the offshore bar grew in size by October 2019.

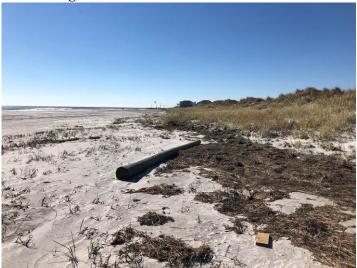
Figure 2a was taken October 30, 2018 following the weekend northeast storm. The debris shows into the lower dune slope grass along with a piling that washed up.

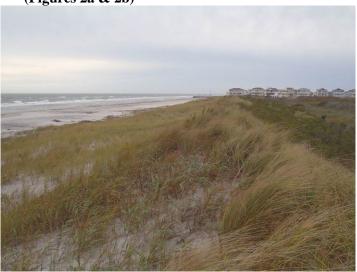
Figure 2b taken October 16, 2019 from the crest of the foredune, shows excellent grass growth seaward over the past 12 months.

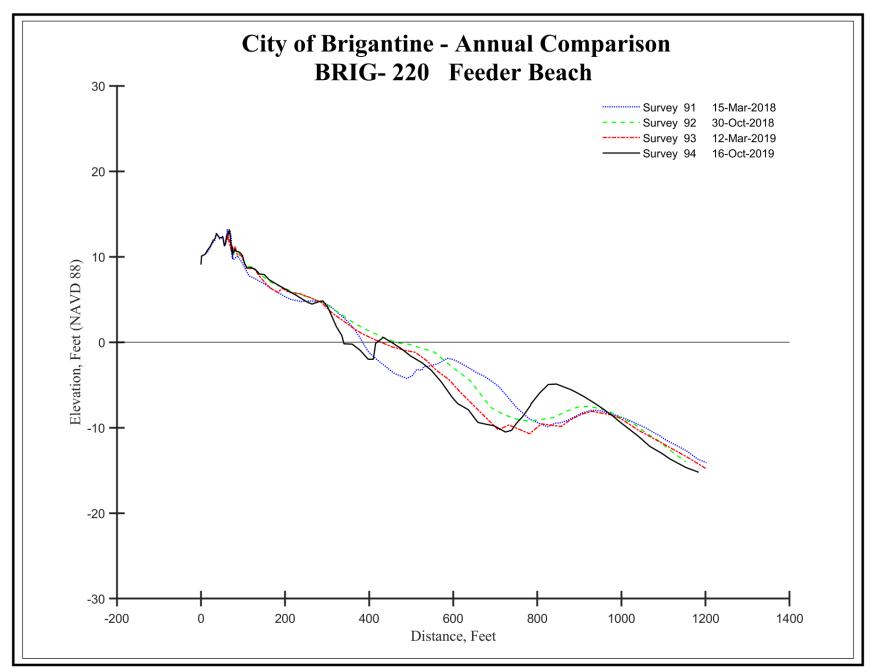
Figure 2c - Sand placed here by the USACE has remained stable between the dune and the beachface while extensive changes occurred offshore where the trough became deeper and a large bar and a nearshore ridge of sand appeared in the October 2019 survey. The net volume change was just 1.008 yds<sup>3</sup>/ft. June to October 2019, but the shoreline advanced 25 feet seaward.

The dunes and beach performed quite well over the past year gaining sand in both locations. Offshore the same pattern seen at Site 132 to the north produced a deep trough with a ridge about to attach to the beachface as of October 16, 2019.

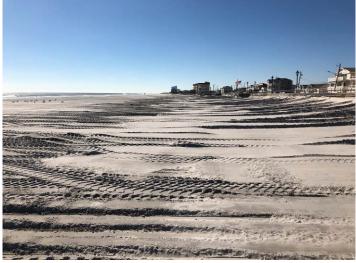
Figure 3a taken October 30, 2018 shows the completed work on the beach by the USACE. The bulldozer pushed up material to the top of the bulkhead while the rocks were covered during sand slurry placement.

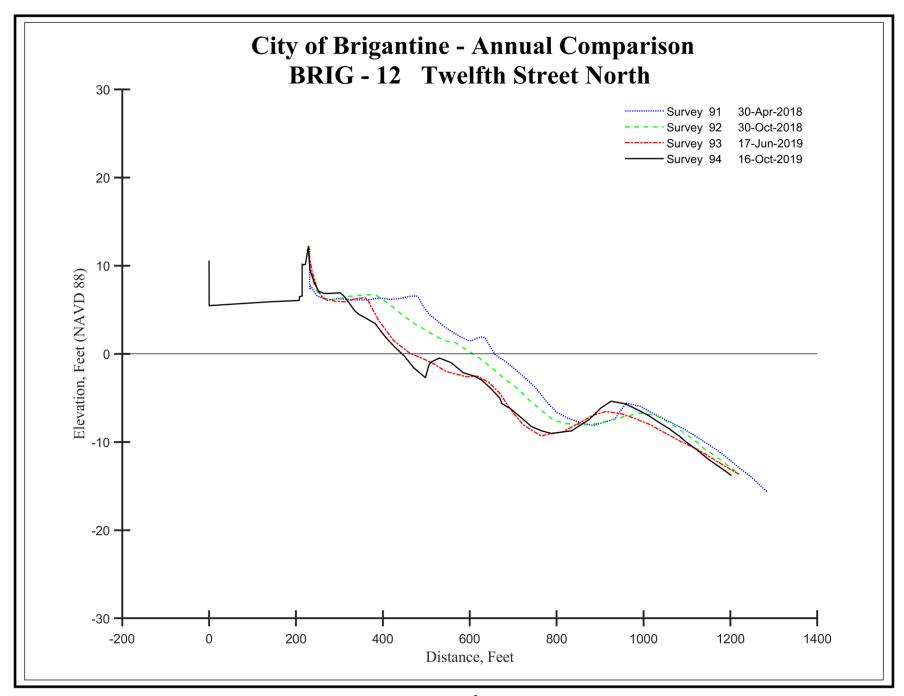
Figure 3c - This profile site was restored by the USACE project with 160.43 yds<sup>3</sup>/ft. The summer of 2018 saw general beachface retreat. The winter of 2018-2019 saw the largest volume loss and shoreline retreat (-52.86 yds<sup>3</sup>/ft. with a 163-foot shoreline retreat by October 2019).

The April 2018 survey shows the sand volume put in place by the federal maintenance work with subsequent surveys defining an erosion and shoreline retreat rate. The greatest loss occurred during the winter of 2018 to 2019. Offshore, the bar system provided increased sand volume and a ridge developed close to the beach in October 2019 indicating sand movement onto the beachface.

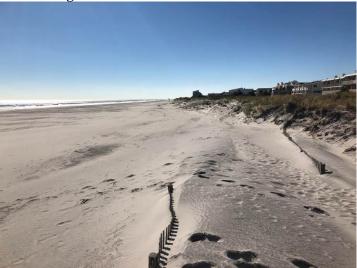
Figure 4a taken October 30, 2018 along the dune toe where wind transport has already deposited new sand. The USACE project had a positive impact here as well.

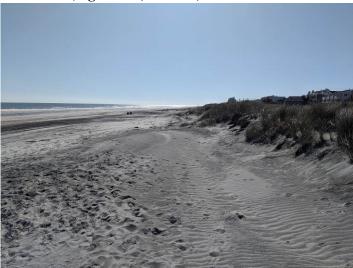
Figure 4b taken October 15, 2019 with the same perspective as last year, showing a stable beach and few changes at the toe of the dunes.

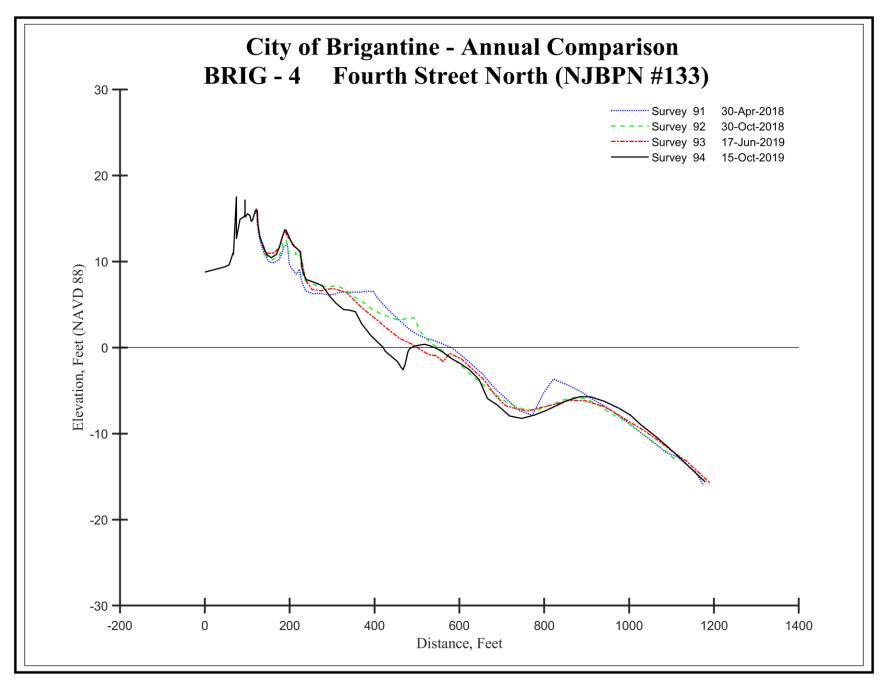
Figure 4c - Located south of the promenade, this site received sand in 2018, but lost beach width incrementally over the next three surveys. The annual change was -22.36 yds<sup>3</sup>/ft. accompanied by an 8-foot shoreline retreat (the computer counts the nearshore ridge as the "shoreline" because it rises above zero elevation).

Dune erosion has been relatively rare here since beach nourishment began in 1997. The beach slope remains gentle and allows waves to dissipate over a fairly wide distance, so the dunes are not frequently affected. Sand was added in 2018 increasing the beach width (Survey 91, April 2018). Subsequent surveys show some beach retreat with the June to October 2019 retreat the largest (-15.49 yds<sup>3</sup>/ft. in sand volume loss between 210 and 420 feet from the reference point. The entire comparison for this survey (#93 to #94) found a -15.91 yds<sup>3</sup>/ft. in sand volume loss, therefore most of the change was seen at the beachface.

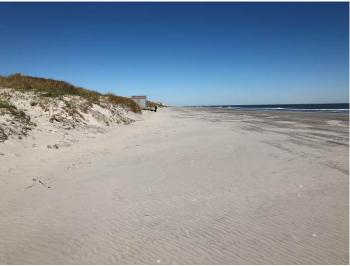
Figure 5a photo on October 30, 2018 looking north along the dune toe. The beach width was unaffected by the northeast storm two days earlier, but the water did reach nearly to the dune toe slope.

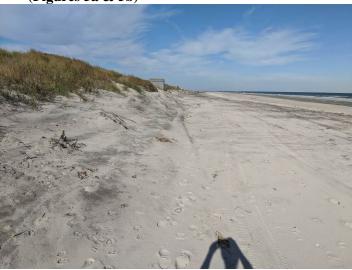
Figure 5b photo taken October 15, 2019 looking north along the seaward toe of the dunes showing the sand added to the dune slope and a wide, stable beach seaward.

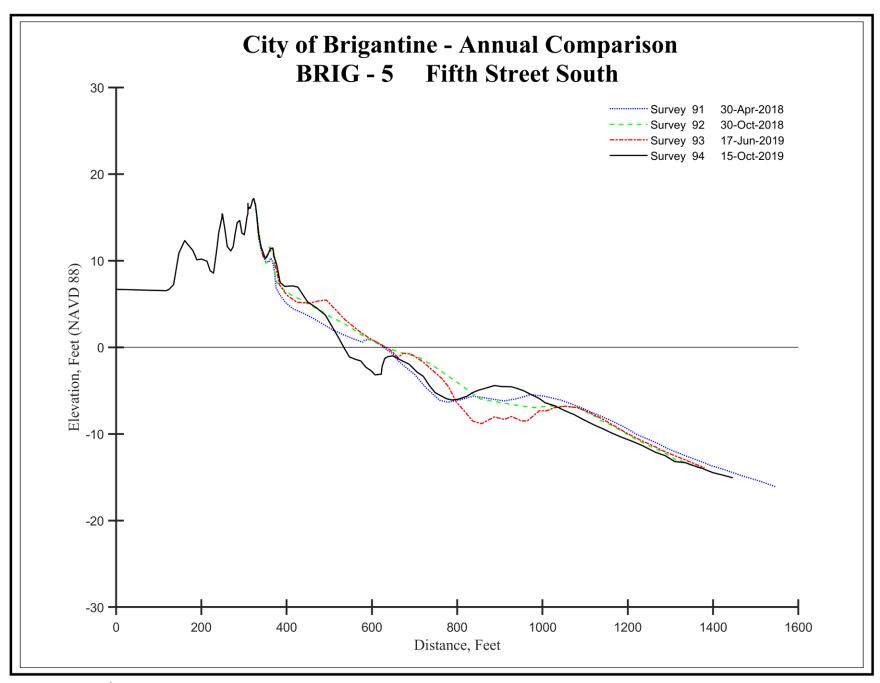
Figure 5c - The 5th Street South site had dune growth documented in the small foredune area. The beach remained accretional between April 2018 and June 2019, then retreated 98 feet as sand moved offshore and formed into a nearshore ridge immediately seaward and a larger offshore deposit.

Following the April 2018 survey, the beach gained sand during each of the next two time intervals (October 2018 and June 2019) only to lose sand between June and October 2019. The beach above the zero datum, lost 7.67 yds<sup>3</sup>/ft. while offshore lost only 0.79 yds<sup>3</sup>/ft. The shoreline retreated 98 feet after essentially no change since April 2018.

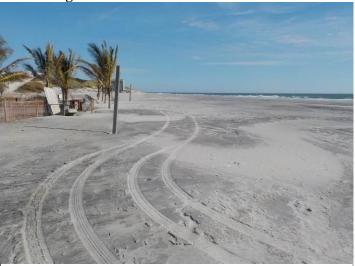
Figure 6a taken October 31, 2018 closer to the bulkhead and resort beach development. The flat beach remains over 200 feet wide to the berm crest, but at a low elevation susceptible to storm wave approach.

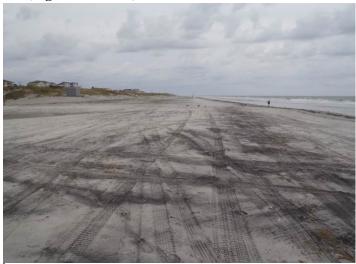
Figure 6b taken October 15, 2019 further seaward to the beach berm crest looking north across the entire beach width at this site.

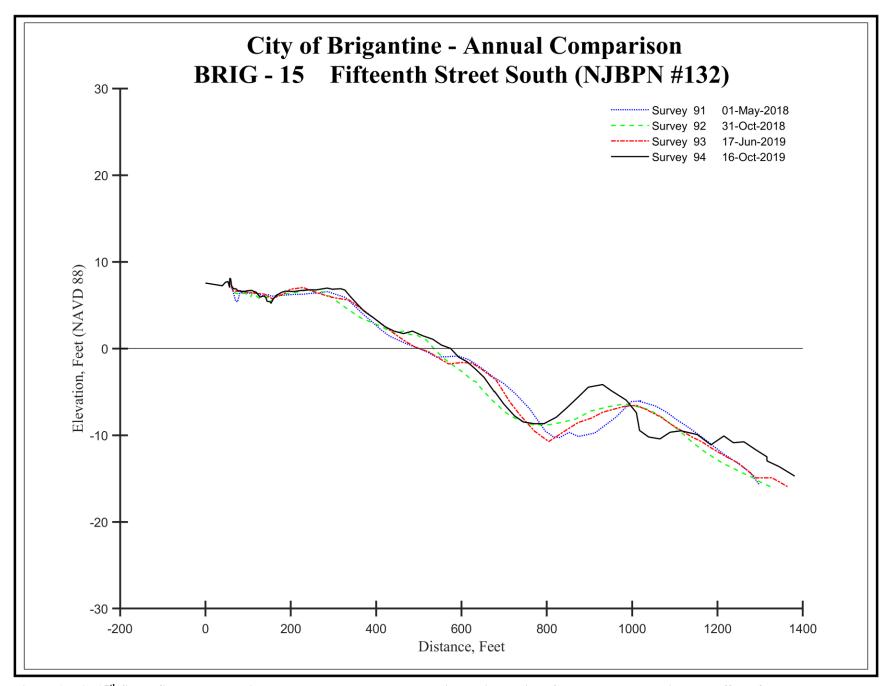
Figure 6c - At  $15^{th}$  Street South sand continues to be transported south to this location derived from the beach nourishment efforts further north. The offshore bar is extremely large for this location and sand appeared at the distal end of the survey.  $33.67 \text{ yds}^3$ /ft. in sand was deposited between June and October 2019. The beach gained 7.15 yds $^3$ /ft. while offshore accumulated 26.52 yds $^3$ /ft. and the shoreline advanced 73 feet seaward.

This year the set of surveys begins to demonstrate sand accumulation on the beach derived from the 2018 federal maintenance effort further north. The October 2019 survey shows the widest beach with a very large offshore bar deposit.

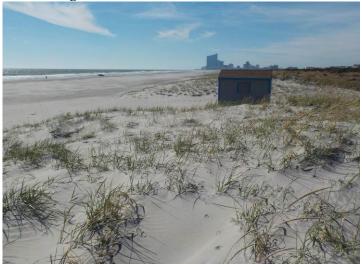
Figure 7b Photo taken October 31, 2018, from the primary dune crest looking south. The beach width is evident as is the extensive width of the dune system.

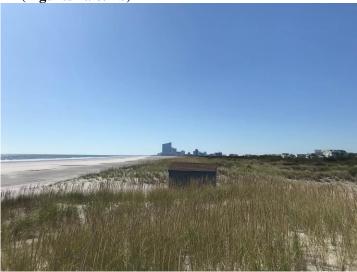
Figure 7b Photo taken October 15, 2019, once again, showing excellent grass growth over the past 12 months. This profile shows the expanse of sand extending south toward Absecon Inlet in the distance.

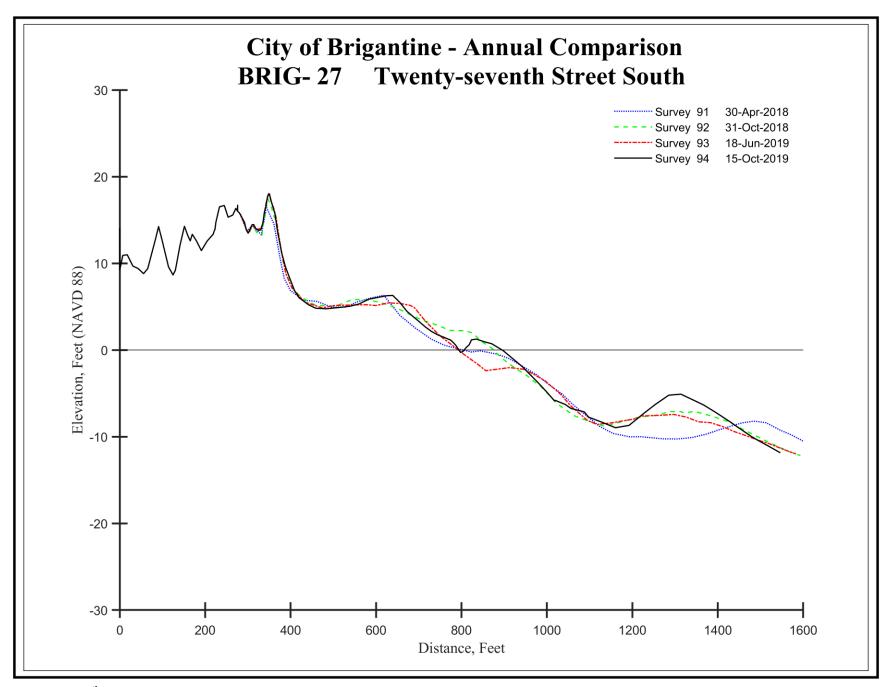
Figure 7c - 27<sup>th</sup> Street South survey site continued to accumulate sand on the seaward dune slope and on the beach. Offshore a ridge was in the act of attaching itself to the beachface and there was an extensive accumulation as a distant offshore bar as well. Above the zero elevation the gains were limited to 2.49 yds<sup>3</sup>/ft. while 20.54 yds<sup>3</sup>/ft. in sand volume were added below the zero elevation.

The 27<sup>th</sup> Street South beach added sand to the dune's seaward slope, on the beach itself, and with a series of offshore bars providing an additional 7.74 yds<sup>3</sup>/ft. in sand volume in the past year with 20.54 yds<sup>3</sup>/ft. added between June and October 2019. The shoreline this past summer advanced 102 feet seaward due to the actual addition of a nearshore bar system adding to the base of the beach near the zero-elevation position.

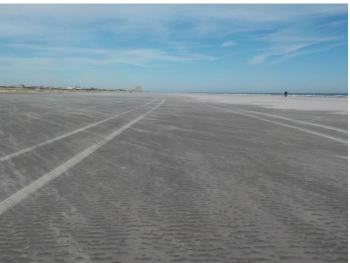
Figure 8a. Photo taken October 31, 2018 approximately in the middle of the vast beach surface at 43<sup>rd</sup> Street South. Water sat here during the northeast storm as indicated by the wind-generated ripple marks on the surface, but no

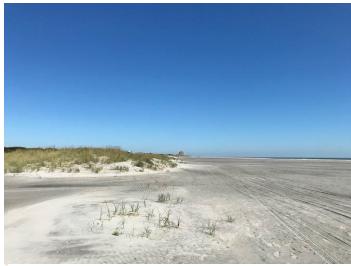
Figure 8b. Photo taken October 15, 2019 looking north along the seaward toe of the dune system. The extent of the dunes and beach are only comprehensible from an aerial view, but this does show that at this location, development appears non-existent.

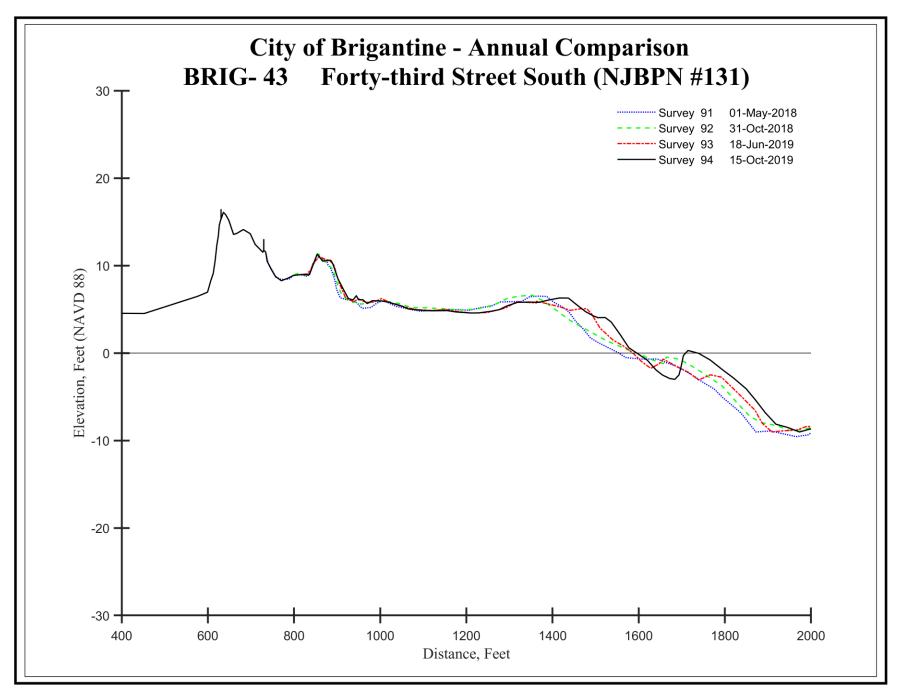
Figure 8c – This site has tripled its width over the 34-year monitoring history. Sand added to the beachface (6.18 yds³/ft. and offshore (14.47 yds³/ft.) since June 2019. Annual changes were only slightly larger (21.18 yds³/ft. for the entire cross section). The shoreline moved 140 feet seaward since 2018.

Change was seen in the seaward-most foredune and in the advance seaward by the beachface by October 2019. Offshore a ridge was forming and could provide more sand to the beach if it successfully moved onto the beach after the October 15, 2019 survey.

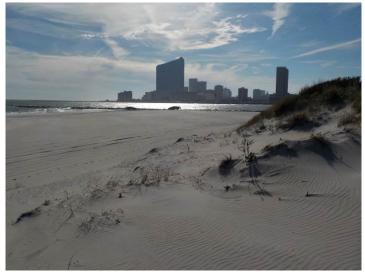
Figure 9a Photo taken on October 31, 2018 looking southeast toward Atlantic City with the dune in the foreground. The beach has advanced to within 200 feet of the end of the inlet jetty, but storm waves do move sand around and over the structure.

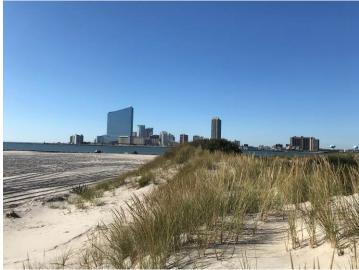
Figure 9b Photo taken October 15, 2019 from the survey instrument setup position looking toward Absecon Inlet and Atlantic City. The beach here, is extensively used by recreational vehicles in all but the harshest seasonal weather.

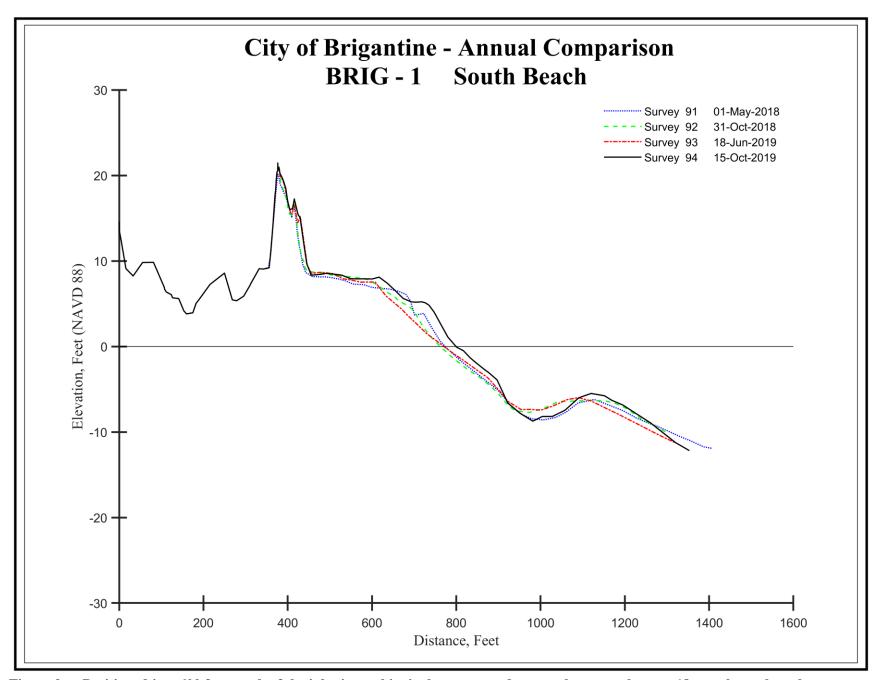
Figure 9c – Positioned just 600 feet north of the inlet jetty, this site has seen sand accumulate over the past 18 months perhaps because there have been few serious northeast storms to drive it into Absecon Inlet. Offshore was relatively quiet as contrasted with the extensive growth of bar systems elsewhere along the City's oceanfront shoreline.

The dune added material to its seaward slope over the interval of study. The largest change was seen between June and October 2019 where 21.64 yds<sup>3</sup>/ft. in sand volume were added as the shoreline moved 29 feet seaward. The annual change was in the same order of magnitude with a sand volume gain of 19.45 yds<sup>3</sup>/ft. and a shoreline advance of 37 feet.
