**ANNUAL REVIEW FOR 2020  
OF THE CAPE MAY POINT, NJ MUNICIPAL BEACHES**

PREPARED FOR: THE BOROUGH OF CAPE MAY POINT  
215 LIGHTHOUSE AVENUE  
CAPE MAY POINT, NJ 08212

PREPARED BY: STOCKTON UNIVERSITY COASTAL RESEARCH CENTER  
30 WILSON AVENUE  
PORT REPUBLIC, NJ 08241

May 8, 2020

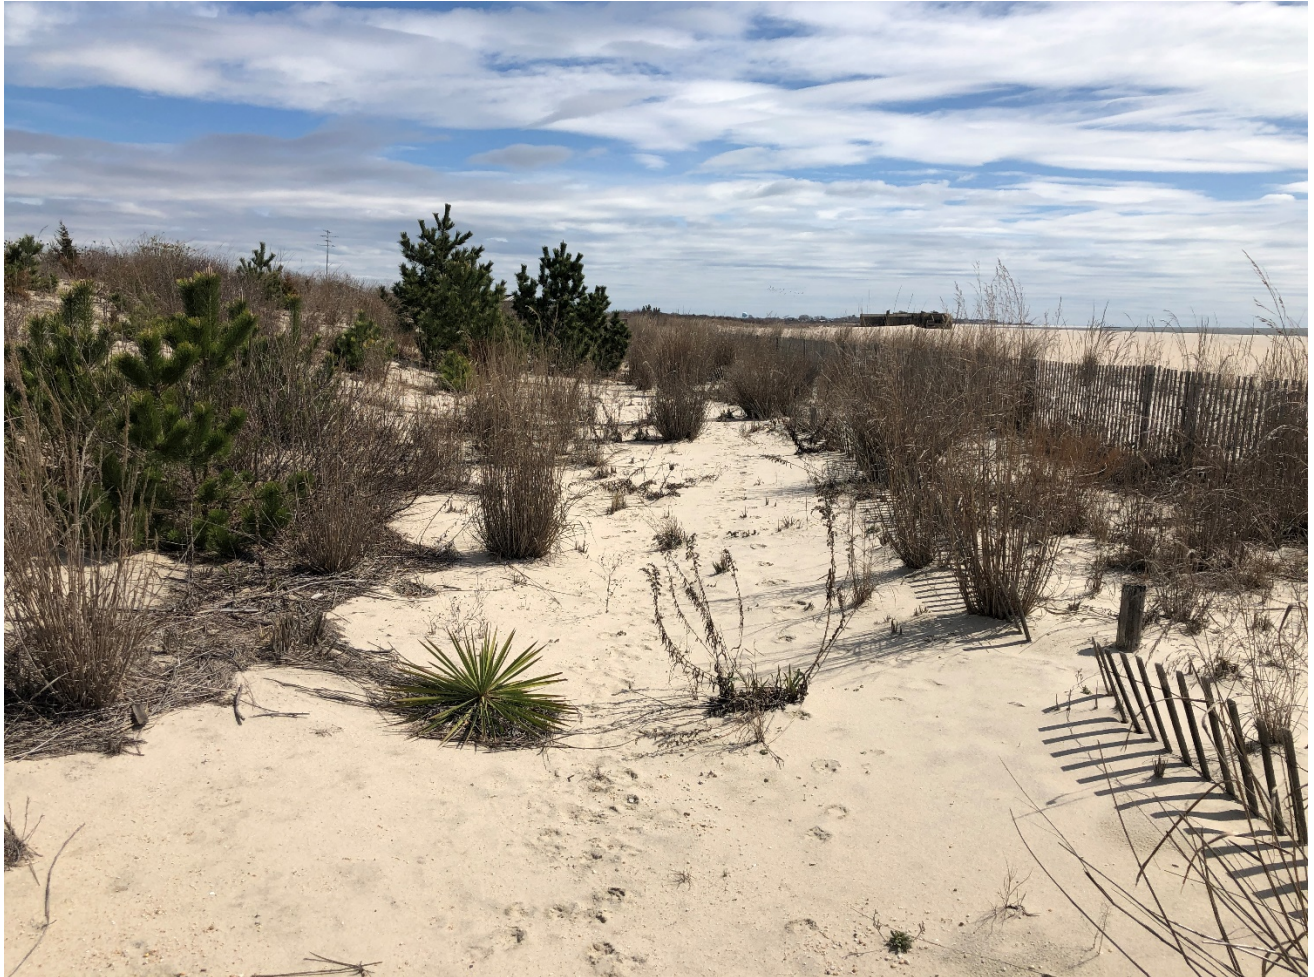
*The photo above taken on April 4, 2020 from the landward side of the dune fencing on Lighthouse Avenue looking out across the foredune vegetation into the State Park. The WW II concrete fire control bunker, now residing within the dry sand beach was entirely beyond the water line prior to the beach restoration. Where the photographer is standing would have been at or perhaps slightly in the ocean in 1990. The pine trees are naturally seeded into the dune along with the yucca plant in the left-center foreground.*

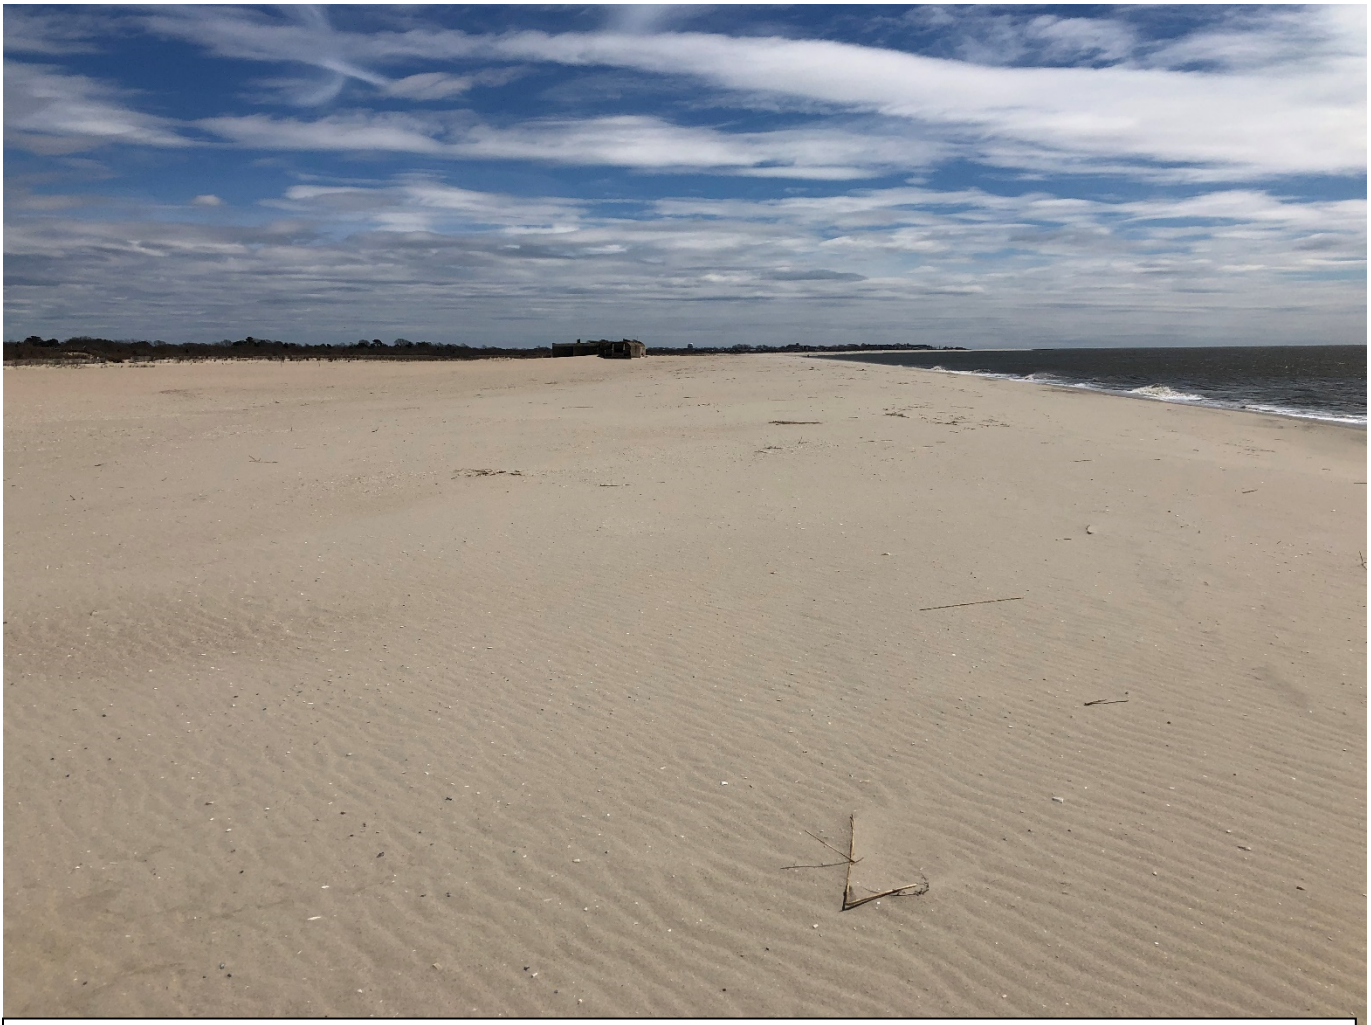
*Figure 1. The view was taken April 3, 2020 showing the transition into the NJ State Park and with Cape May City in the far distance. This expanse of beach remains a direct result of federal beach restoration at this location.*

The Lighthouse Avenue beach is currently 400 feet wide from the dune toe to the water's edge. There has been minimal change in the profile configuration. Sand has added to the dune, shifted nominally on the dry beach, and moved upslope onto the berm at the beachface. Offshore, the slope has remained constant, if rather steep.

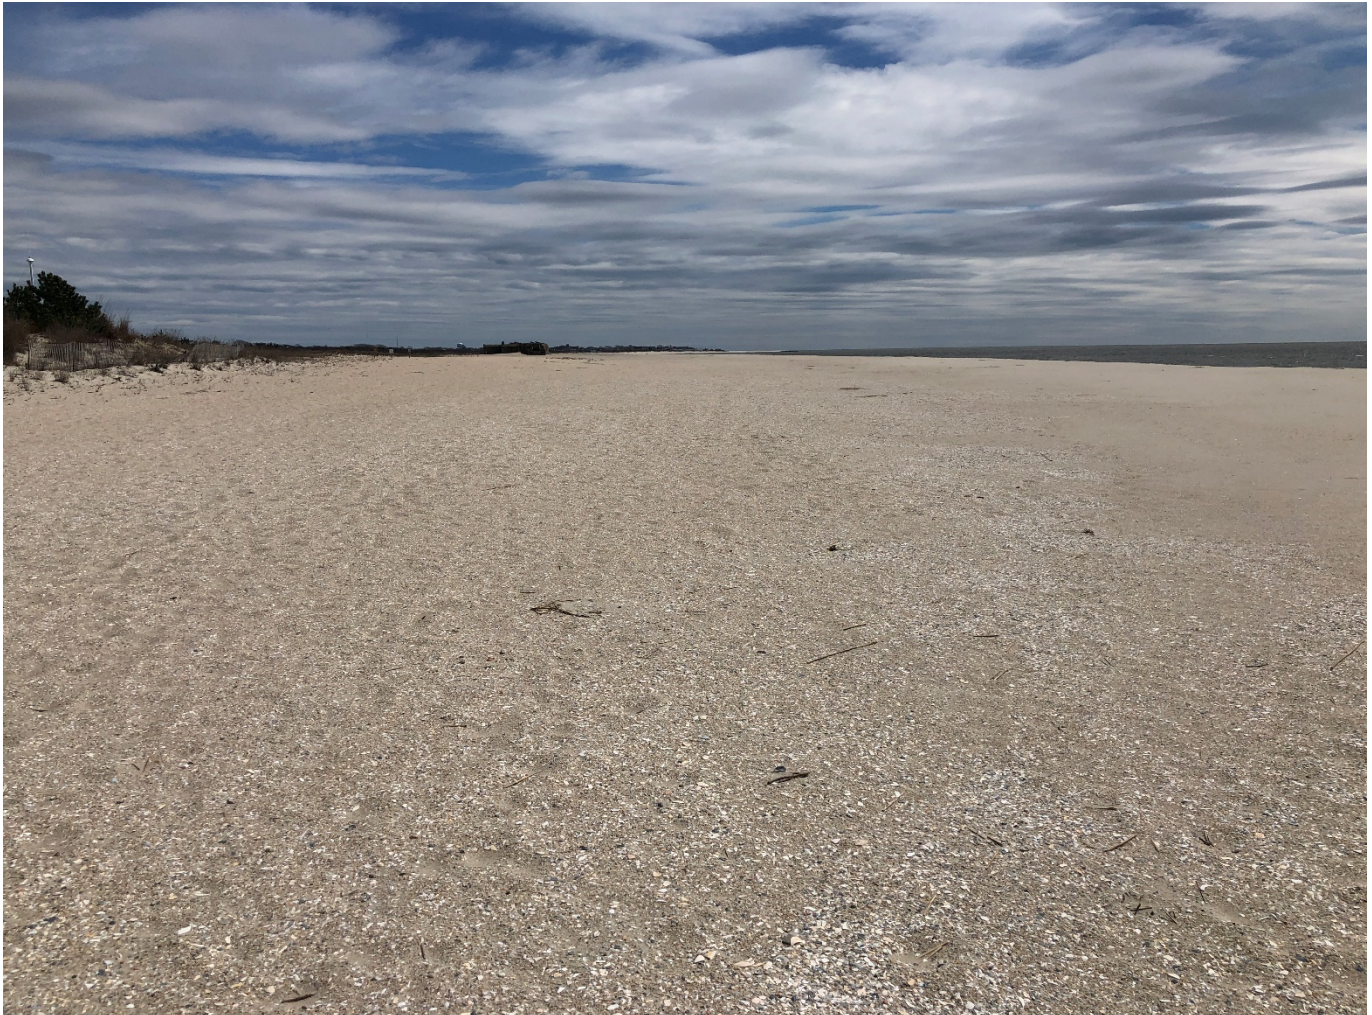
*Figure 2. This view is to the northeast showing the beach width present as of April 3, 2020. The dune to the left side sits on top of the stone revetment and the beach is many times the pre-beach nourishment width creating an excellent storm barrier as well as a recreational resource to the Borough citizens.*

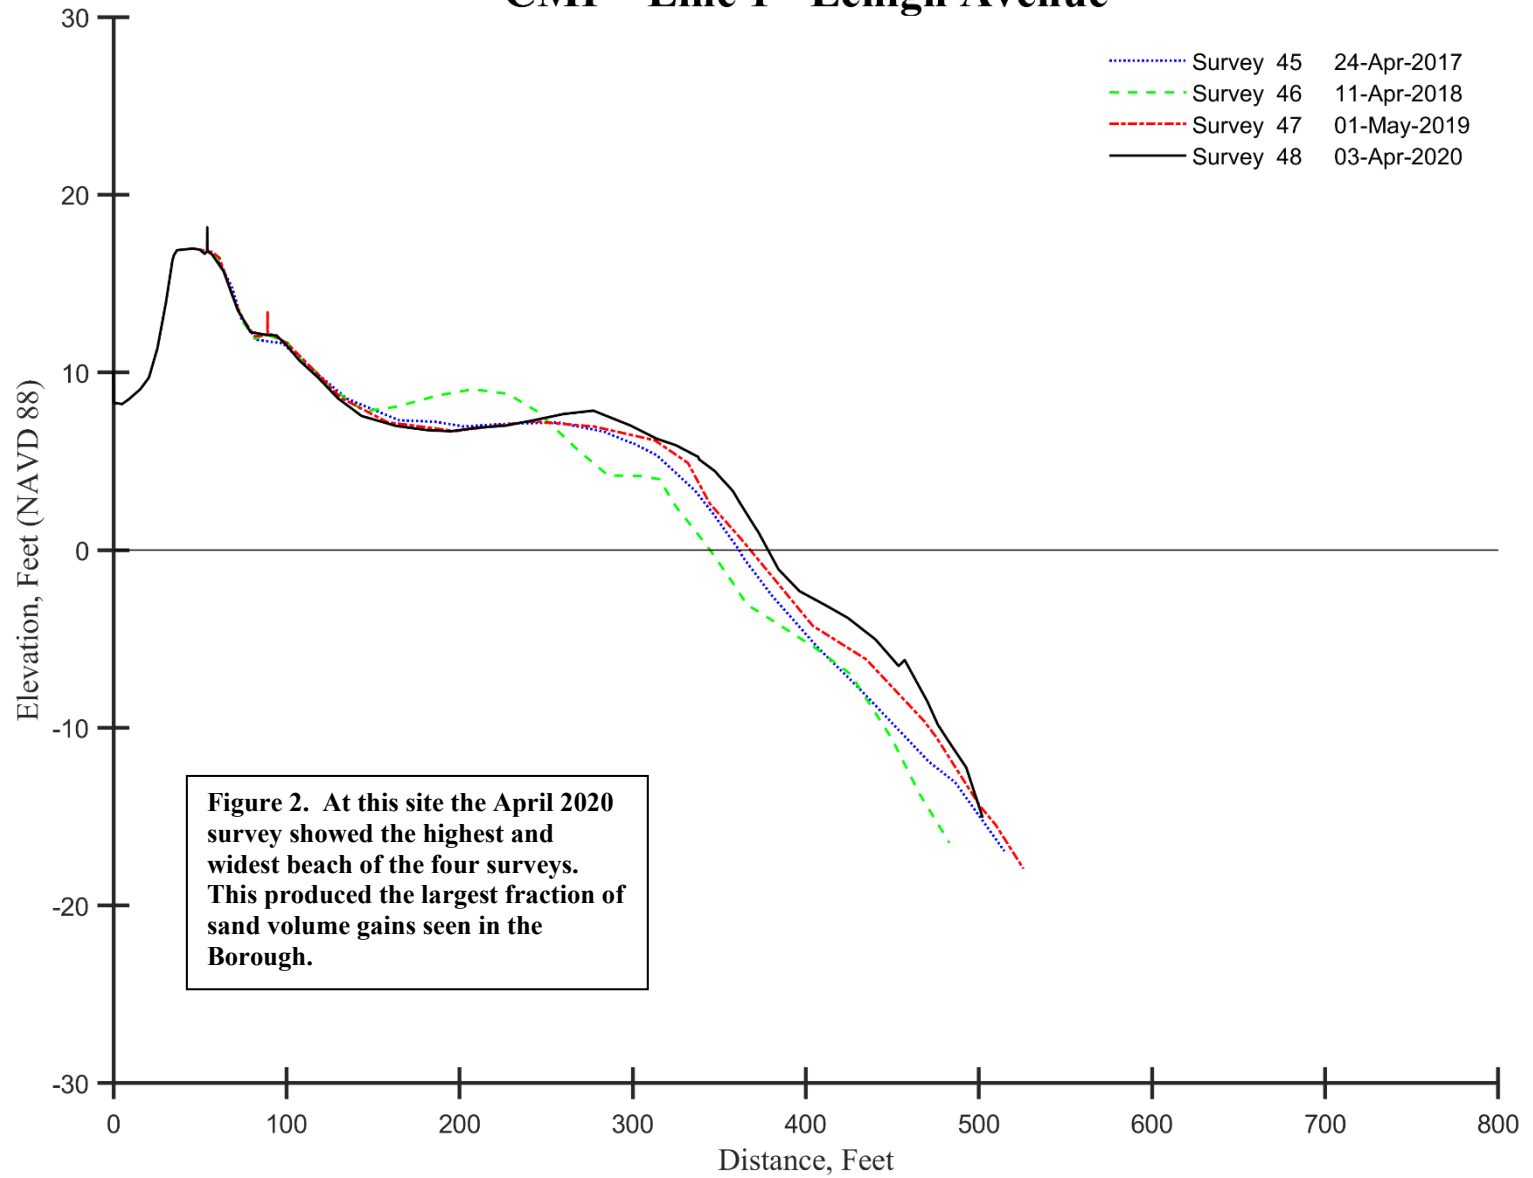
## Cape May Point - Annual Comparison CMP - Line 1 - Lehigh Avenue

This site also received sand during the USACE authorized second maintenance project conducted between November 2012 and January 2013. The most recent project counted both Lighthouse and Lehigh sites as one placement volume at 78,174 cubic yards. The visual impact is like that seen at Lighthouse Avenue with both sites seeing similar shoreline advances. Sand continued to move into this groin cell between 2018 and 2020. Both the shoreline advance (+33.5 feet) and the sand volume increase (25.13 yds<sup>3</sup>/ft.) were the largest seen across the Borough shoreline in the two-year interval.

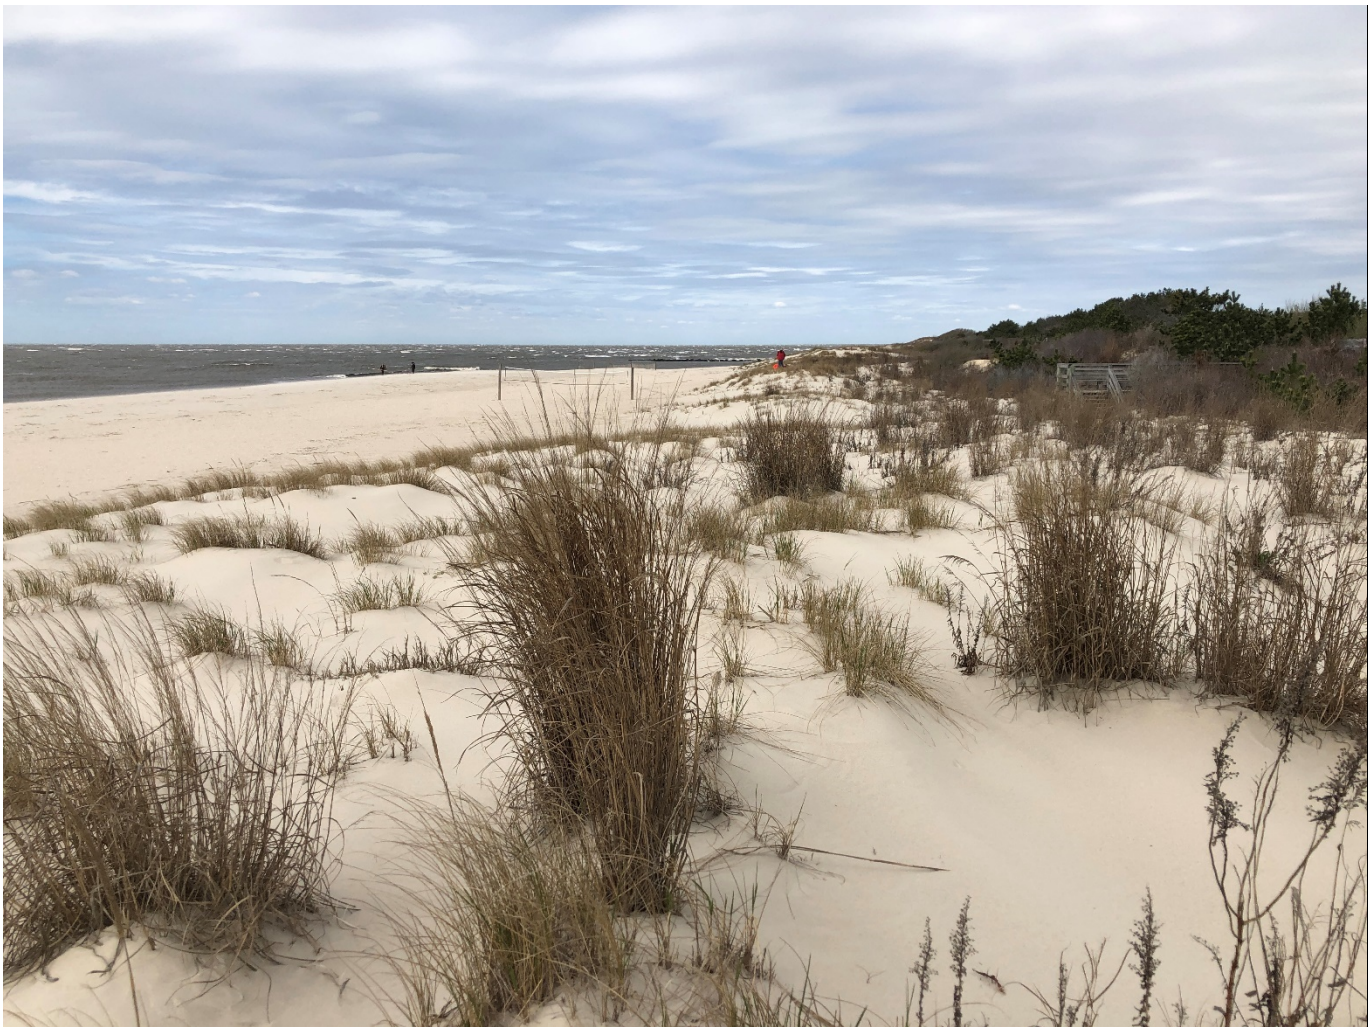
*Figure 3. The April 3, 2020 view to the west shows an expanding foredune zone with large mounds of wind deposition around clumps of few grass plants indicating continued dune growth. The beach width is recreationally sufficient and serves as an effective wave barrier too.*

The recent cycle of USACE sand placement also did not directly put sand into this cell. However, sand added to this cell by natural processes with a wider berm and continued extensive burial of the 1993 “Beachsaver” reef system.

However, the concrete barriers are still exposed on the seabed and have become more of a tripping hazard and risk of cut feet on the marine growth on the structure than previous potential for wave rush or back wash of swimmers into the structures.

2. Cell 2 at Whilden Avenues, the shoreline position (zero datum) is approximately 120 feet distance from the breakwater structure. Depth of the scour trough landward of the units has increased a bit from 2019, but with 2.5 feet of the reef structure now exposed above the sea floor around the units. The swimming area width has increased by 30 feet, but there is a risk of injury to unwary visitors if they step on the reef structure by accident. Wave surge should be far less than when 6-7 feet of height existed between the reef crest and the landward seafloor. The CRC again recommends installing a line of floats indicating the maximum distance for swimming that should be about 20 feet from the breakwater reef.

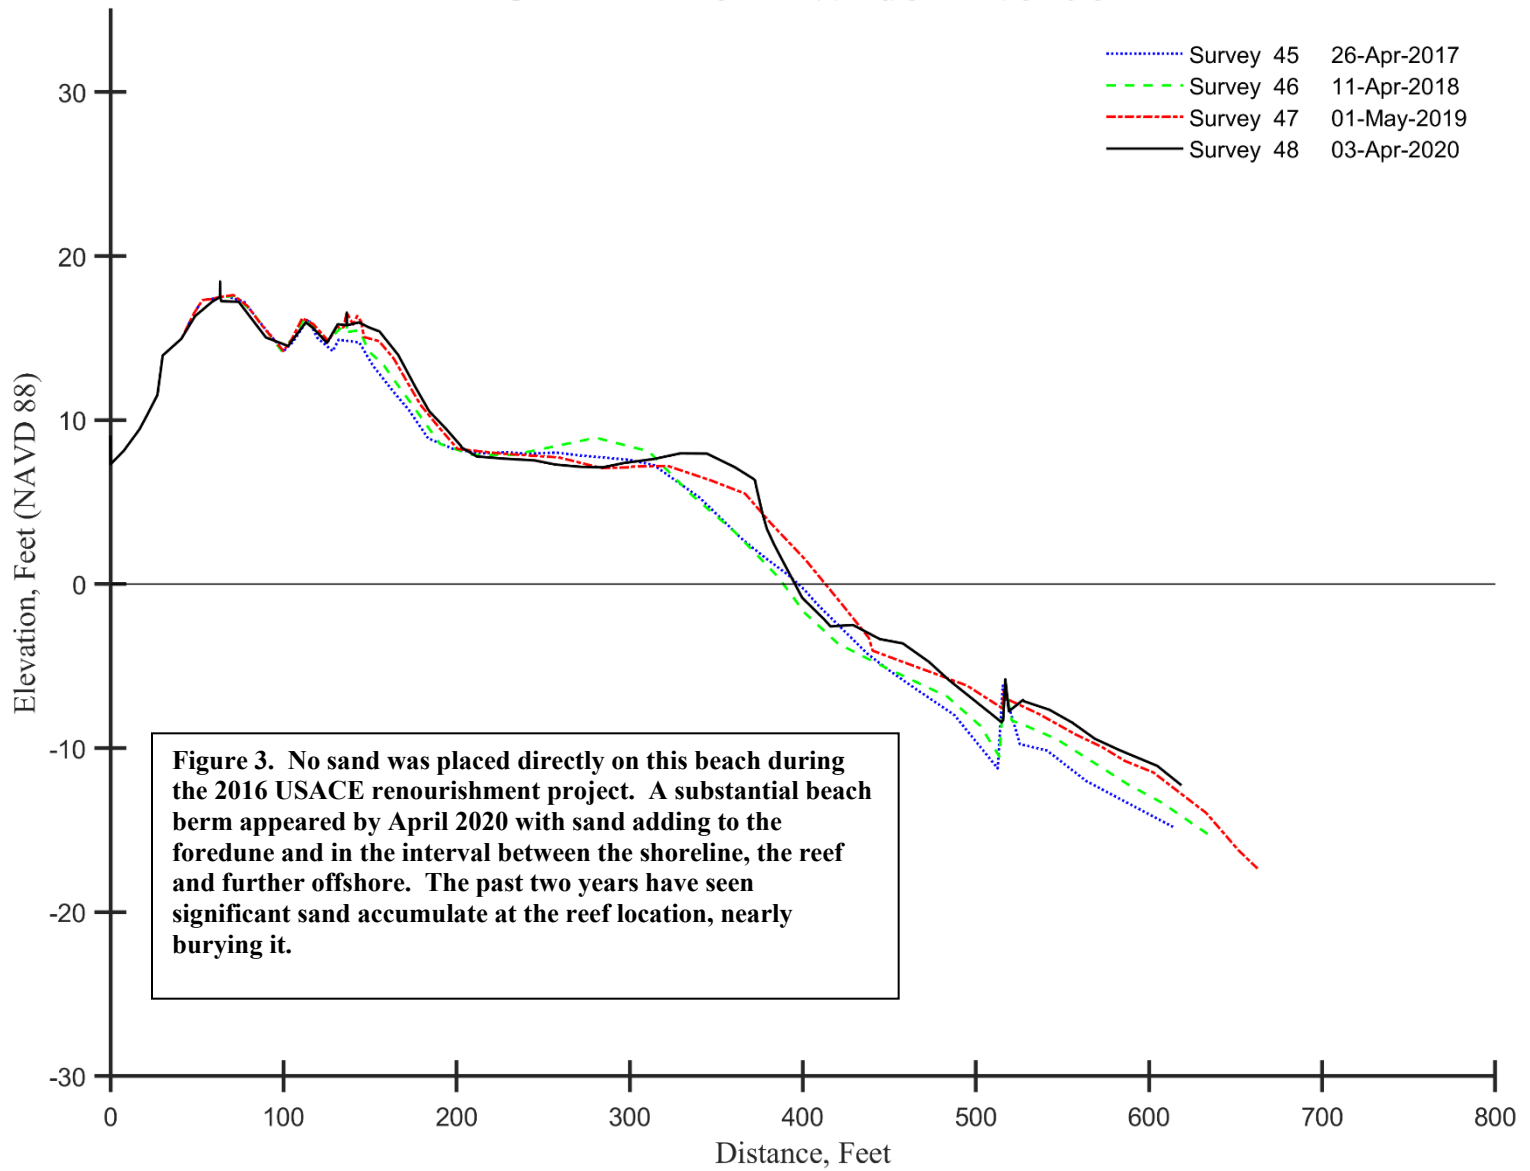
## Cape May Point - Annual Comparison CMP - Line 2 - Wilden Avenue

The “Beachsaver” unit has been incrementally buried by sand reducing its crest exposure above the seabed from 6 to barely 2.0 feet above the sea floor at its location. Landward of the units, a very minor trough remains with even shallower sand slopes further seaward as material was added offshore. There is a 90-foot area between the zero-elevation position on the beach and the barriers. The top elevation has remained constant for many years, so the structure appears stable. At low tide the distance would be less than 90 feet and at high tide a bit more. The depth at the base of the beachsaver is 7.05 feet NAVD 1988.

This beach gained 1.63 yds<sup>3</sup>/ft. in sand volume while seeing a 17.6-foot shoreline retreat between 2019 and 2020. Over the past two years the site gained 19.22 yds<sup>3</sup>/ft. in sand volume while enjoying a 6.7-foot shoreline advance.

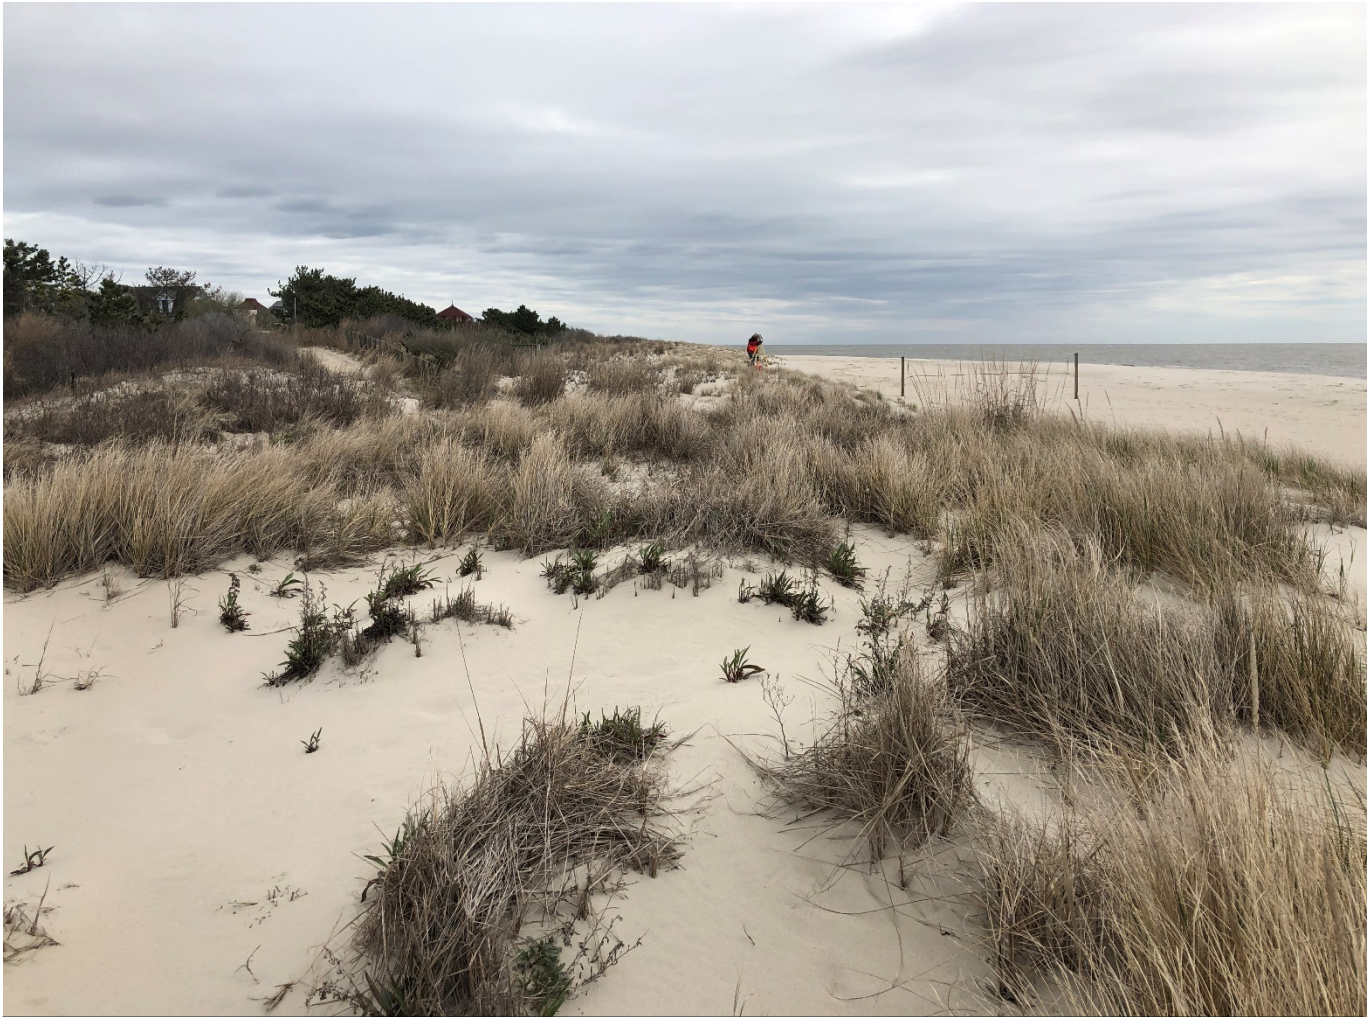
*Figure 4. The view to the east along the foredune toe shows the grass mounding of the added sand where root extensions have generated tufts of new growth expanding the dune’s width. The beach view is back toward CMP-2 showing the same two posts on the beach.*

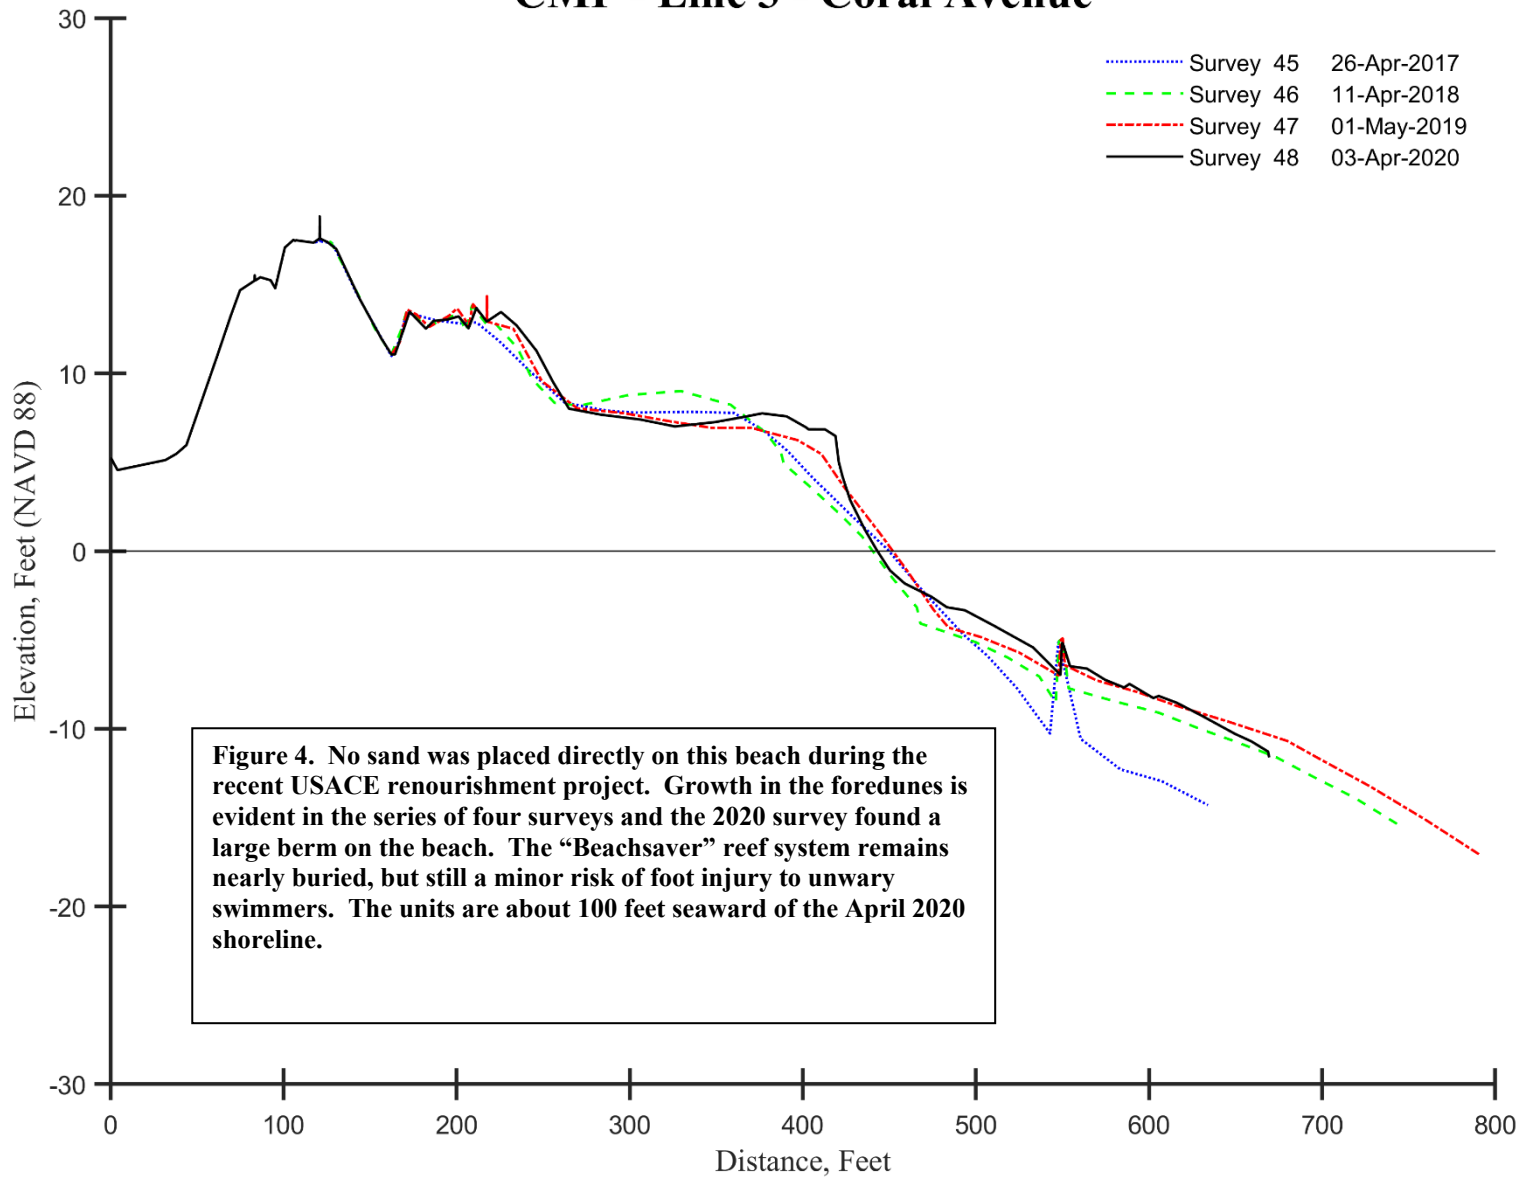
## Cape May Point - Annual Comparison CMP - Line 3 - Coral Avenue

This site has seen near burial of the “beachsaver” reefs where the elevation relief on the concrete structures has been reduced from 5.0 feet showing above the seabed in 2016 to 2.25 to 2.5 feet showing May 1, 2019. This year, the reef system remains nearly buried with sand with more trapped between the shoreline and the reef structure.

3. Cell 3 at Coral Avenue, the shoreline position remained relatively constant; the breakwater units in April 2020 were approximately 110 feet from the shoreline position (zero datum). The space between the water's edge and the reefs filled in dramatically to allow bathers to walk into the water to the reef itself. Wave turbulence over the structures should be minimal this season because about 2 feet of reef structure is exposed above the seafloor. The reduction in exposed reef structure above the sand surface reduces the wave turbulence over the reef and makes for safer swimming. Markers or floats should be used if swimming is allowed. Perhaps both CMP 2 & 3 could be used this season as a means to space out summer visitors as part of social distancing and allow chest deep water access in both of these beach cells.

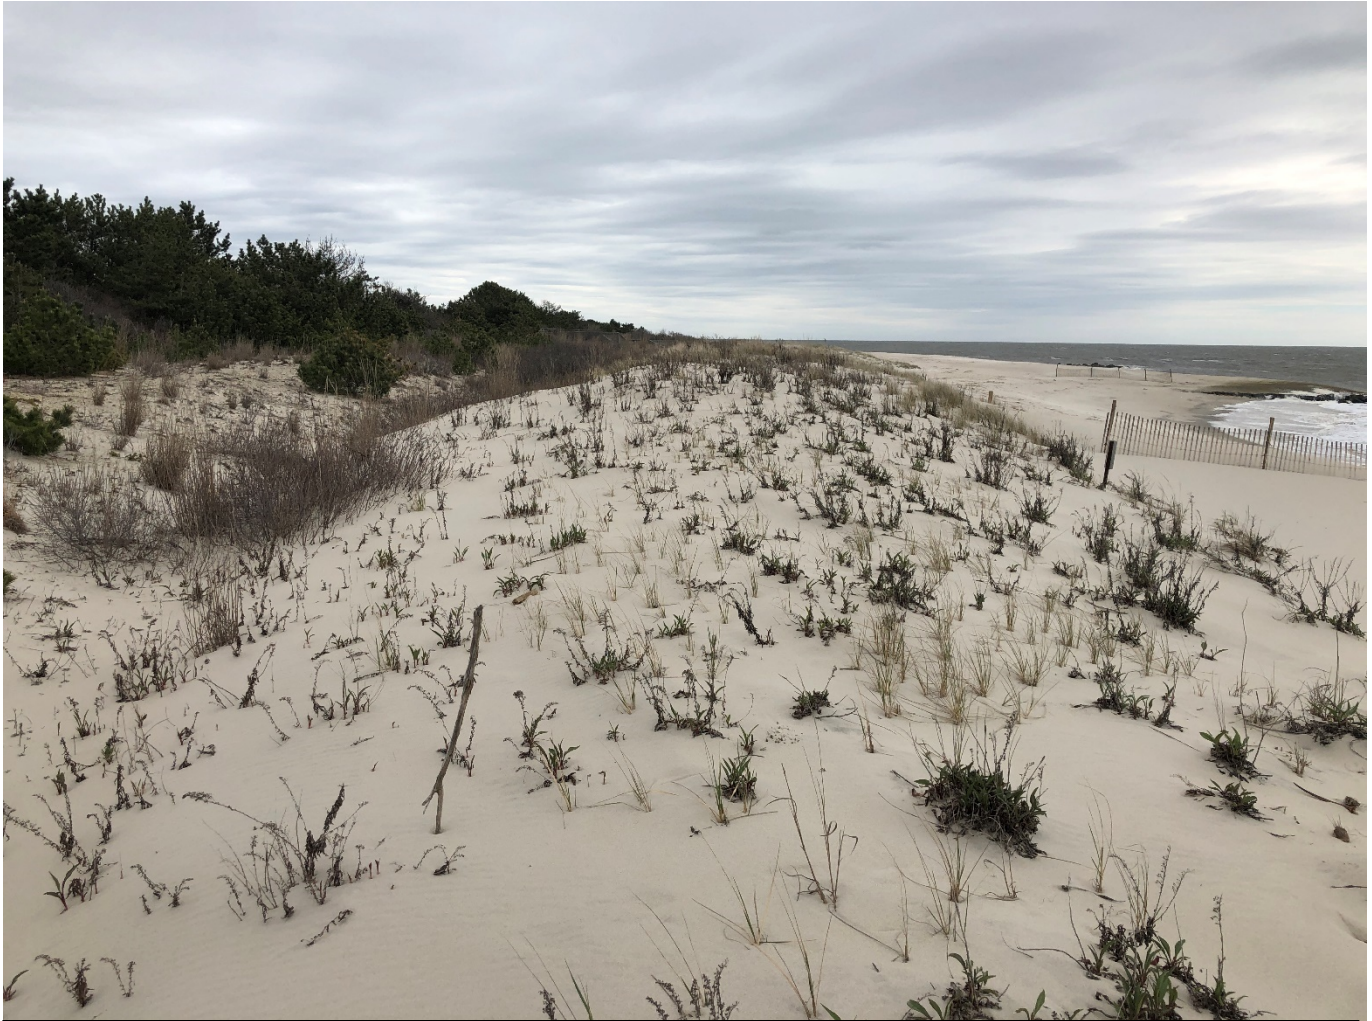
*Figure 5. This April 3, 2020 view to the east shows the extensive foredune, but a narrow beach curving toward the dune from the rock groin.*

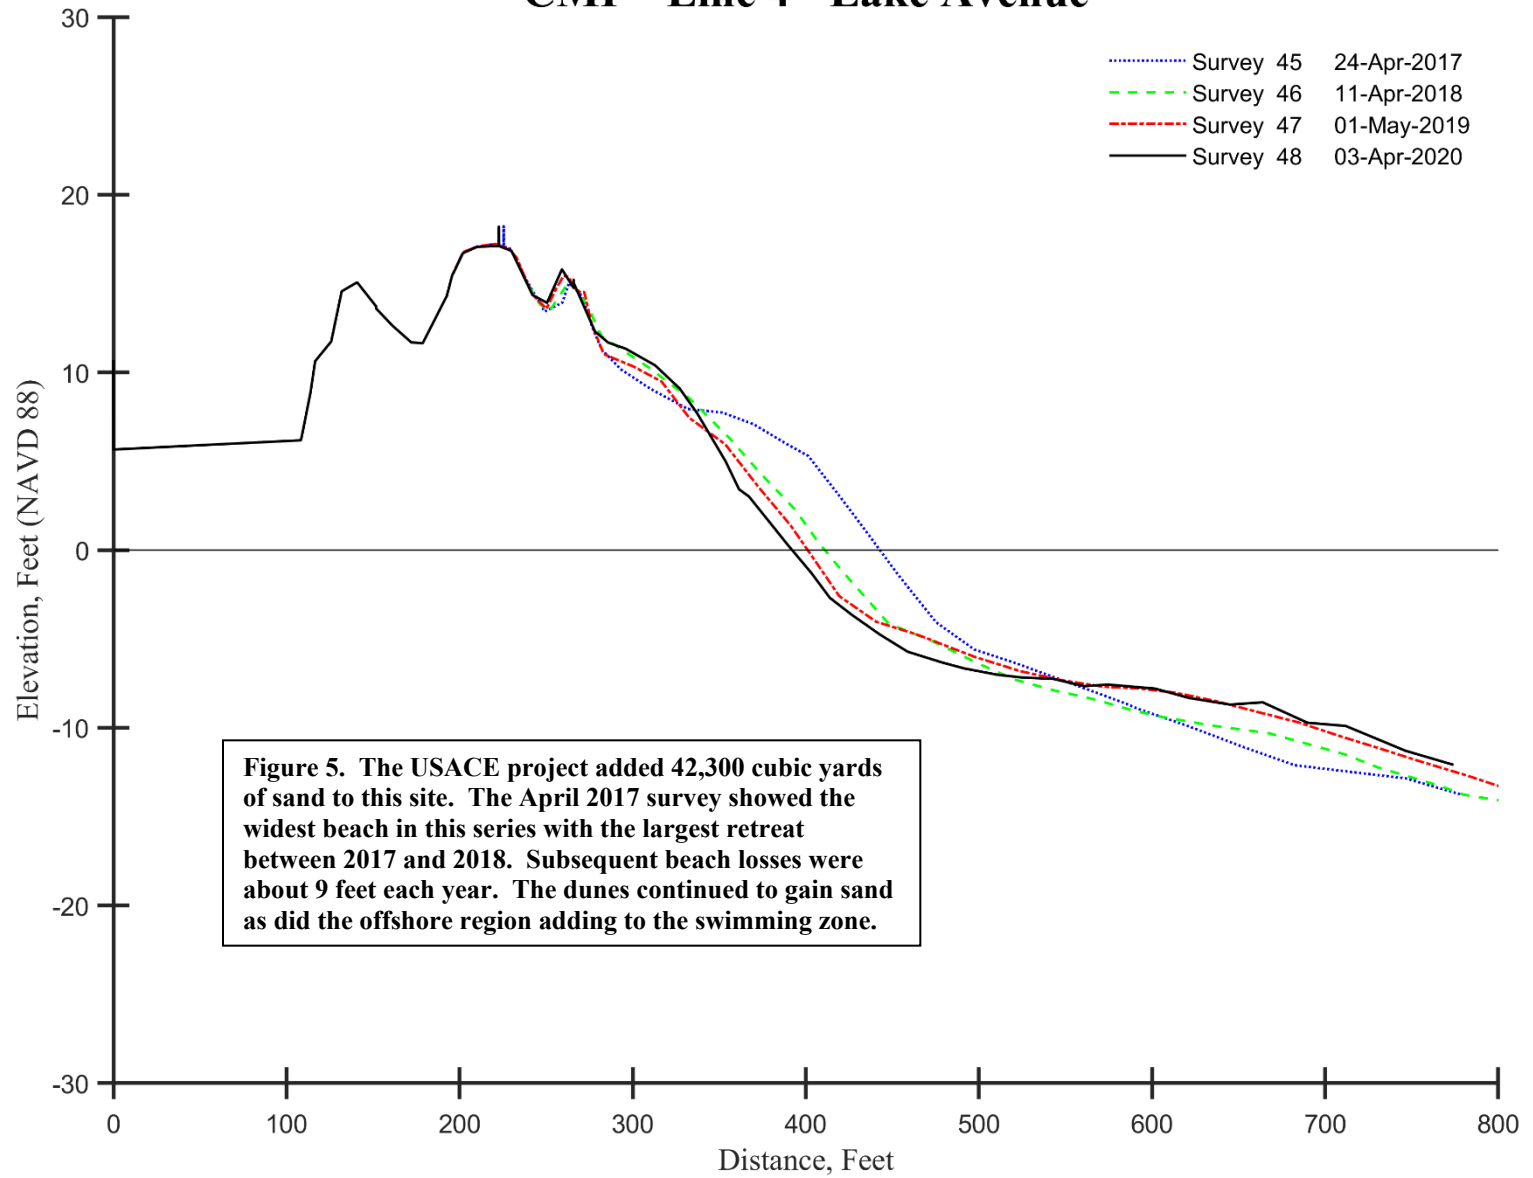
## Cape May Point - Annual Comparison CMP - Line 4 - Lake Avenue

Lake Drive continues a multi-survey beachface retreat this year with approximately 9 feet of shoreline retreat in both 2019 and 2020. The sand volume increased by 17.55 yds<sup>3</sup>/ft. in 2019 and then remained constant with a minor gain of 1.63 yds<sup>3</sup>/ft. in 2020. The total of 19.22 yds<sup>3</sup>/ft. was added over two years.

**Figure 5. The USACE project added 42,300 cubic yards of sand to this site. The April 2017 survey showed the widest beach in this series with the largest retreat between 2017 and 2018. Subsequent beach losses were about 9 feet each year. The dunes continued to gain sand as did the offshore region adding to the swimming zone.**

4. Cell 4 (Lake Ave.) has no structures offshore and a relatively flatter nearshore slope. This site remains overall a good option for a swimming beach in Cape May Point this season and the recreational berm is about the same this year. The relatively shallow slope platform in the water between groins make wading and swimmer relatively safer for beach patrons.

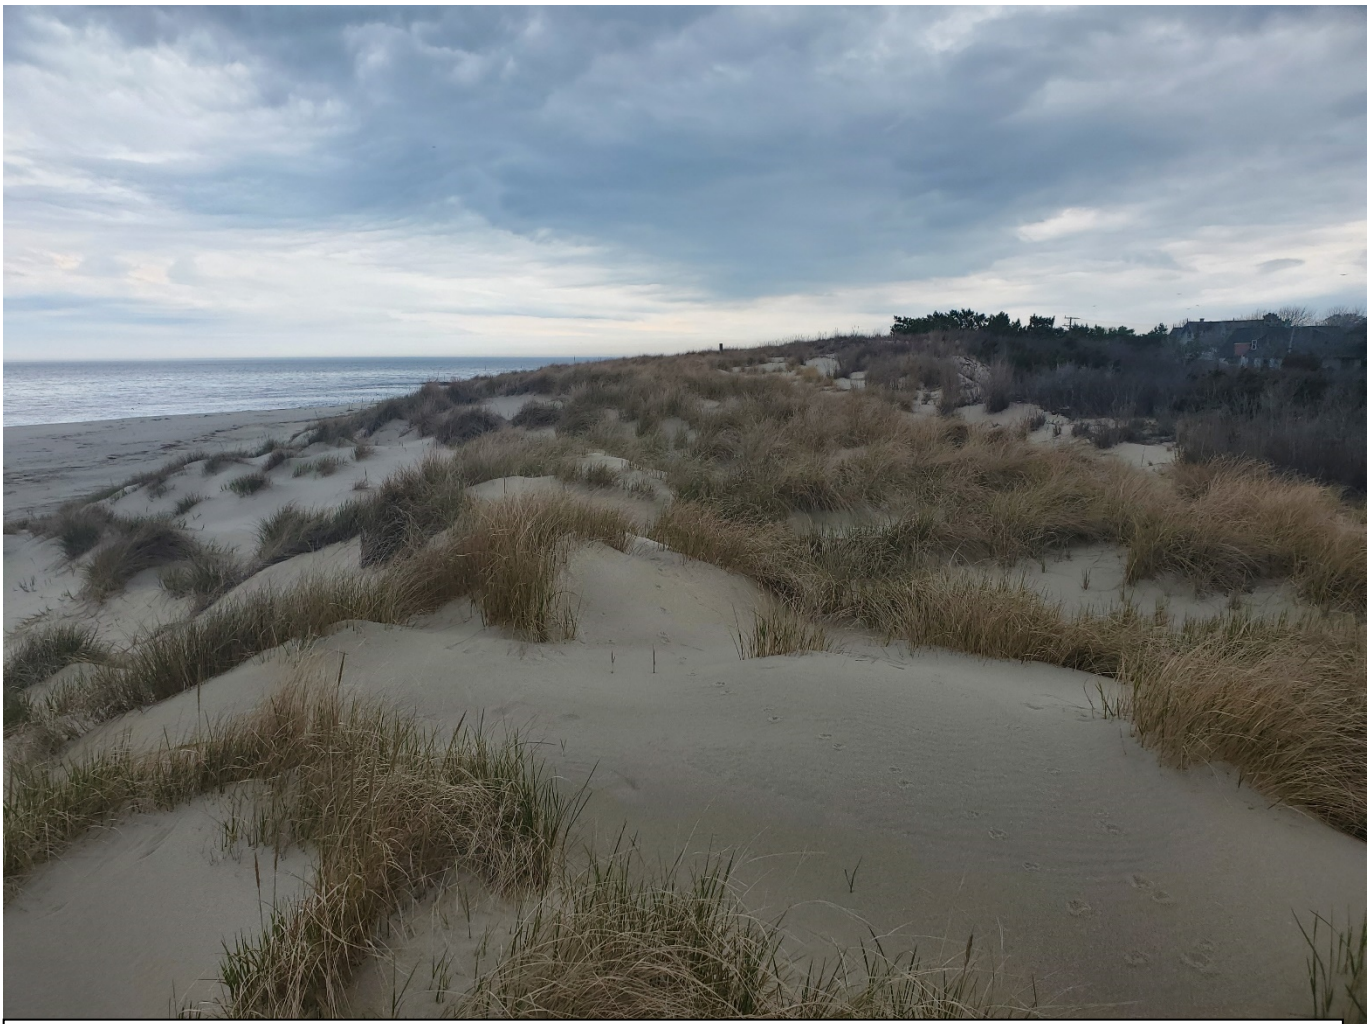
*Figure 6. This beach also saw continued wind deposition within the foredune zone adding to the combination of grass growth and seaward expansion of the dune’s seaward toe. The beach width is sufficient for the current conditions.*

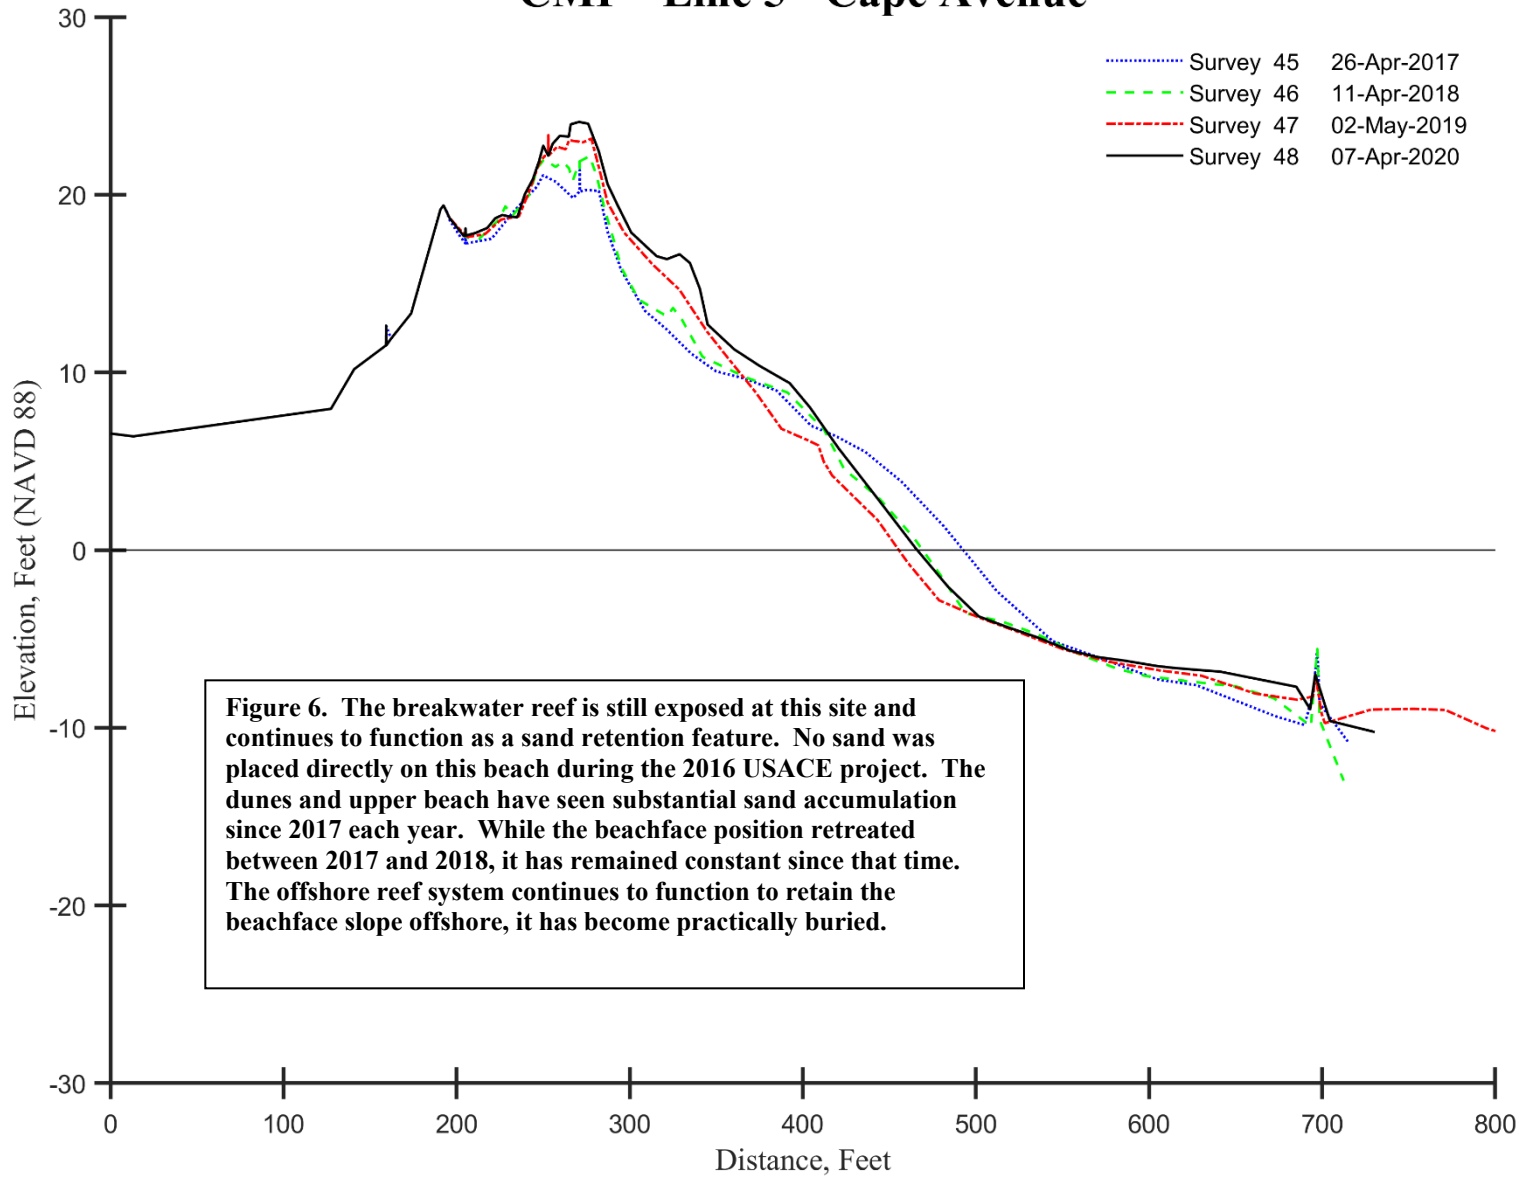
## Cape May Point - Annual Comparison CMP - Line 5 - Cape Avenue

The wider beaches have provided a source of sand for the wind to move sand onto the seaward slope and crest of the dune. The beach from the dune crest to the waterline continued to gain sand volume between 2017 and 2020. The 2020 increase was 13.88 yds<sup>3</sup>/ft. overall and 10.73 yds<sup>3</sup>/ft. above the zero elevation. The “Beachsaver” reef system was detected, but with even less relief than documented last year.

**Figure 6. The breakwater reef is still exposed at this site and continues to function as a sand retention feature. No sand was placed directly on this beach during the 2016 USACE project. The dunes and upper beach have seen substantial sand accumulation since 2017 each year. While the beachface position retreated between 2017 and 2018, it has remained constant since that time. The offshore reef system continues to function to retain the beachface slope offshore, it has become practically buried.**

5. Cells 5 (Cape Ave.) and 6 (Pearl Ave.) contain the newer submerged breakwater units but they pose minimal risk for swimming in 2020. Both reef structures lie in greater than -8 feet of water approximately 200 hundred feet from the shoreline at low tide. The landward trough filled in at Cell 5 as well, generating a flat area between the reef and the shoreline. The "Double Tee" structure in Cell 6 is buried with additional sand. Swimming near the groins should always be avoided since the units are slightly closer to the beach adjacent to the rocks.

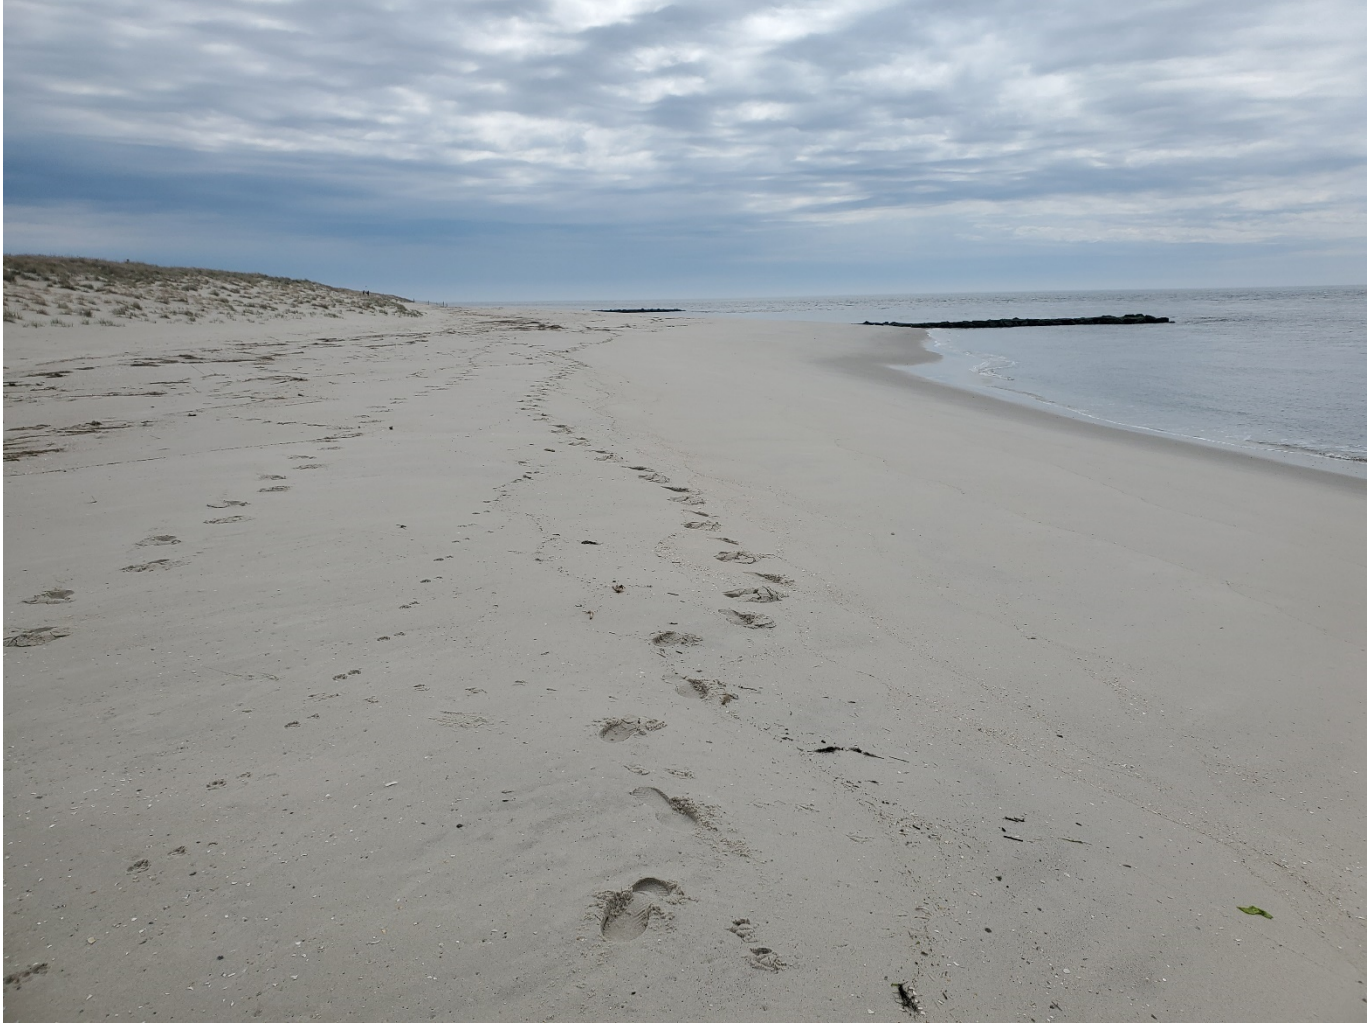
*Figure 7. This view was taken April 7, 2020 at the berm crest on the beach looking east toward the rock groin. The dune toe defines the extent of dune growth leaving a modest dry beach widening toward the groin.*
