**ANNUAL REVIEW FOR 2020  
OF THE CAPE MAY POINT, NJ MUNICIPAL BEACHES**

PREPARED FOR: THE BOROUGH OF CAPE MAY POINT  
215 LIGHTHOUSE AVENUE  
CAPE MAY POINT, NJ 08212

PREPARED BY: STOCKTON UNIVERSITY COASTAL RESEARCH CENTER  
30 WILSON AVENUE  
PORT REPUBLIC, NJ 08241

May 8, 2020

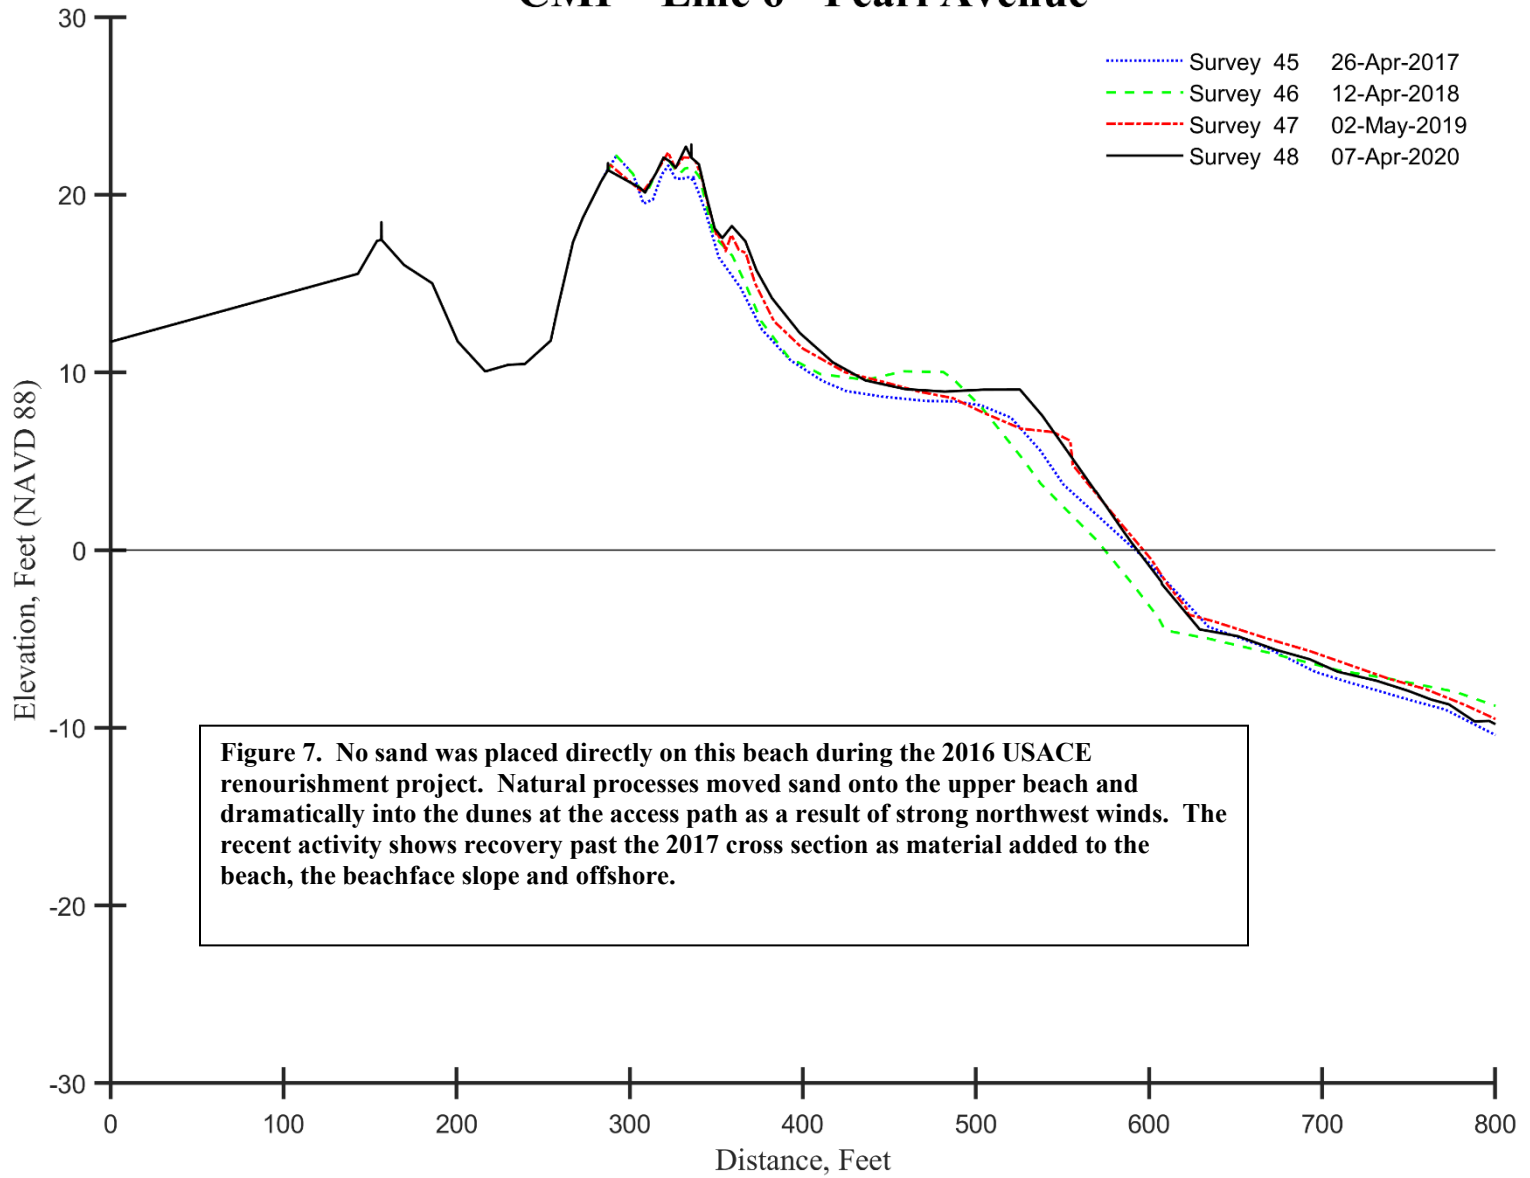
## Cape May Point - Annual Comparison CMP - Line 6 - Pearl Avenue

No sand was placed this far west during the USACE nourishment project, so beach building has been a result of natural processes. This past year has seen added material to the berm, the foredune slope with very little loss offshore.

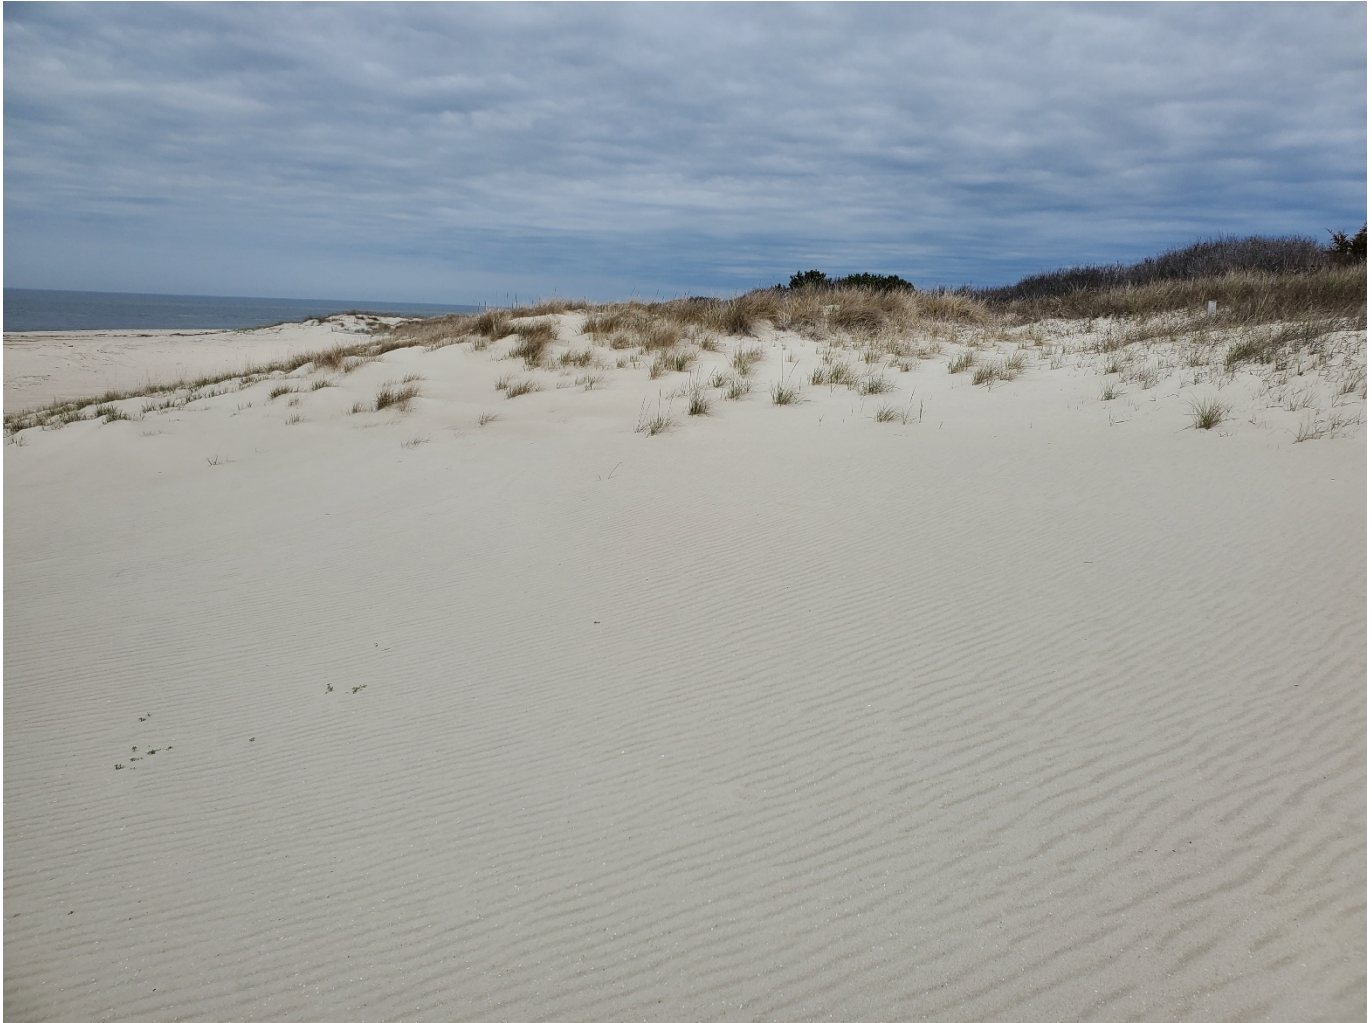
*Figure 8. The April 7, 2020 view to the west on CMP-7 shows the expanse of foredune slope and its vegetation. The mass of accumulated dune sand remains the largest among the Cape May beach segments in both total elevation and width of the dunes. The beach provides excellent protection as well.*

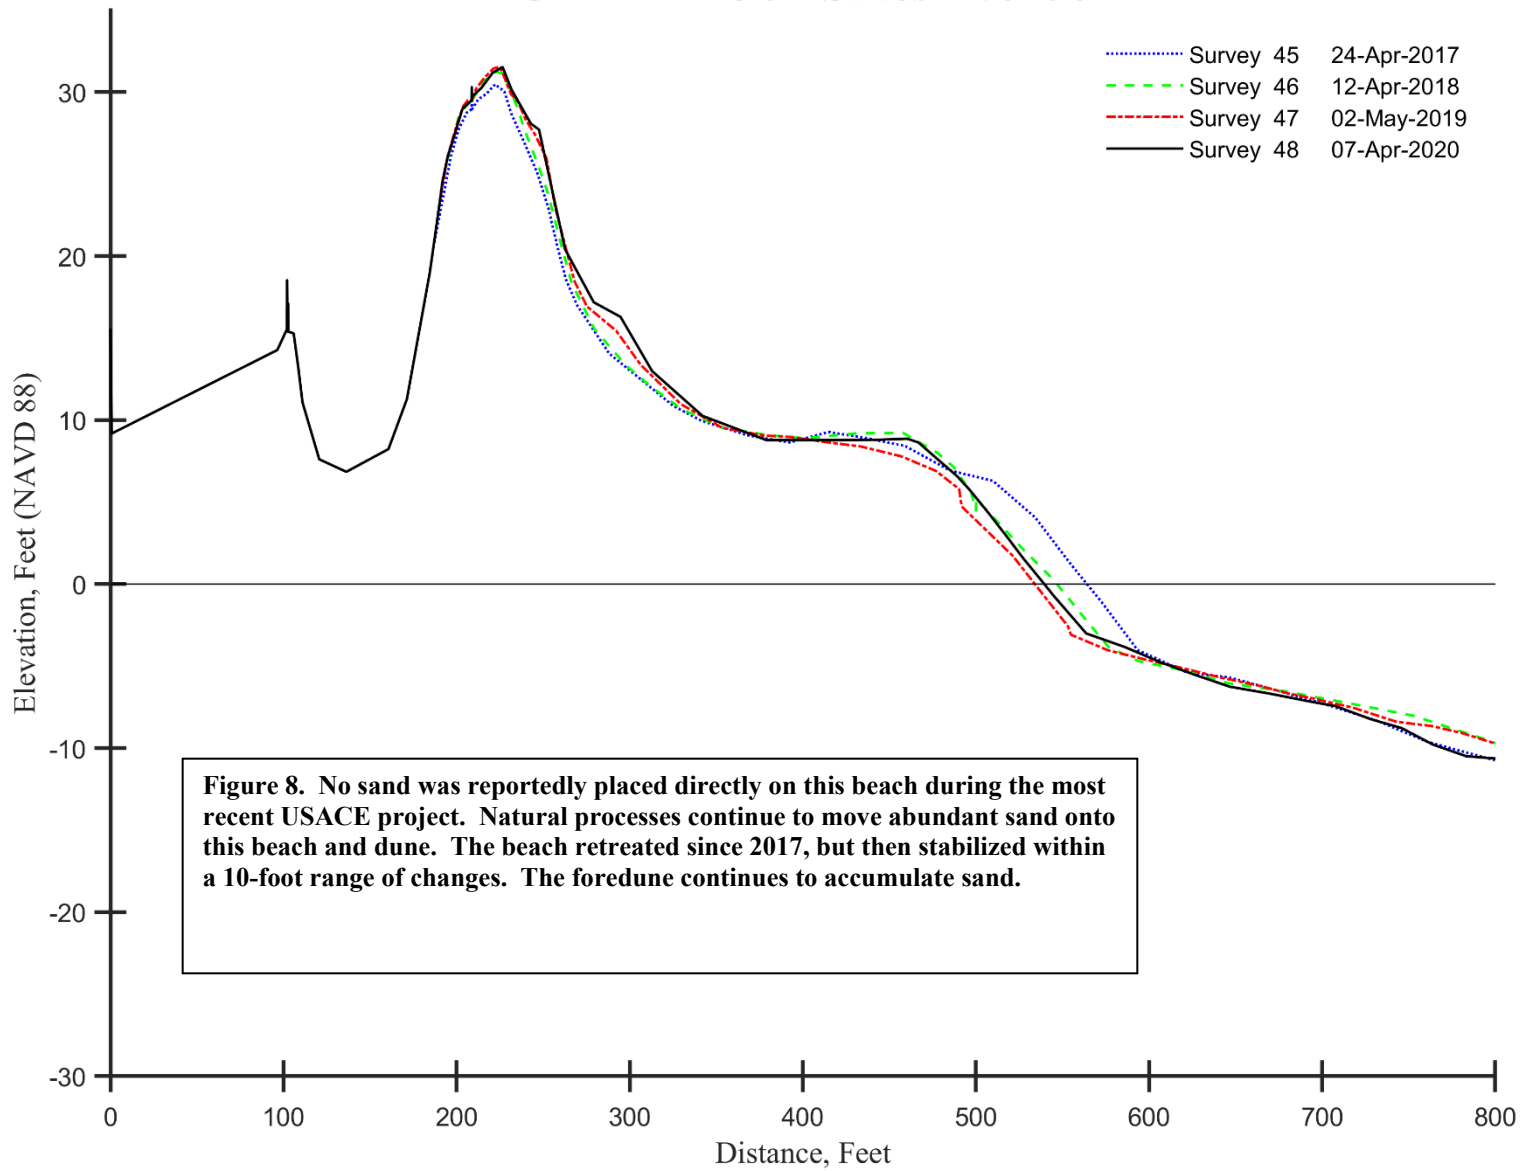
## Cape May Point - Annual Comparison CMP - Line 7 - Stites Avenue

Dune crest elevations in excess of 30 feet NAVD 1988 provide excellent storm protection, especially since the beach faces southwest where major events do not directly impact the shoreline. The beach, the dunes and the nearshore regions all gained sand since 2019. The volume totals were not high (1.41 yds<sup>3</sup>/ft.) added by 2020 and a small net loss (-0.9 yds<sup>3</sup>/ft.) seen between 2018 and 2020. The shoreline retreated 7.4 feet since 2018.

**Figure 8. No sand was reportedly placed directly on this beach during the most recent USACE project. Natural processes continue to move abundant sand onto this beach and dune. The beach retreated since 2017, but then stabilized within a 10-foot range of changes. The foredune continues to accumulate sand.**

6. Cell 7 at Stites Avenue benefited from a stable berm area enhancing the recreational value of the beach, this paired with the shallow offshore platform will offer a relatively safe option for swimming. The beach is wider in 2020, but only by 6 feet.

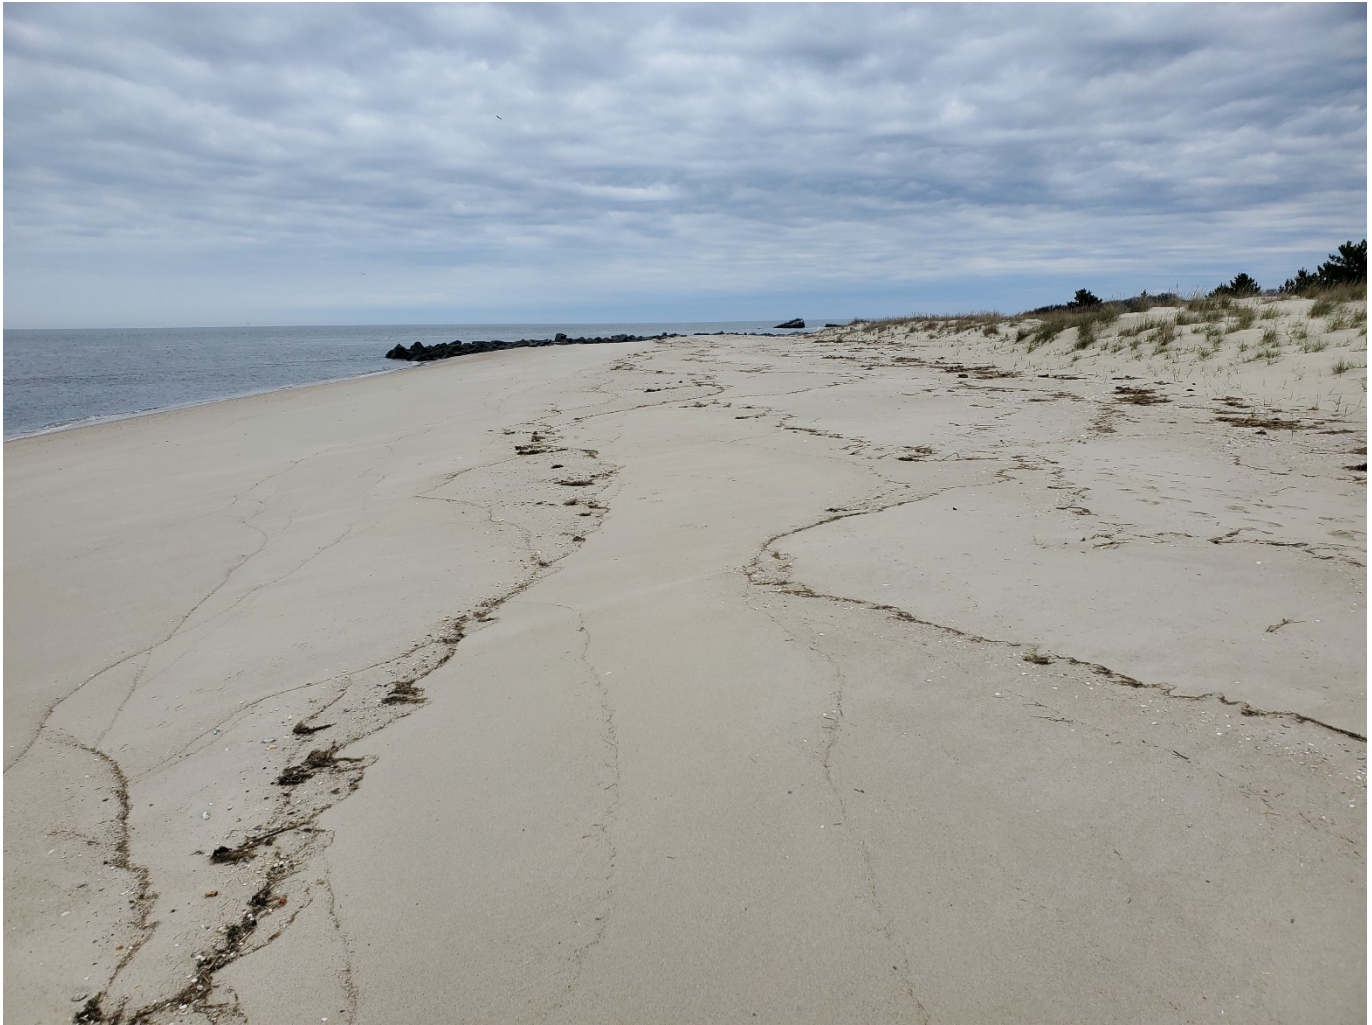
*Figure 9. This westernmost cell ends at the groin in the distance. Lower Township is immediately adjacent to the structure. The wave swash has recently reached the expanding dune toe slope without causing erosion to date. The ancient concrete ship is visible in the far distance off Sunset Boulevard beach in the Township.*

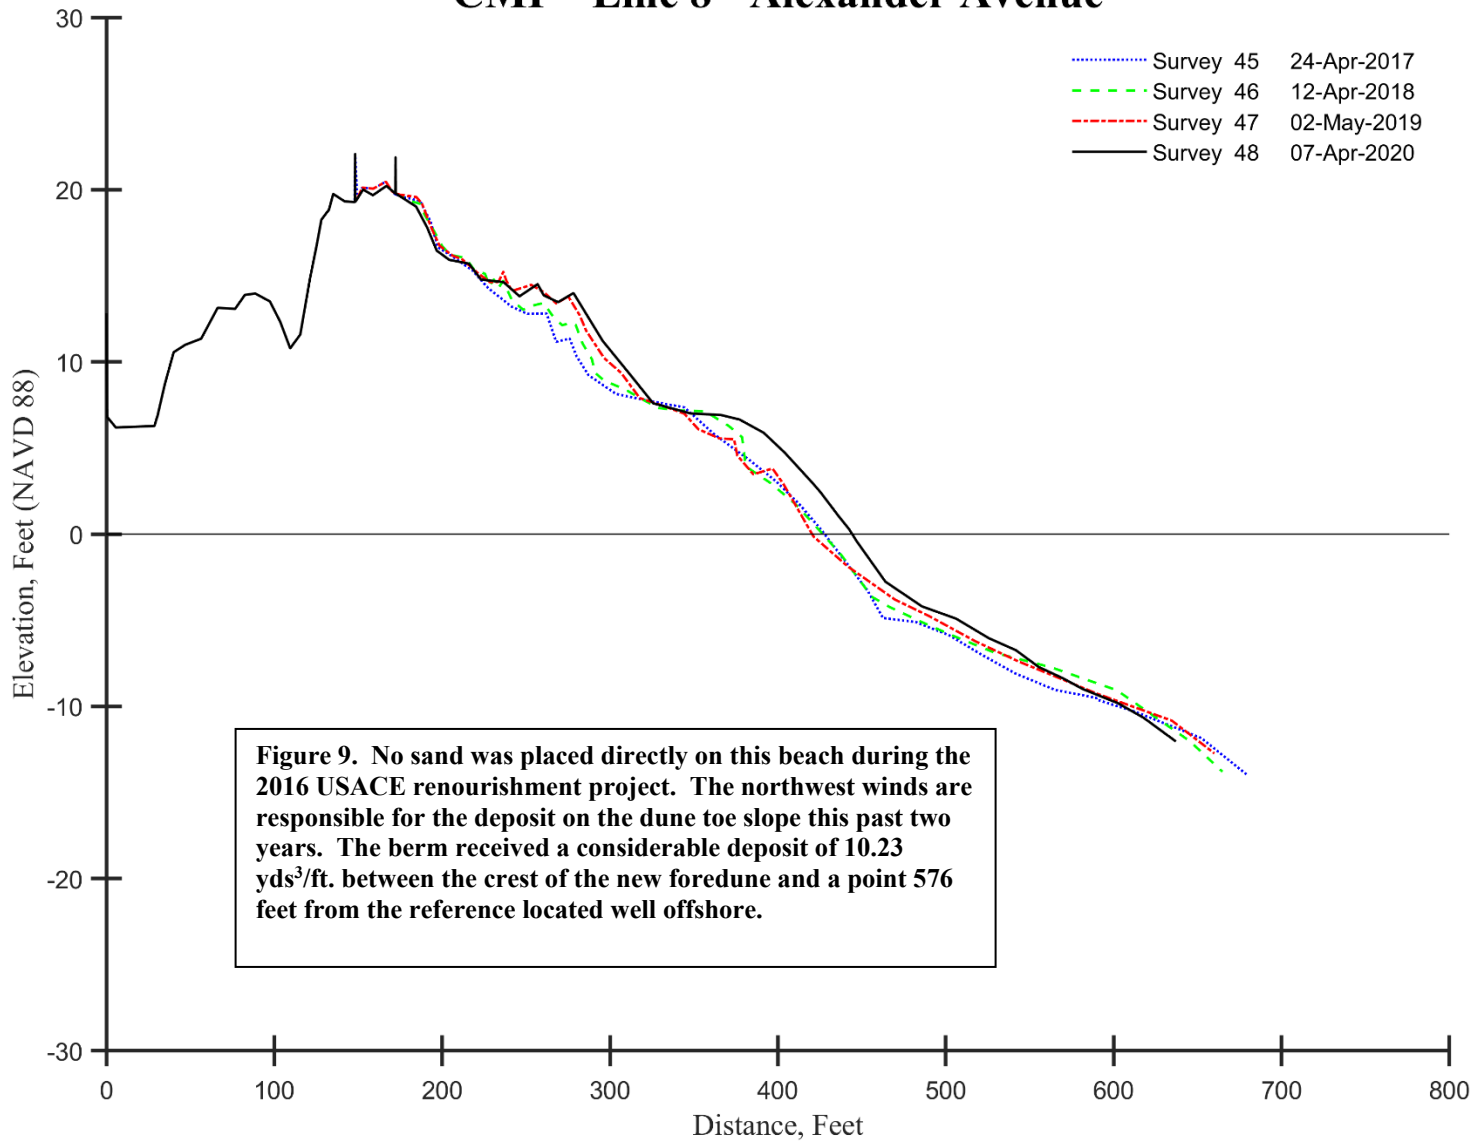
### Cape May Point - Annual Comparison CMP - Line 8 - Alexander Avenue

Following completion of the initial USACE project sand began to accumulate in increasing amounts, 2015 was the first year in which this accretive trend stopped. In 2016, sand accumulation resumed with a large wedge of sand appearing from the seaward dune crest seaward to the profile limits. The dune has

provided the most dramatic volume gain of any along the Cape May coastline. It accounts for about 40% of the entire site's sand accumulation since 2017. The beachface added the remaining 60% as the berm advanced seaward. The shoreline advanced 17.6 feet between 2018 and 2020 with 23.9 feet of advance in 2020 responsible for the net positive change.

7. Cell 8 at Alexander Avenue has seen a large gain in dune width as the foredune dramatically accumulated sand. The berm also grew wider increasing the recreational use area too. This beach has traditionally been closed to swimming. Allowing water access would entail additional life guards be hired to protect it.
