**2021 ANNUAL REPORT ON  
THE CONDITION OF THE MUNICIPAL BEACHES FOR  
THE BOROUGH OF STONE HARBOR, CAPE MAY COUNTY, NEW JERSEY**

**PREPARED FOR: THE BOROUGH OF STONE HARBOR  
9508 SECOND AVENUE  
STONE HARBOR, NJ 08247**

**PREPARED BY: THE STOCKTON UNIVERSITY COASTAL RESEARCH CENTER  
30 WILSON AVENUE  
PORT REPUBLIC, NEW JERSEY 08241**

**October 27, 2021**

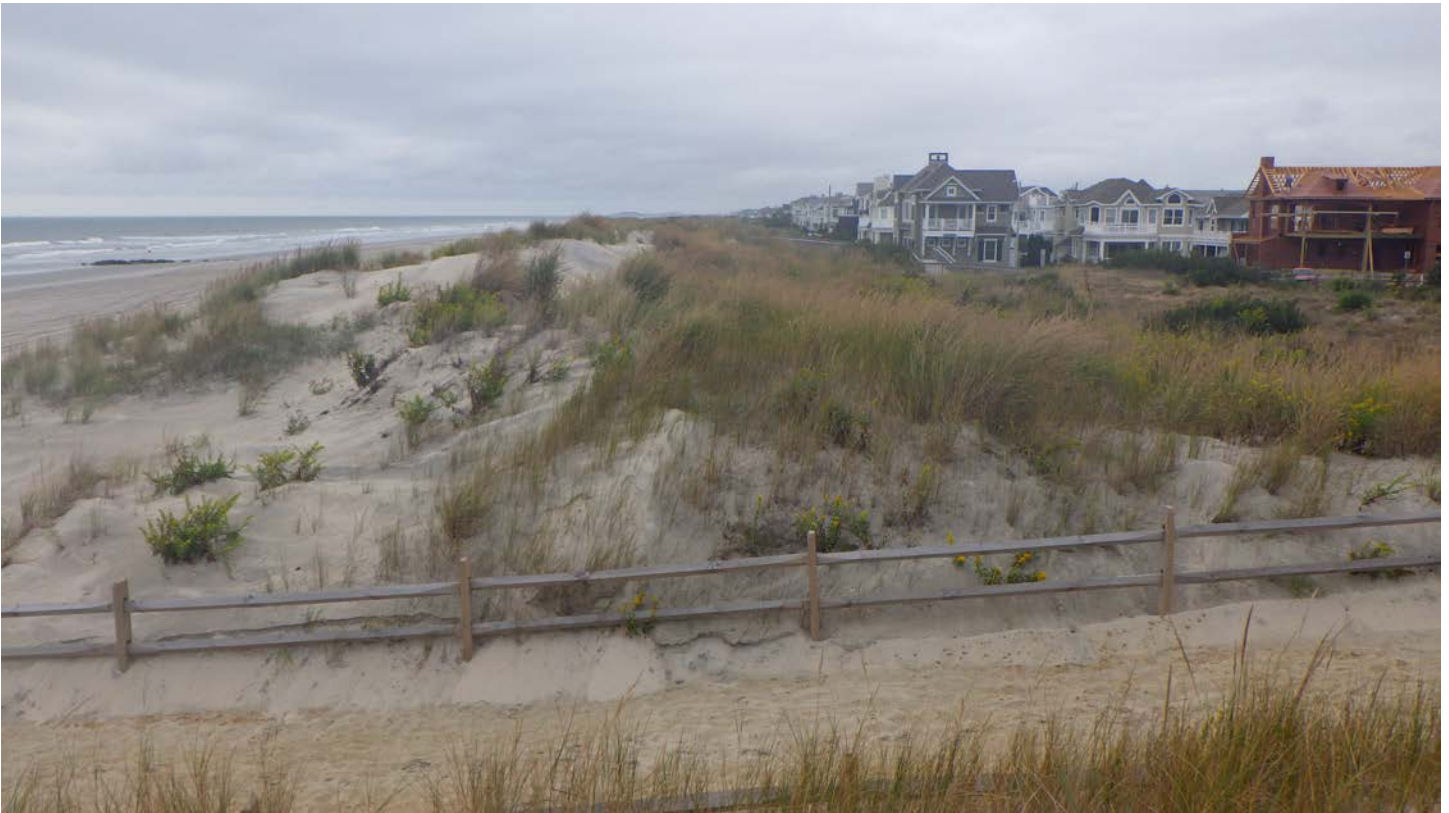
*This view to the south along the 82<sup>rd</sup> Street dune crest from the survey line as of October 5, 2021 provides a broad view of the north Stone Harbor dune field. While the pedestrian access pathway is lower in total elevation than the dune crest, the width of dunes helps this issue. Additional path elevation would improve storm defences at this location.*

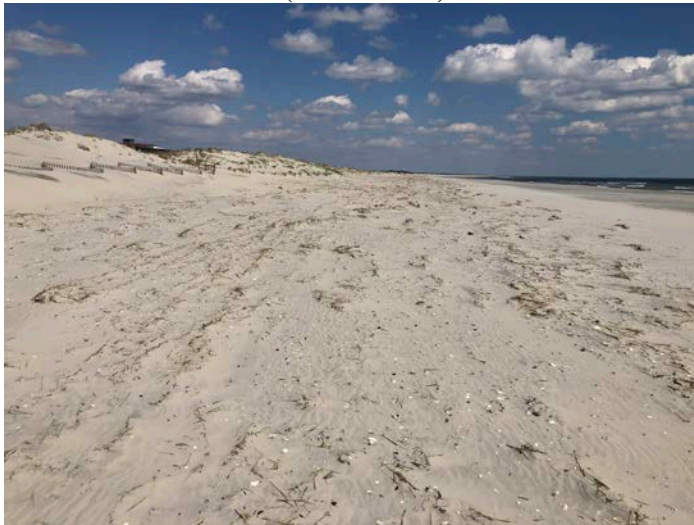
**Photo 1a – Photo taken April 16, 2020 showing a wide, dry beach and sand accumulation at the dune fencing.**

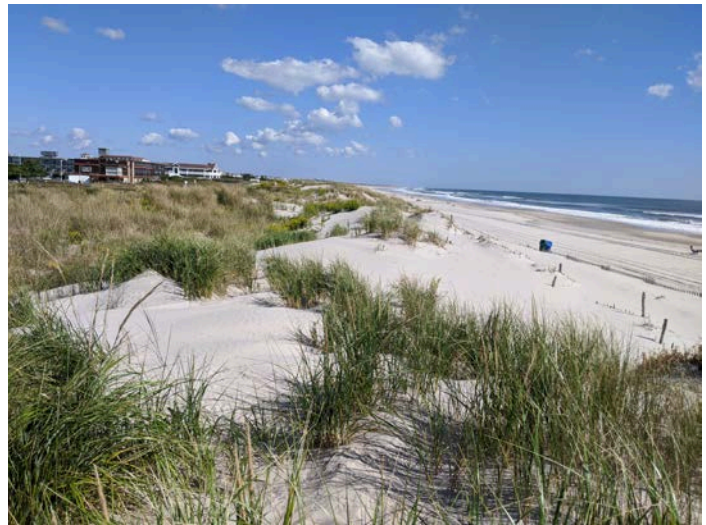
**Photo 1b - Photo taken on October 6, 2020, looking north along the dune crest where sand has been transported into the dunes and the sand fence is essentially buried by what could become a new foredune line.**

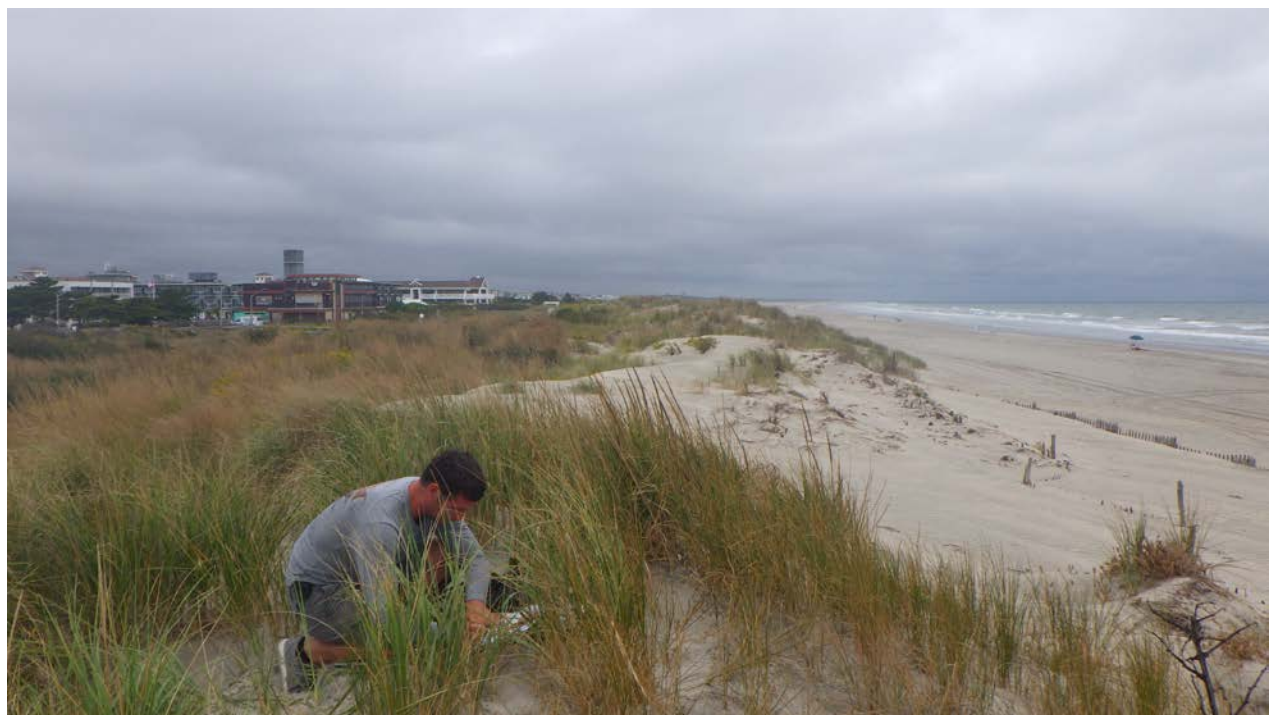
**Photo 1c – Photo taken October 5, 2021 from the primary dune crest looking north. The buried sand fence continues to collect sand adding to the dune mass.**

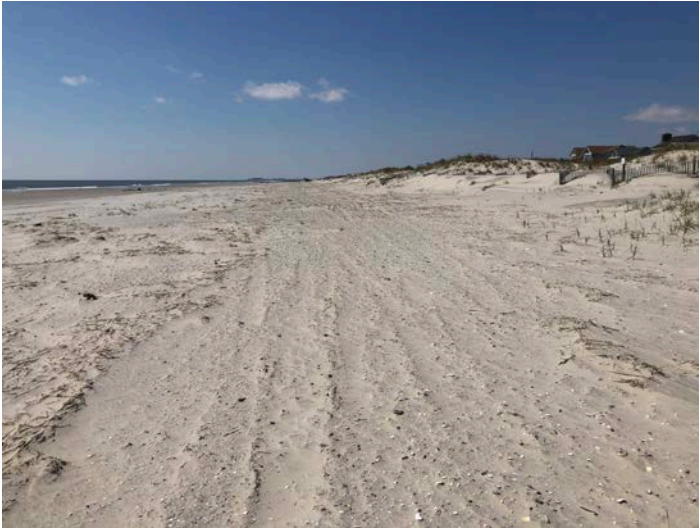
**Photo 2a – Photo taken April 16, 2020 showing an improvement in dry beach width as summer began.**

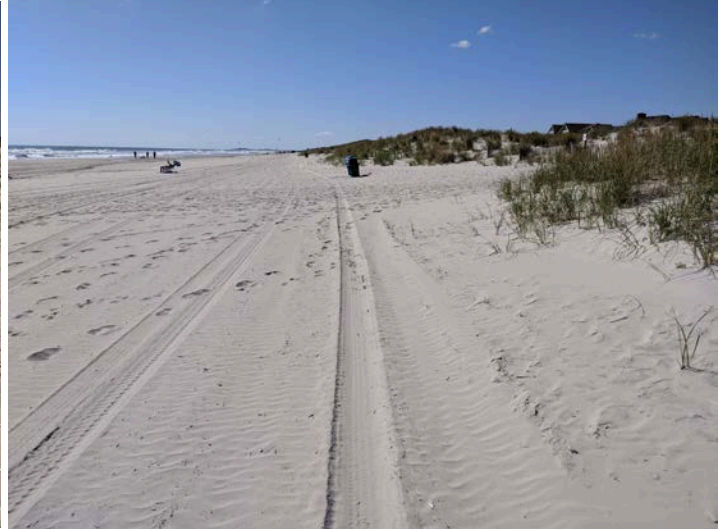
**Photo 2b - Photo taken October 6, 2020 shows substantial dune growth and the wider expanse of dry sand beach following the summer 2020 accumulation.**

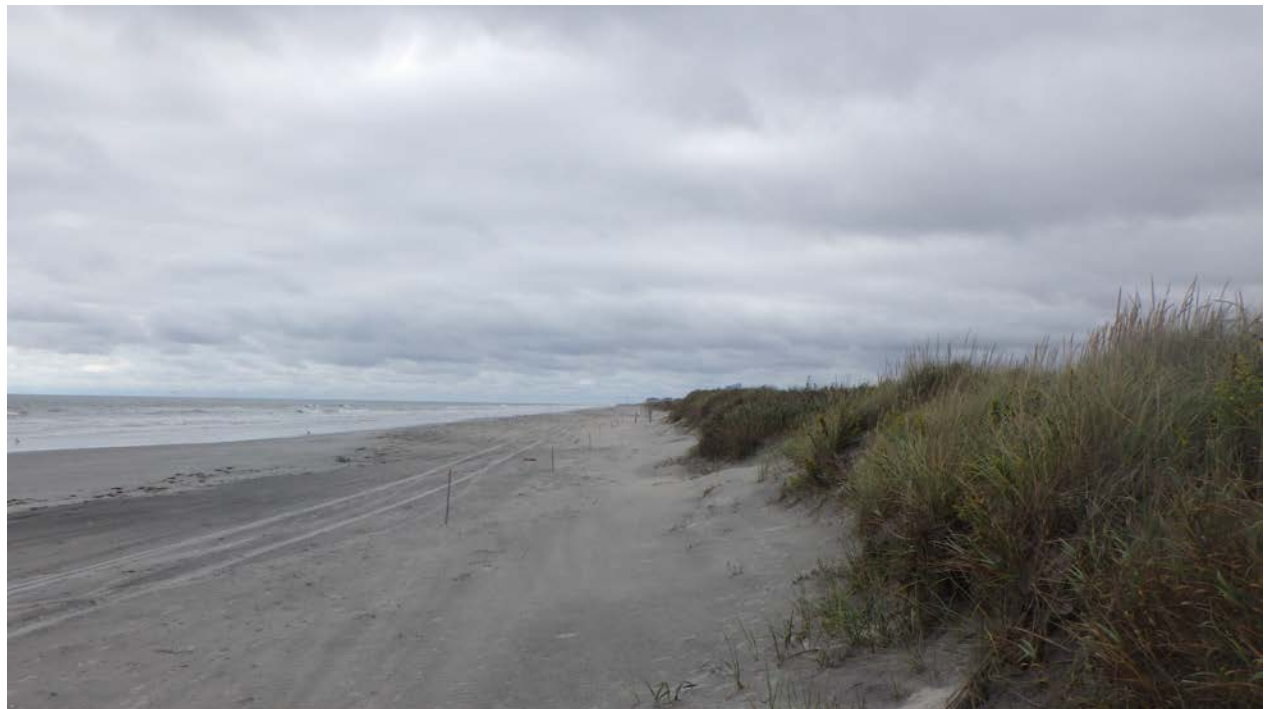
**Photo 2c - Photo taken October 5, 2021 with the beach dry from the dune toe, seaward for about 50 feet. There is a wide intertidal zone this fall.**

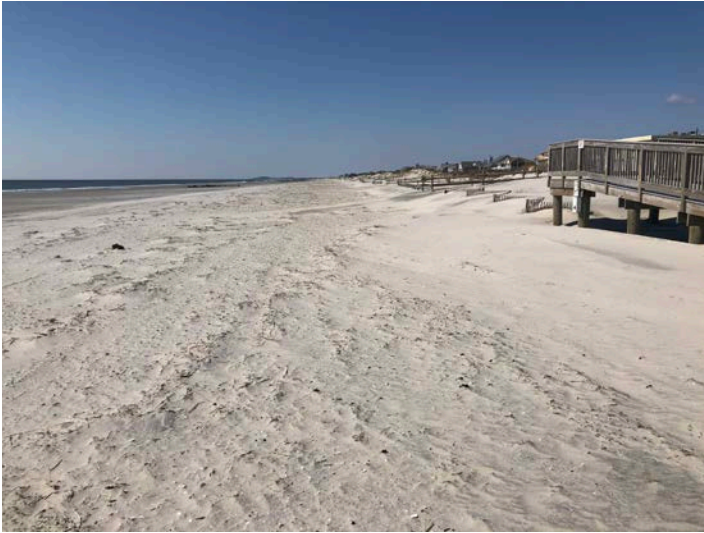
**Photo 3a -** The April 16, 2020 photo presents a wider dry beach with sand added to the nearly buried sand fencing at the toe of the seaward dune slope.

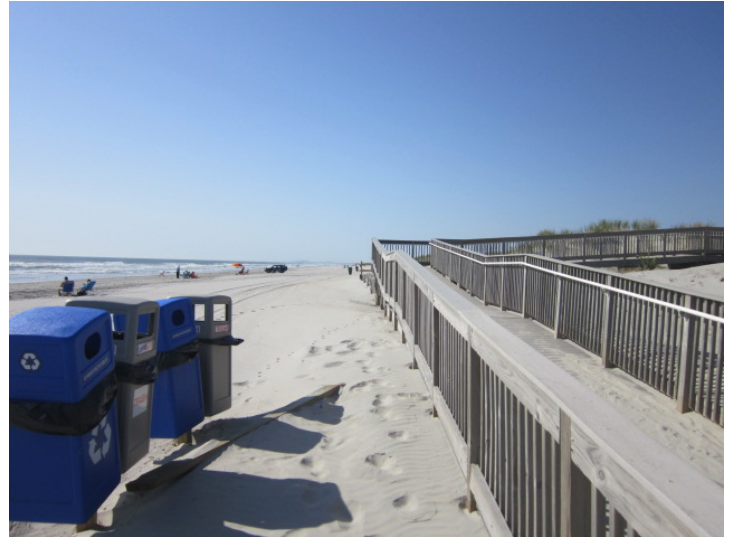
**Photo 3b –** The photo taken October 6, 2020 along the access pathway. The beach continued to accumulate sand at the dune toe.

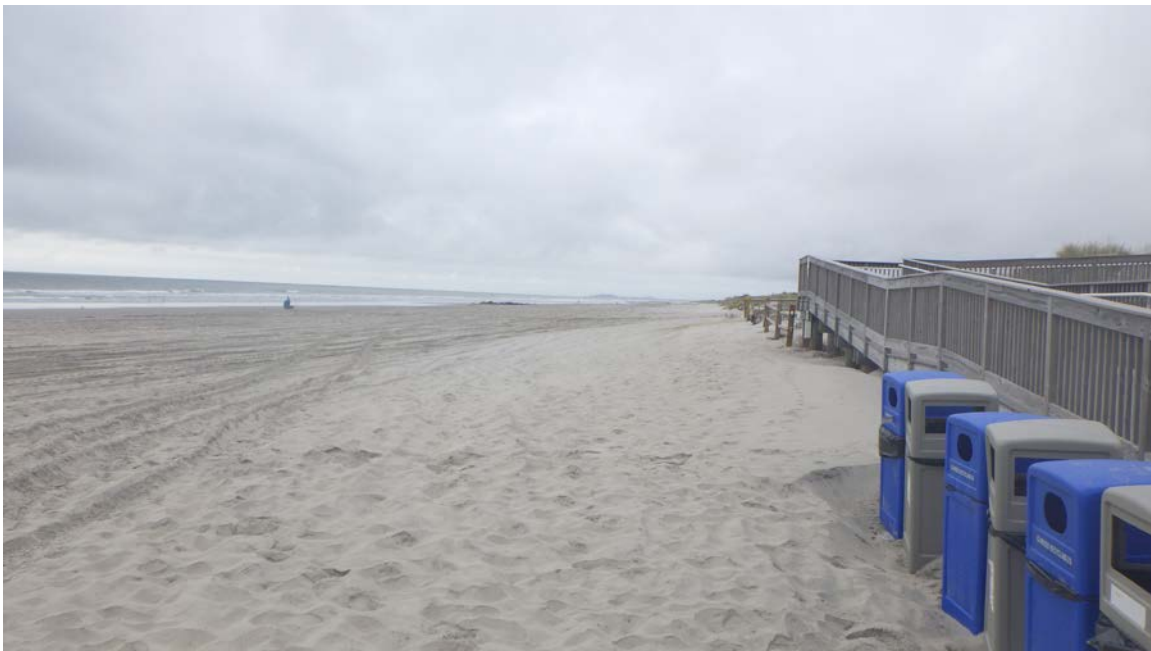
**Photo 3c –** This photograph was taken October 5, 2021 and shows the recreational beach looking south along the access ramp to the dune toe further south. The beach width has remained consistent.

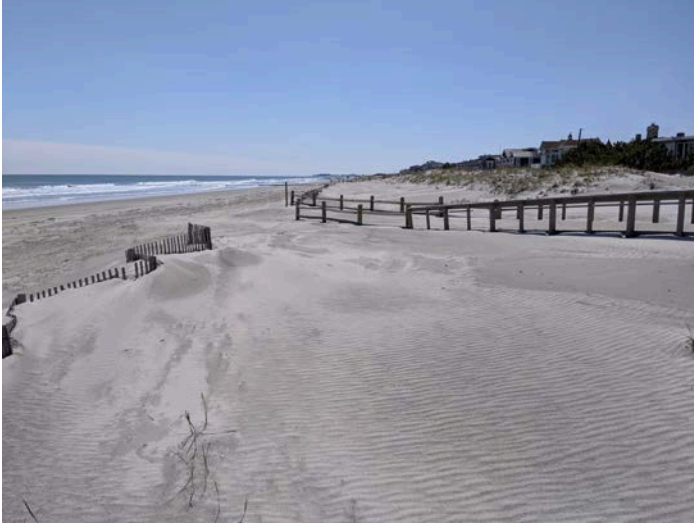
**Photoplate 4a - Photo taken October 14, 2019 showing sand continuing to fill the 4-foot high snow fencing creating a new foredune. The beach width was sufficient to provide the supply.**

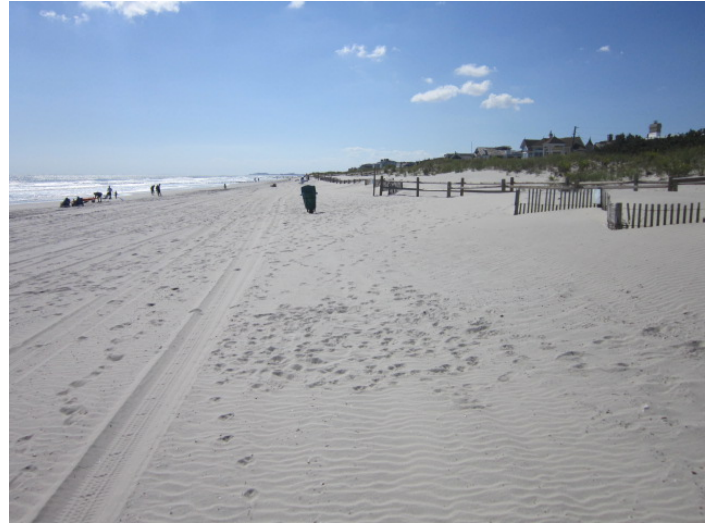
**Photoplate 4b - Photo taken April 15, 2020 shows sand filling in the lower section of the access pathway burying the fencing.**

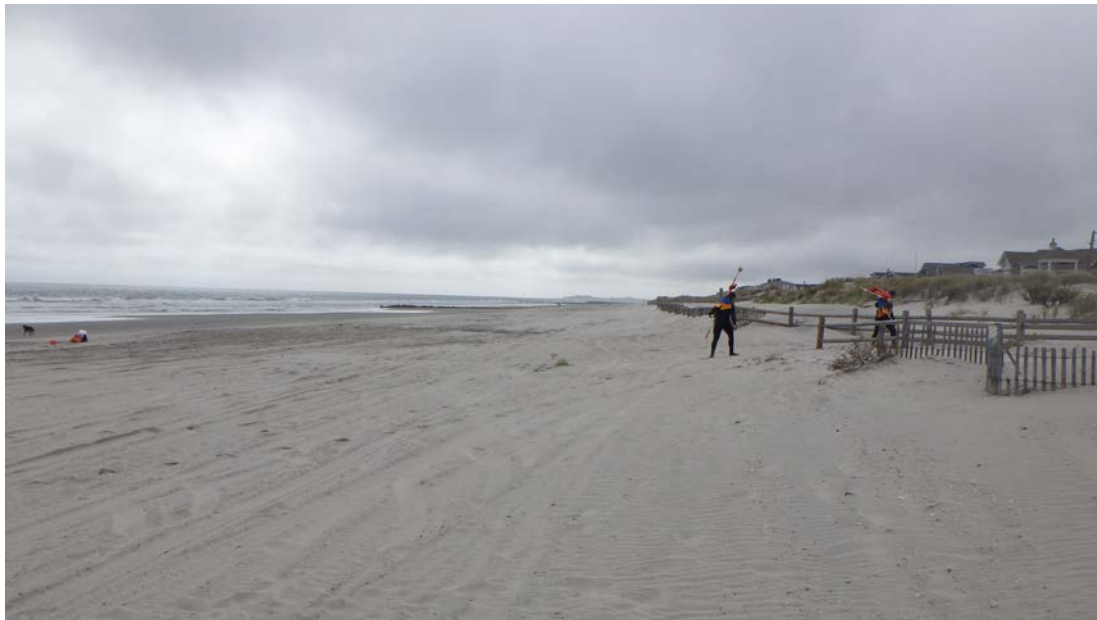
**Photoplate 4c – Photo taken October 5, 2021 on the beach just seaward of the dune’s seaward slope.**

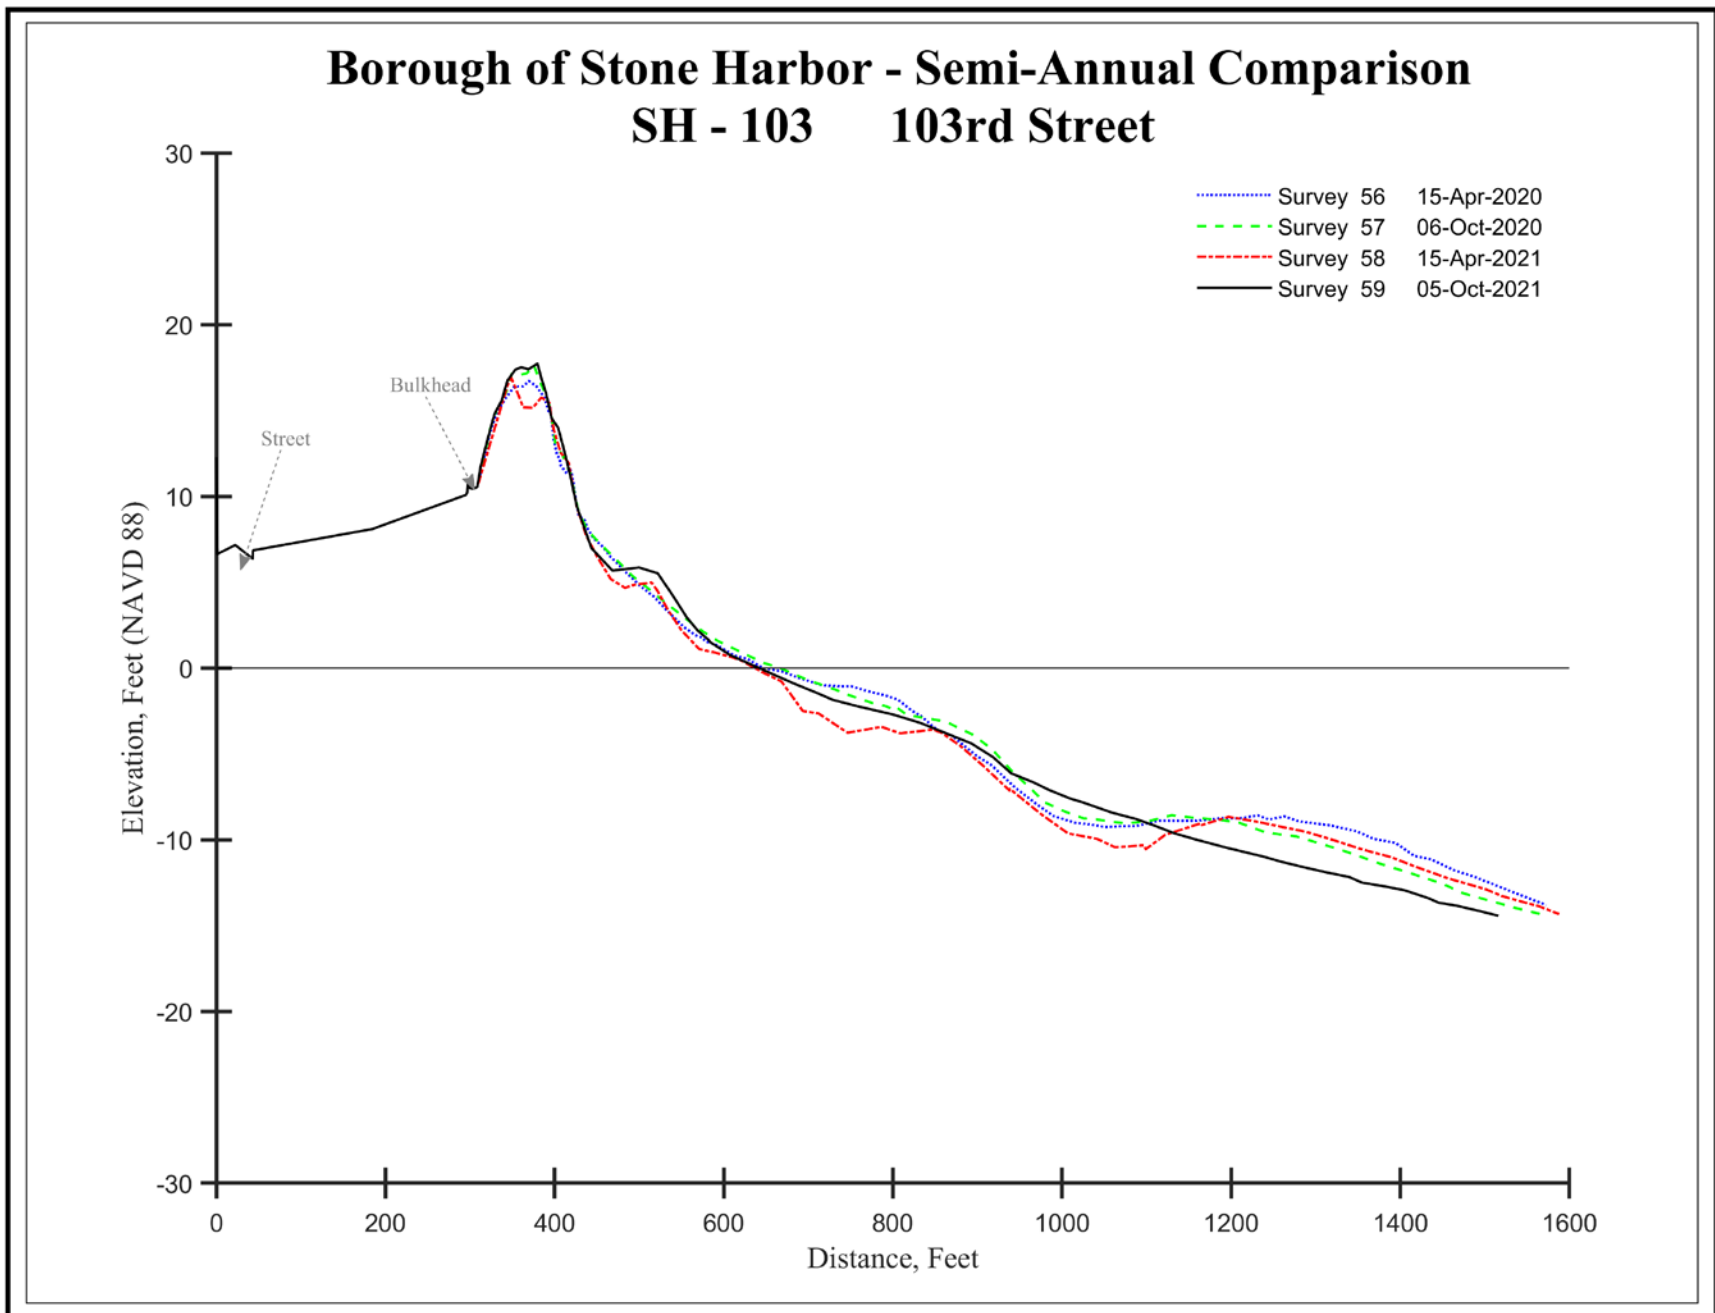
Behaving in similar fashion to SH-95, the beach configuration was augmented modestly across the dune, beach and nearby offshore. Offshore a significant gradient change moved bar crest sand into two nearshore troughs creating a uniform slope seaward by summer’s end.

Figure 4d. The cross sections at 103<sup>rd</sup> Street show a similar pattern to that seen at 95<sup>th</sup> Street where neither the annual shoreline change (-25 feet) or the summer advance of 5 feet provided any dramatic change. The sand volume did not decline on the beach/dune system, but did decrease offshore (-20.28 yds<sup>3</sup>/ft.) because the bar crest shift landward was not equaled by the sand volume filling the nearshore troughs.

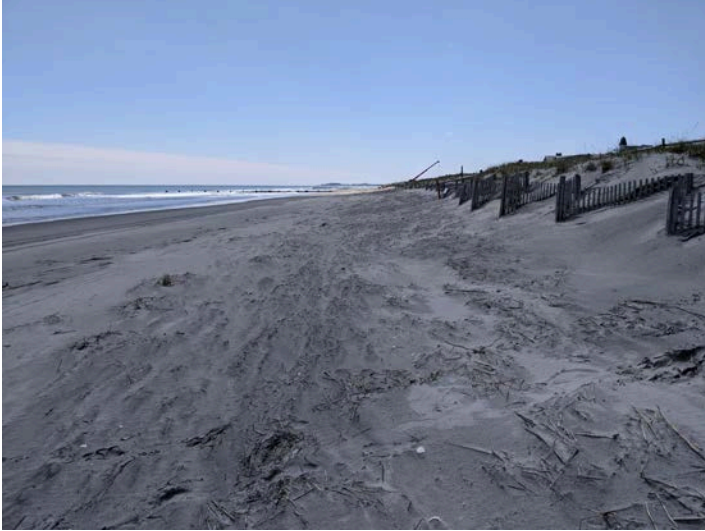
**Photoplate 5a – The photo taken April 15, 2020 shows minor additions of sand near the dune toe, but a similar width beach to the water line.**

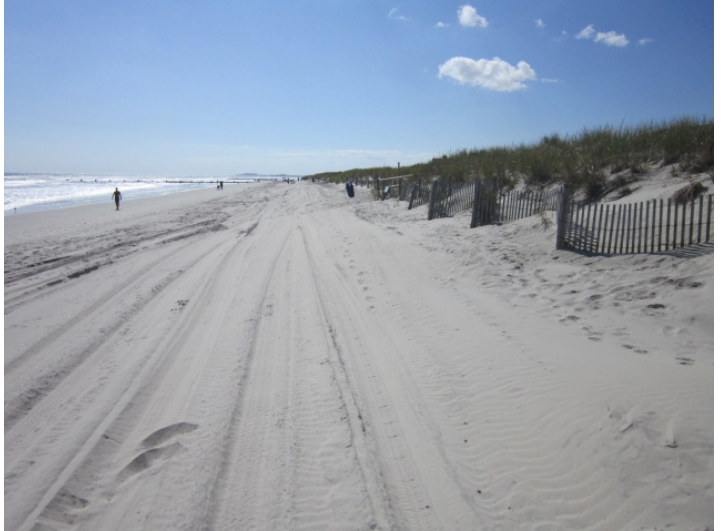
**Photoplate 5b – The photo taken October 6, 2020 shows improvement in beach width as sand was added to the upper part of the dry beach.**

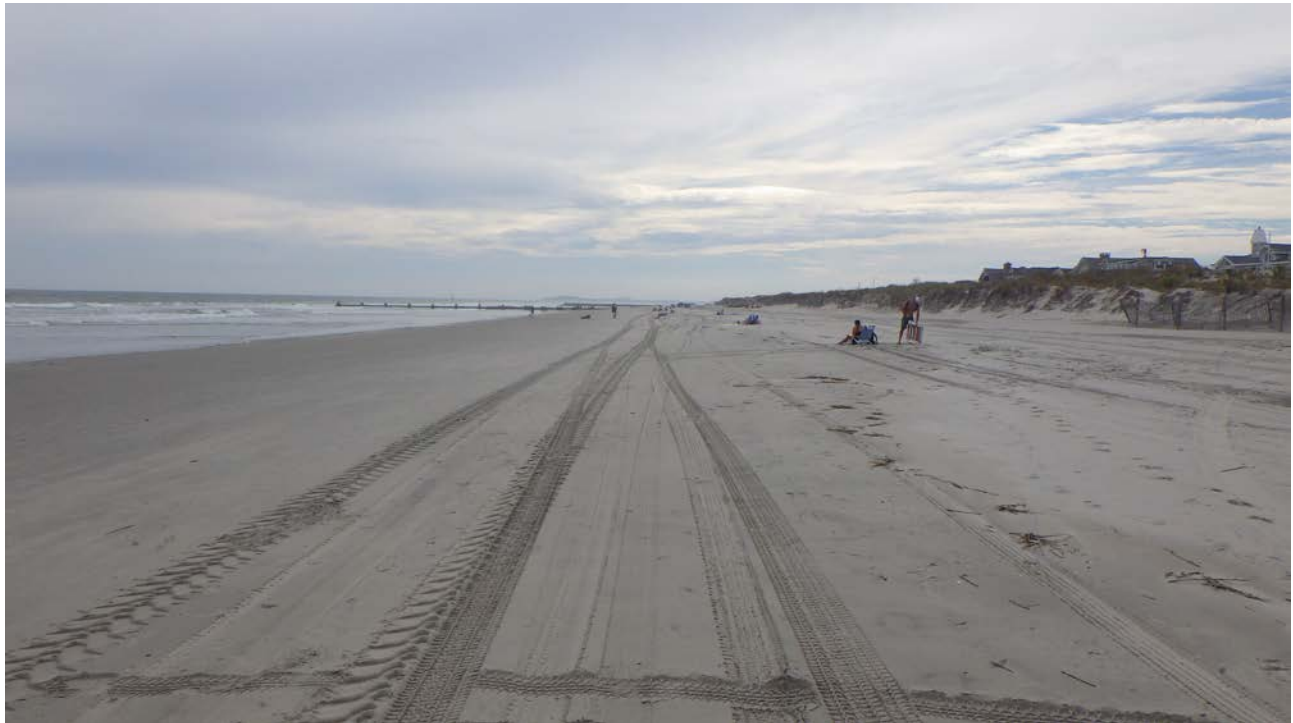
**Photoplate 5c – By October 6, 2021 the beach width had increased by 20 feet annually. A flatter gradient meant that dry recreational area was limited.**

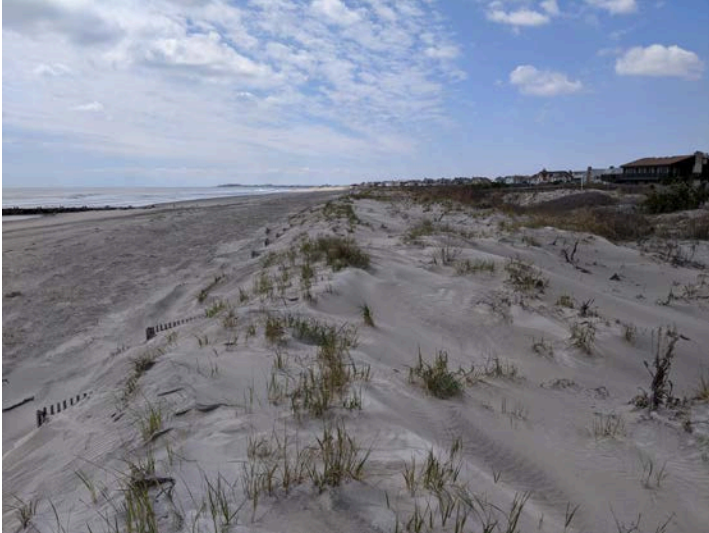
**Photoplate 6a – Photo taken April 15, 2020 and shows large amounts of wind deposition around the existing plants.**

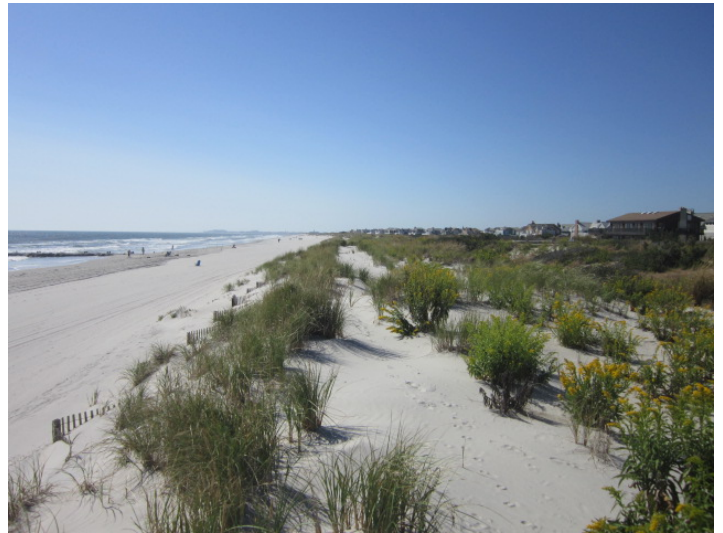
**Photoplate 6b - Photo taken October 7, 2020 where the seasonal plant growth has taken hold on the new sediment supplied by the wind.**

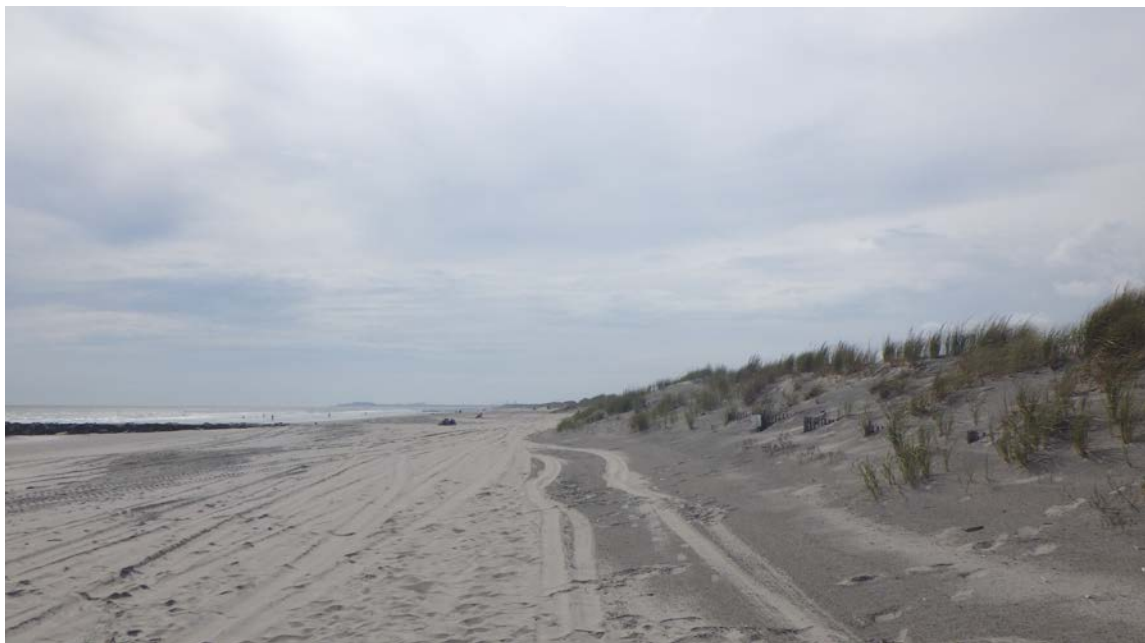
**Photoplate 6c – View to the south October 4, 2021 along the seaward dune toe. The sand supply is sufficient to protect the dune slope thus far.**

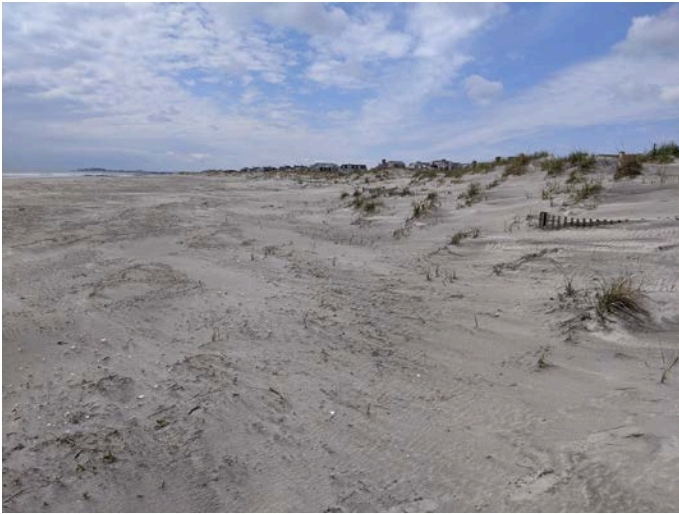
**Photoplate 7a - Photo taken April 15, 2020 showing continued sand deposition around fencing locations and a wide beach seaward .**

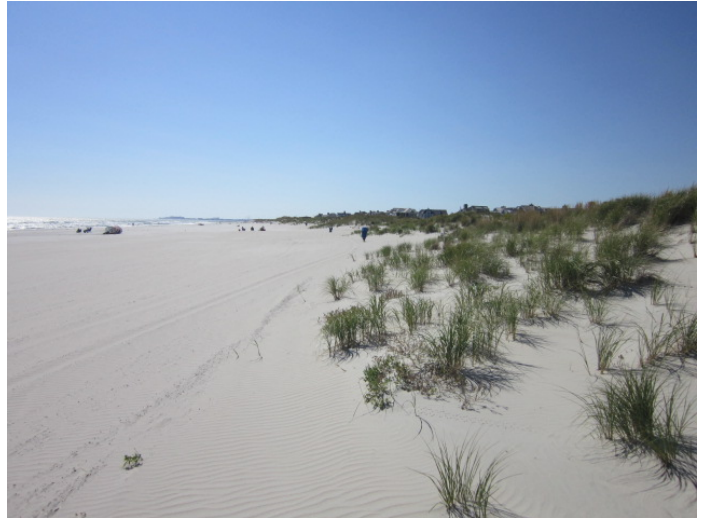
**Photoplate 7b – Photo taken October 7, 2020 provides a view of the wide dry beach and sand deposited among the dune plants at 116<sup>th</sup> Street.**

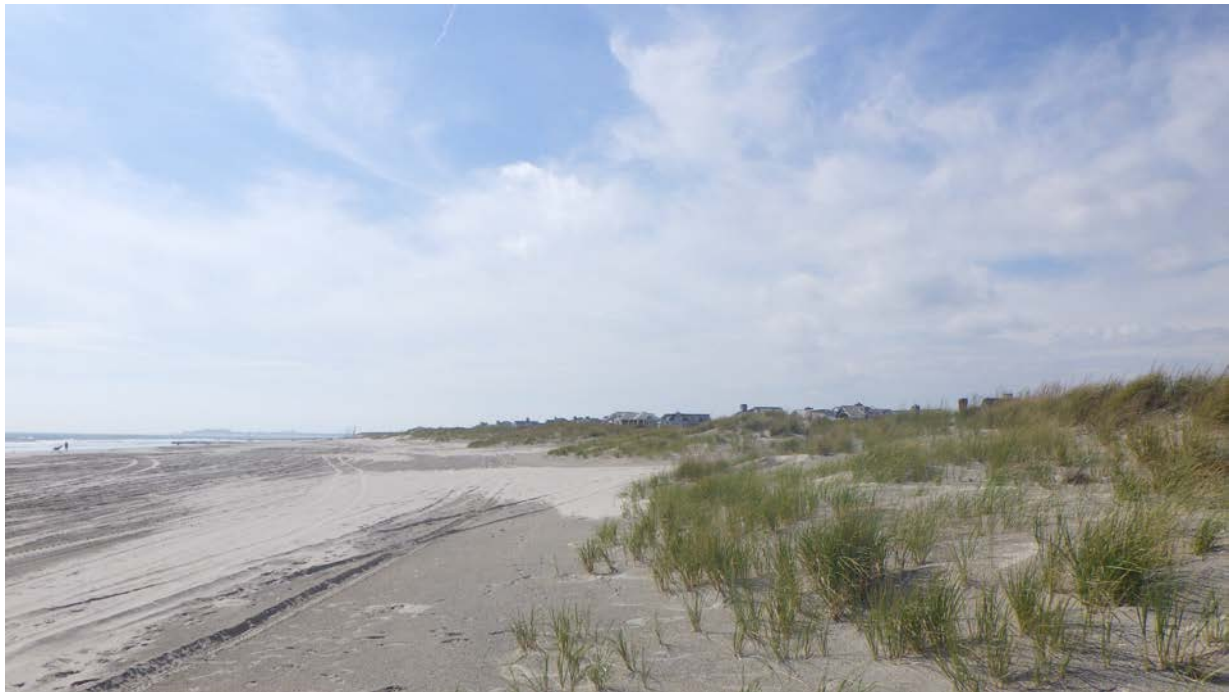
**Photoplate 7c – Photo taken October 4, 2021 showing a series of steady dune grass growth and sand being added to the seaward toe.**

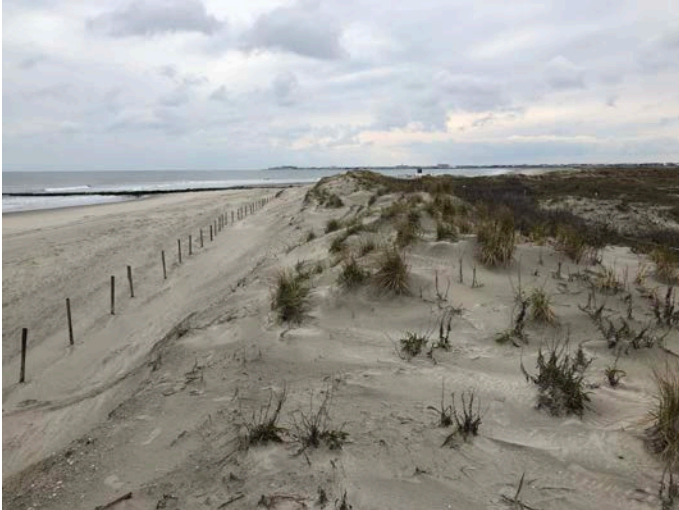
**Photoplate 8a - Photo taken April 15, 2020 following a long interval of quite waves and wind transport placing sand at the scarp. Crest slumping also added sand to the slope.**

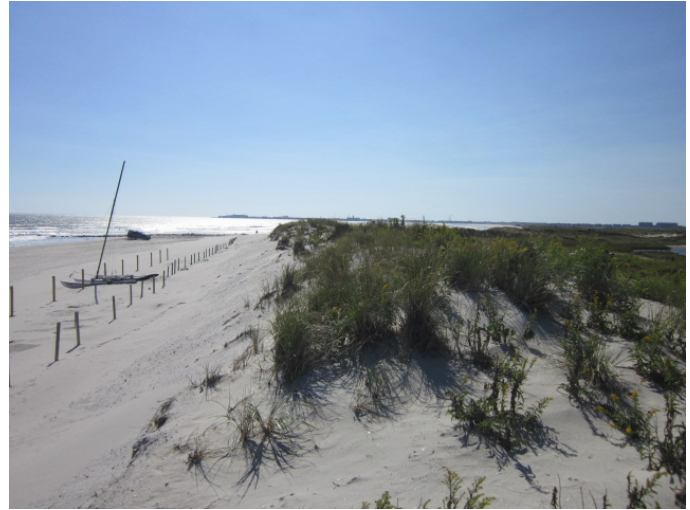
**Photoplate 8b – Photo taken October 7, 2020 illustrates the maximum impact natural wind deposition can have in restoration of dune erosion damage. The beach is wider at the close of the 2020 summer season.**

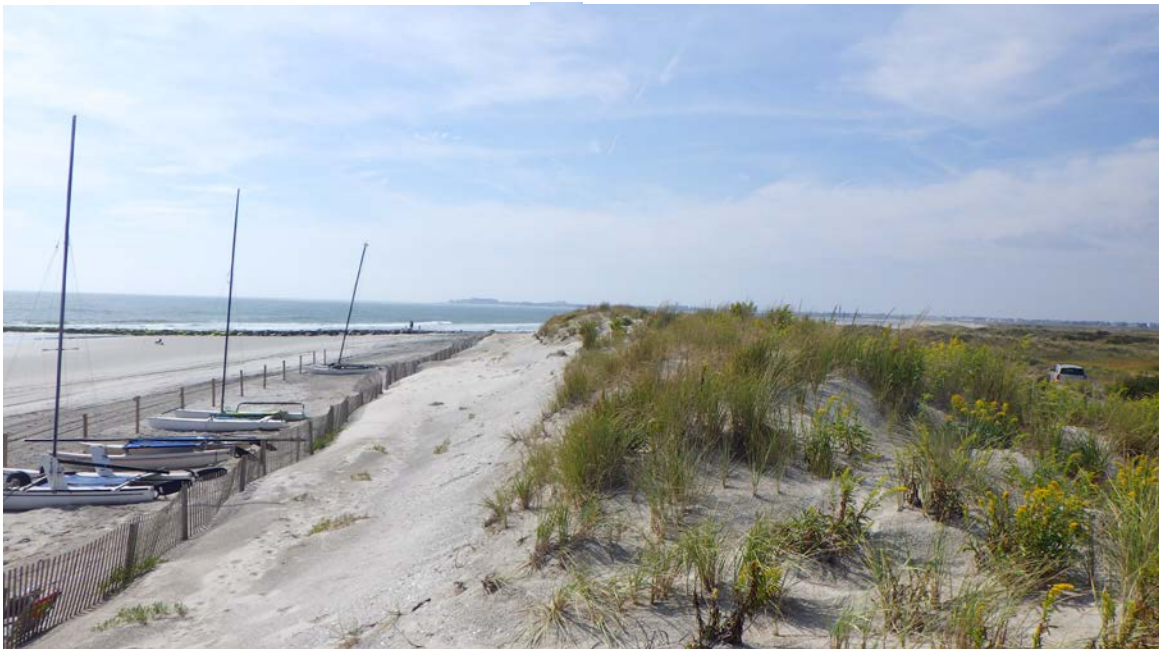
**Photoplate 8c – The photo taken October 4, 2021 shows a little sand accumulated between the fence line and the seaward dune slope. The beach width remains the same as it was earlier.**
