**FINAL REPORT FOR 2019
ON THE CONDITION OF THE MUNICIPAL BEACHES
IN
THE TOWNSHIP OF UPPER, CAPE MAY COUNTY, NEW JERSEY**

**PREPARED FOR: THE TOWNSHIP OF UPPER
PO BOX 205
TUCKAHOE, NEW JERSEY 08250**

**PREPARED BY: THE STOCKTON UNIVERSITY COASTAL RESEARCH CENTER
30 WILSON AVENUE
PORT REPUBLIC, NJ 08241
FEBRUARY 20, 2020**

Annual Report for 2019
To
The Township of Upper On the
Condition of the Municipal Beaches in Strathmere

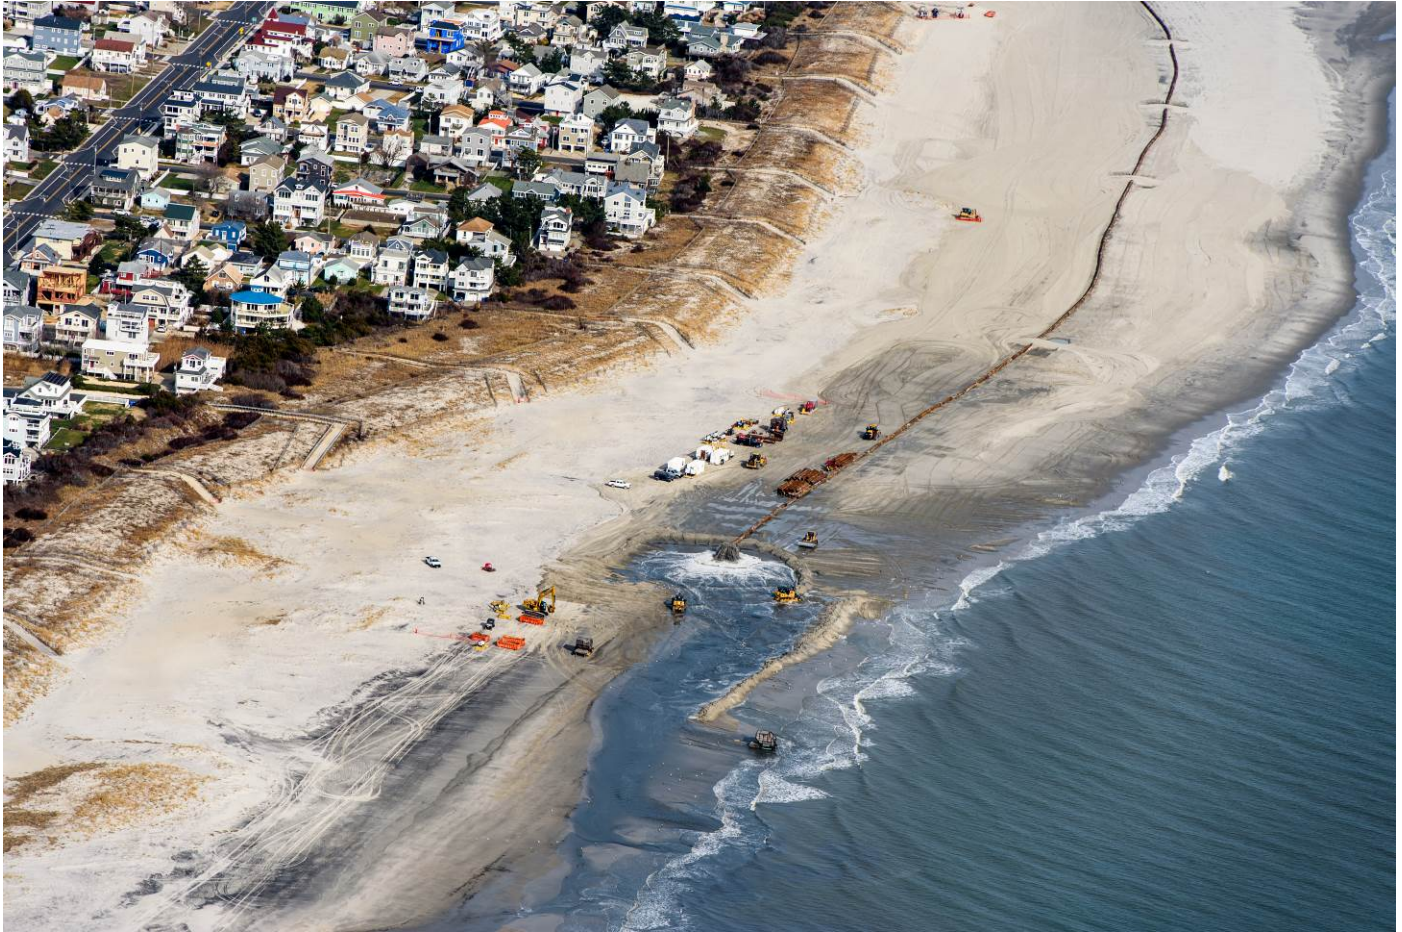
Above is an aerial view of Strathmere, taken December 7, 2019, showing the sand placement operation underway south of Tecumseh Avenue as the maintenance operation proceeded. (Photo by Ted Kingston).

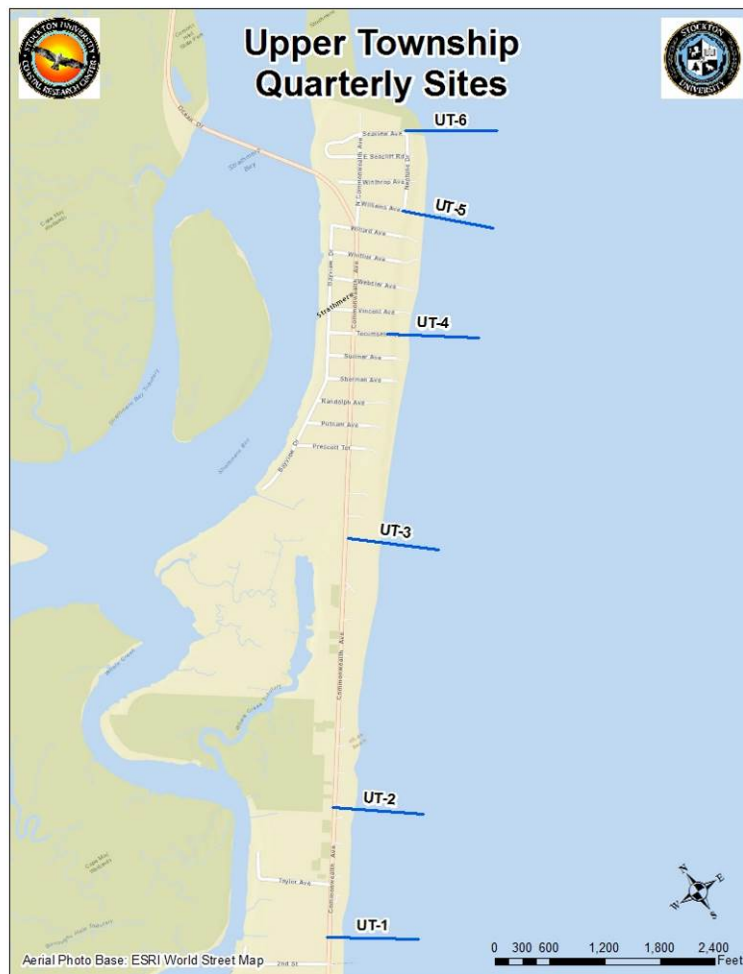
Figure 1. Locations of the 6 beach profile stations for the engineered beach in Upper Township.

Figure 1 below shows the locations of the 6 cross section locations used for this analysis.

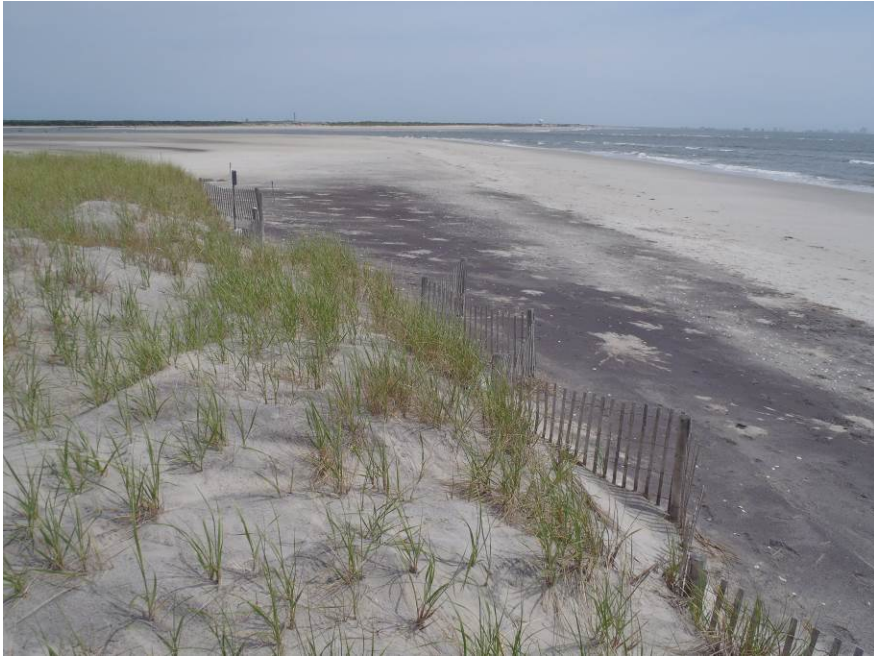
3a. June 8, 2018

Photograph 3a in June 2018, the beach and dune were undamaged with a substantial width to the high tide line.

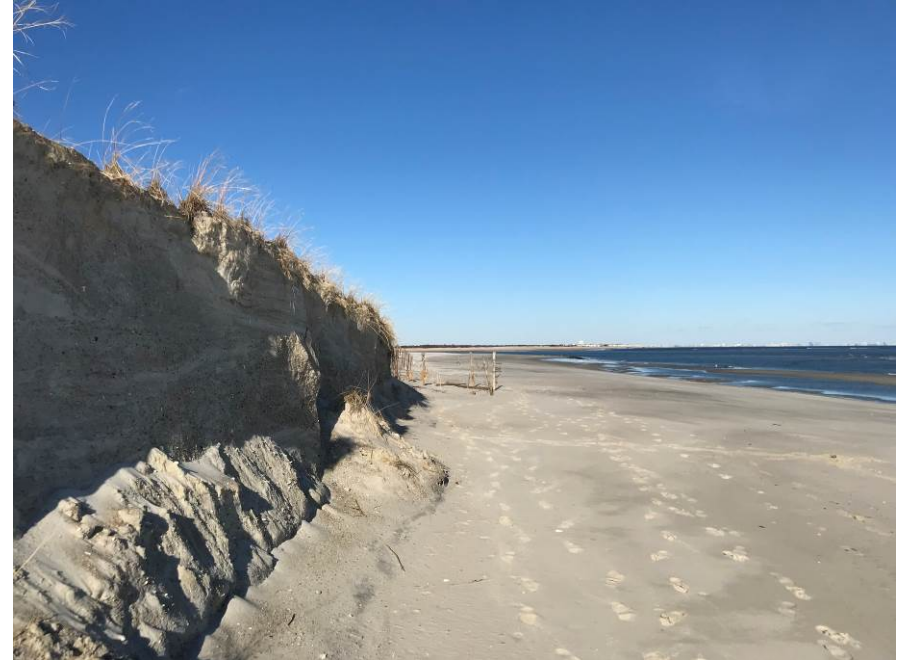
3b. December 7, 2018

This site is located adjacent to Corson's Inlet making it highly vulnerable to rapid beach changes from inlet dynamics and northeast storms. Serious erosion was threatening the seaward end of Seaview Avenue and its associated private residences. The US Army Corps stepped in with a maintenance effort that extended from southern Ocean City and included Strathmere to a point somewhat north of the Jasper Avenue site (UT-3). The restoration of this beach is outstanding with the dune back to design width and a generous beach width to the water's edge. The key to longer term stability has always been the tendency for secondary tidal channels to form along the back of the beachface and rapidly drag sand either into Corson's Inlet or to the south with usual deposition at and south of the Williams Avenue site. There is no easy and cheap self-help option available to intervene as the local entity at this location because the channel appears rather suddenly, with a sizeable magnitude of action demanded to alter the channel size or location. Careful monitoring of the issue did allow for USACE intervention during the fall of 2019.

Photograph 3b shows that by December 2018, major damage had happened to erode the dune as the beach's high tide line had moved to the dune toe in 6 months.

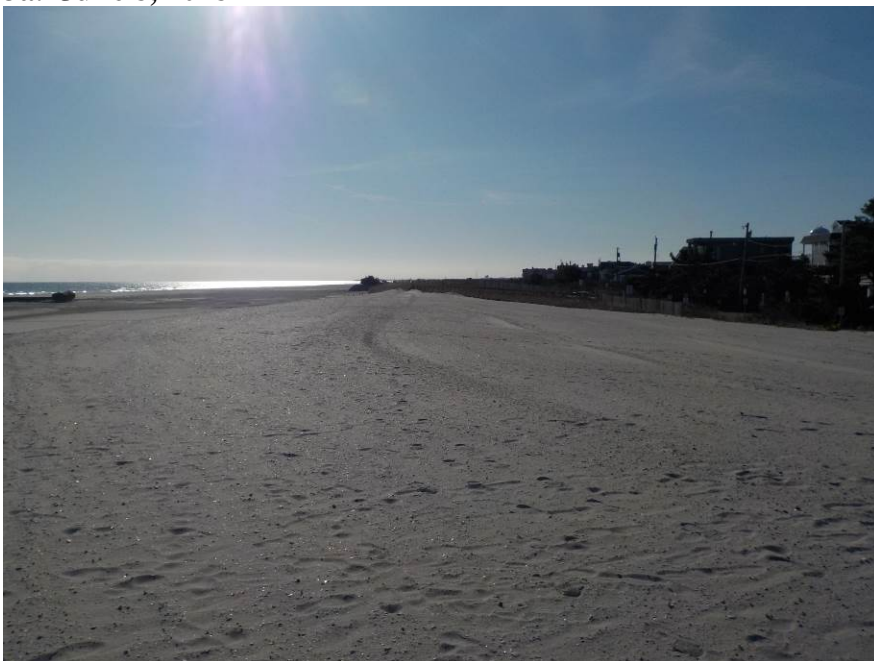
3c. December 12, 2019

Photograph 3c was taken on December 12, 2019 following completion of project maintenance by the USACE. The restored dune has not been vegetated or fenced, but the beach width has been restored to the design specifications.

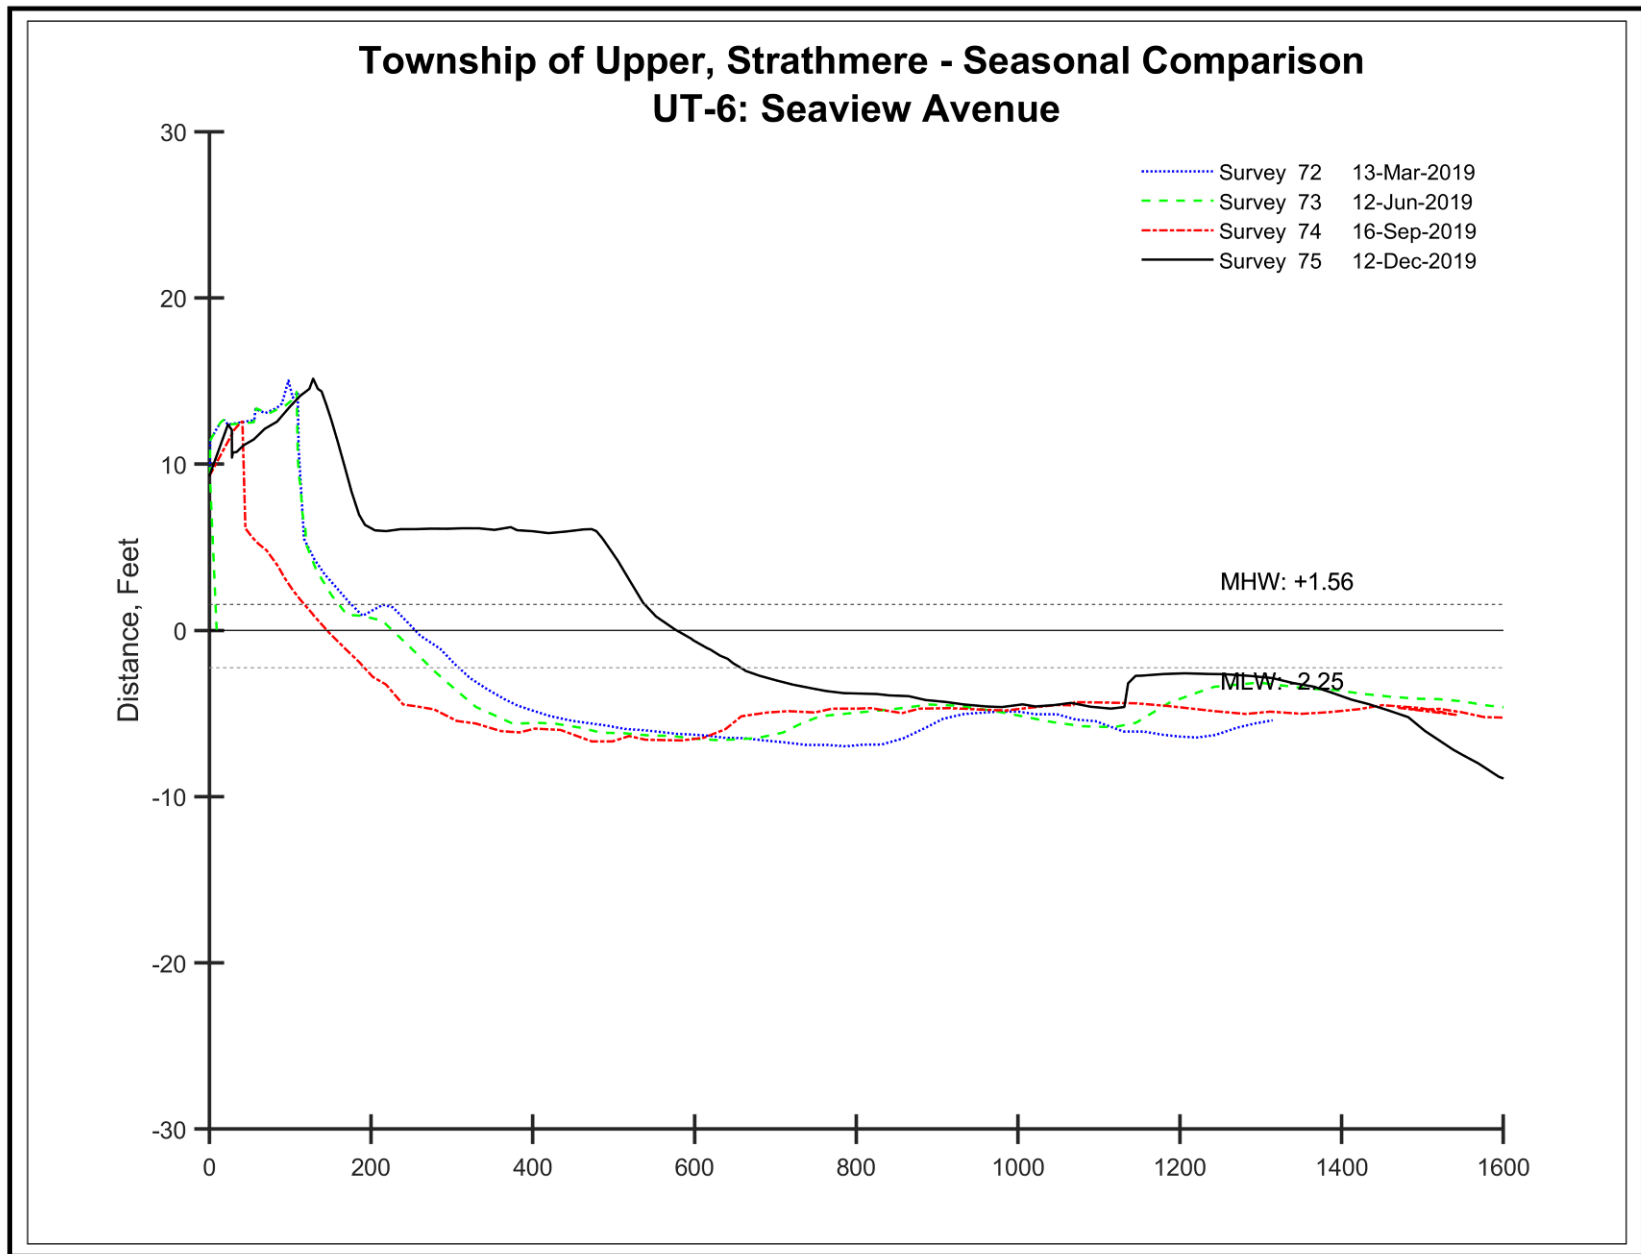
Figure 4. Between March and June of 2019, the beach retreated nearly 70 feet by September compromising the dune as protection from storms. The massive sand volume placed by the USACE shows in the December survey as a volume of 230.95 yds³/ft. added across the extent of the profile line producing a shoreline advance of 432 feet. The offshore bar volume amounted to 19.34 yds³/ft. of that total added by wave action within the ebb-tidal delta.

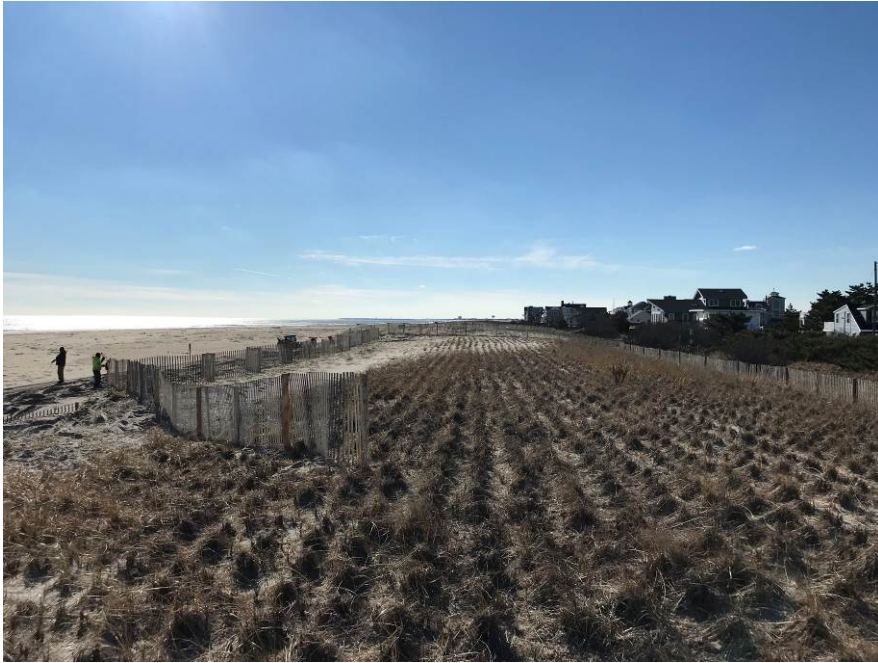
5a. December 10, 2018

Figure 5a shows the beach in December following 200 feet of shoreline retreat.

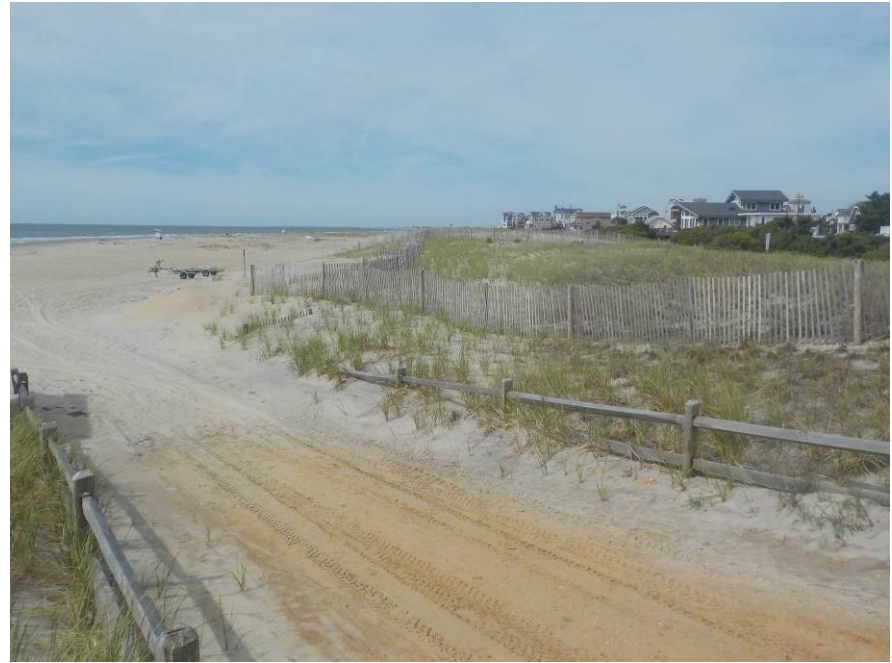
5b. June 12, 2019

Figure 5b was taken in June 2019 looking south from the dune across the vehicle access pathway onto the beach.

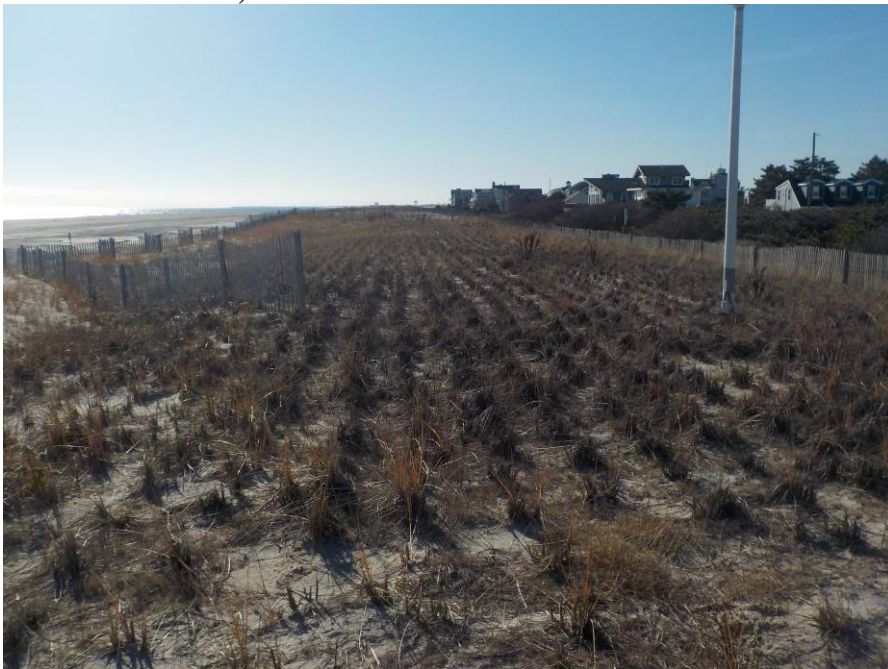
5c. December 12, 2019

The Williams Avenue site was not provided massive sand volumes initially in the federal project. However, recent rates of erosion prompted a significant fill by December 2019. The fill volume was 116.67 yds³/ft. which produced a 272-foot shoreline advance. The fill shows a wider dune* on the plot along with replaced beach sand lost since 2018.

*The survey in December 2019 encountered a substantial sand push added to the seaward edge of the dune to create the vehicle beach access path at Williams Avenue. This sand volume does not represent a regional addition of 15.50 yds³/ft. to the entire foredune slope, so was subtracted from the comparisons shown in the two tables above for UT-5.

Figure 5c is a view of the beach after the federal maintenance widened the beach and added sand to the dune area seaward of the existing grass.

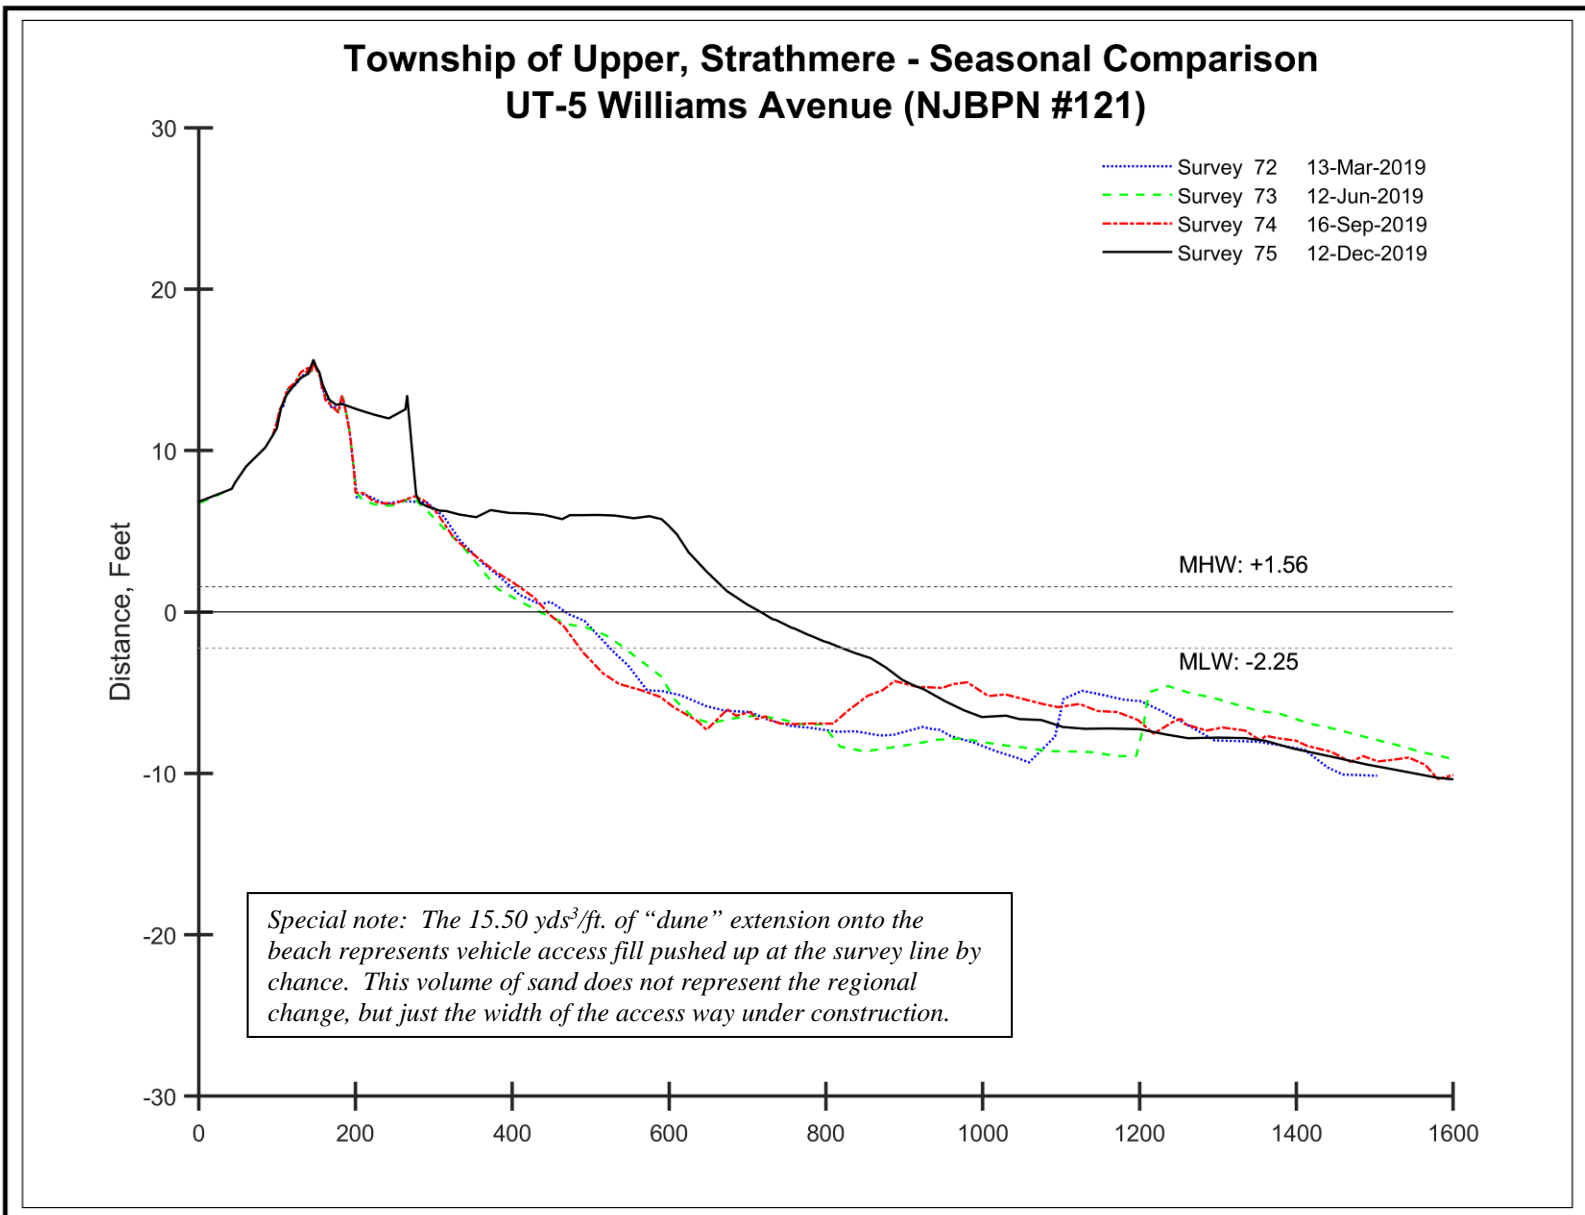
Figure 6. This site lies just south of the influence of the ebb-tidal delta for Corson’s Inlet, but still within the influence of major offshore bar formation. Surveys 72, 73, and 74 show progressive bar creation and landward migration by September. The maintenance fill provided a 272-foot shoreline advance and a beachface toe of slope intersecting the offshore bar from September. The added “dune” volume for the vehicle access was 15.50 yds³/ft. and the beach volume added was 136.23 yds³/ft. Further seaward there were minor additions and losses as the offshore surface changed with sand movements due to breaking waves.

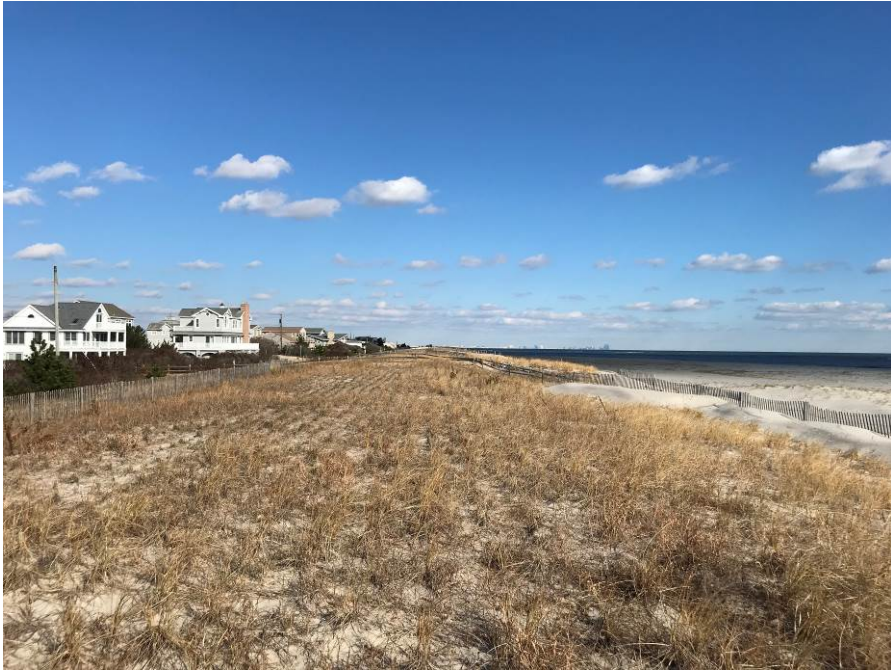
Figure 7a. December 10, 2018

Figure 10a is a view to the north along the dune crest taken during the winter of 2018.

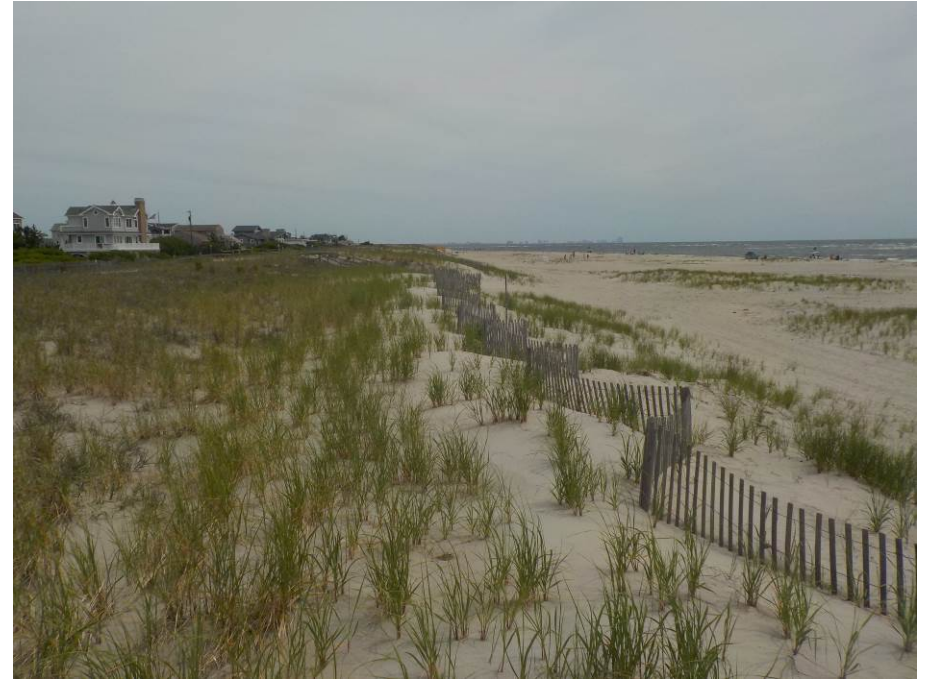
Figure 7b. June 12, 2019

Figure 10b shows the summer beach in June of 2019.

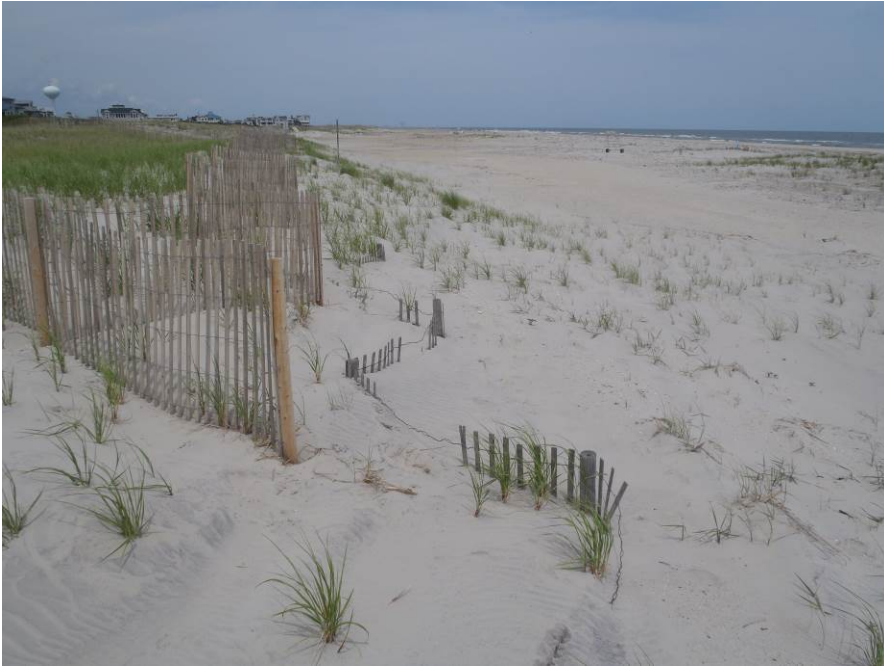
9a. June 8, 2018

Photo 9a is a view to the north along the dune's seaward slope during the summer of 2018. The tops of the old foredune fence are barely exposed at this time as a result of wind-generated sand transport into the dunes. New fencing was installed.

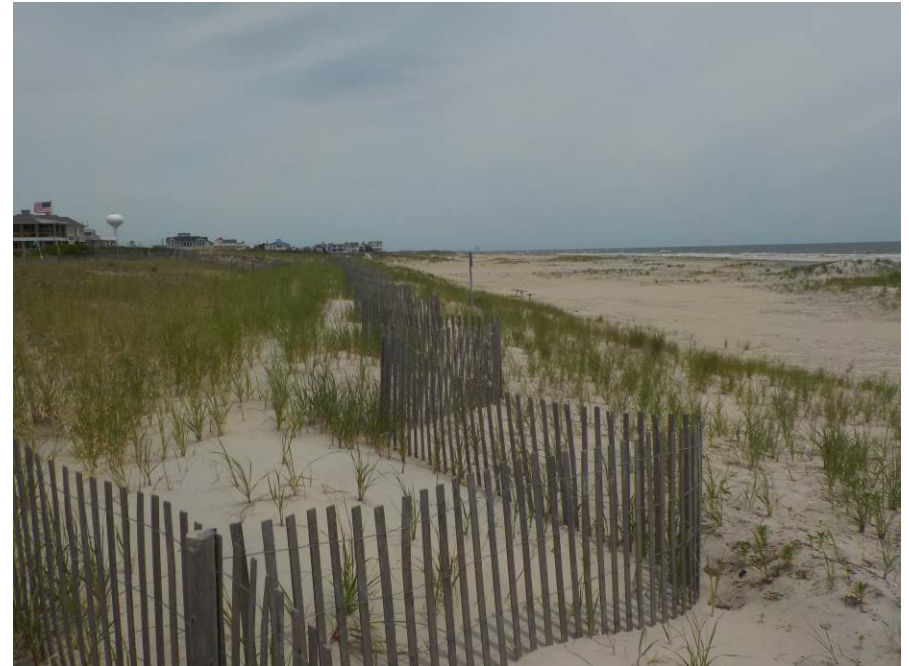
9b. June 12, 2019

Photograph 9b shows the view to the north taken from the foredune perspective a year later with extensive grass growth and spread seaward of the fence line.

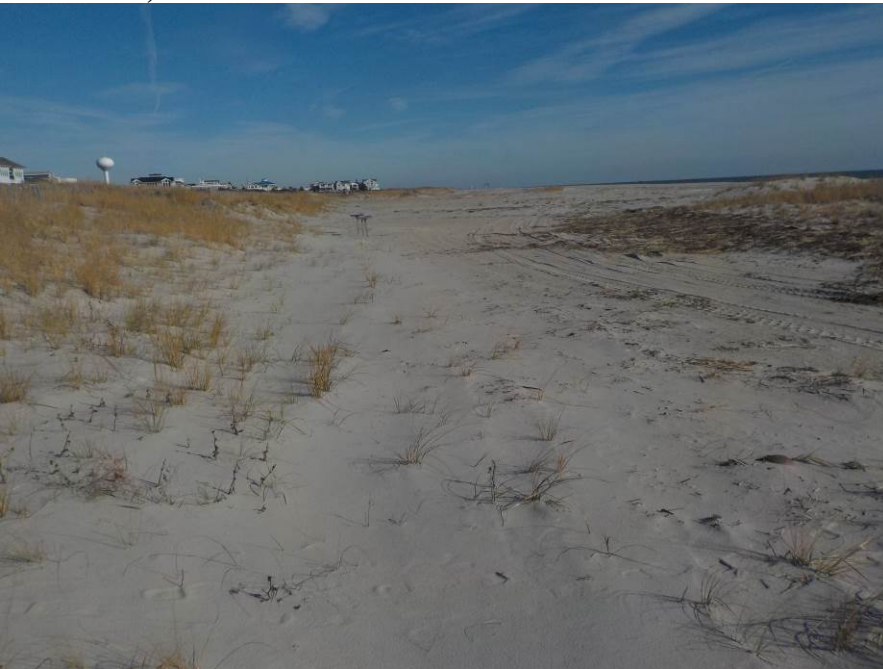
9c. December 12, 2019

Photograph 9c shows the development of dune grass on the dry beach surface since the initial federal work was completed in 2016. Each summer this area expands and acts as a sand trap for wind transported material.

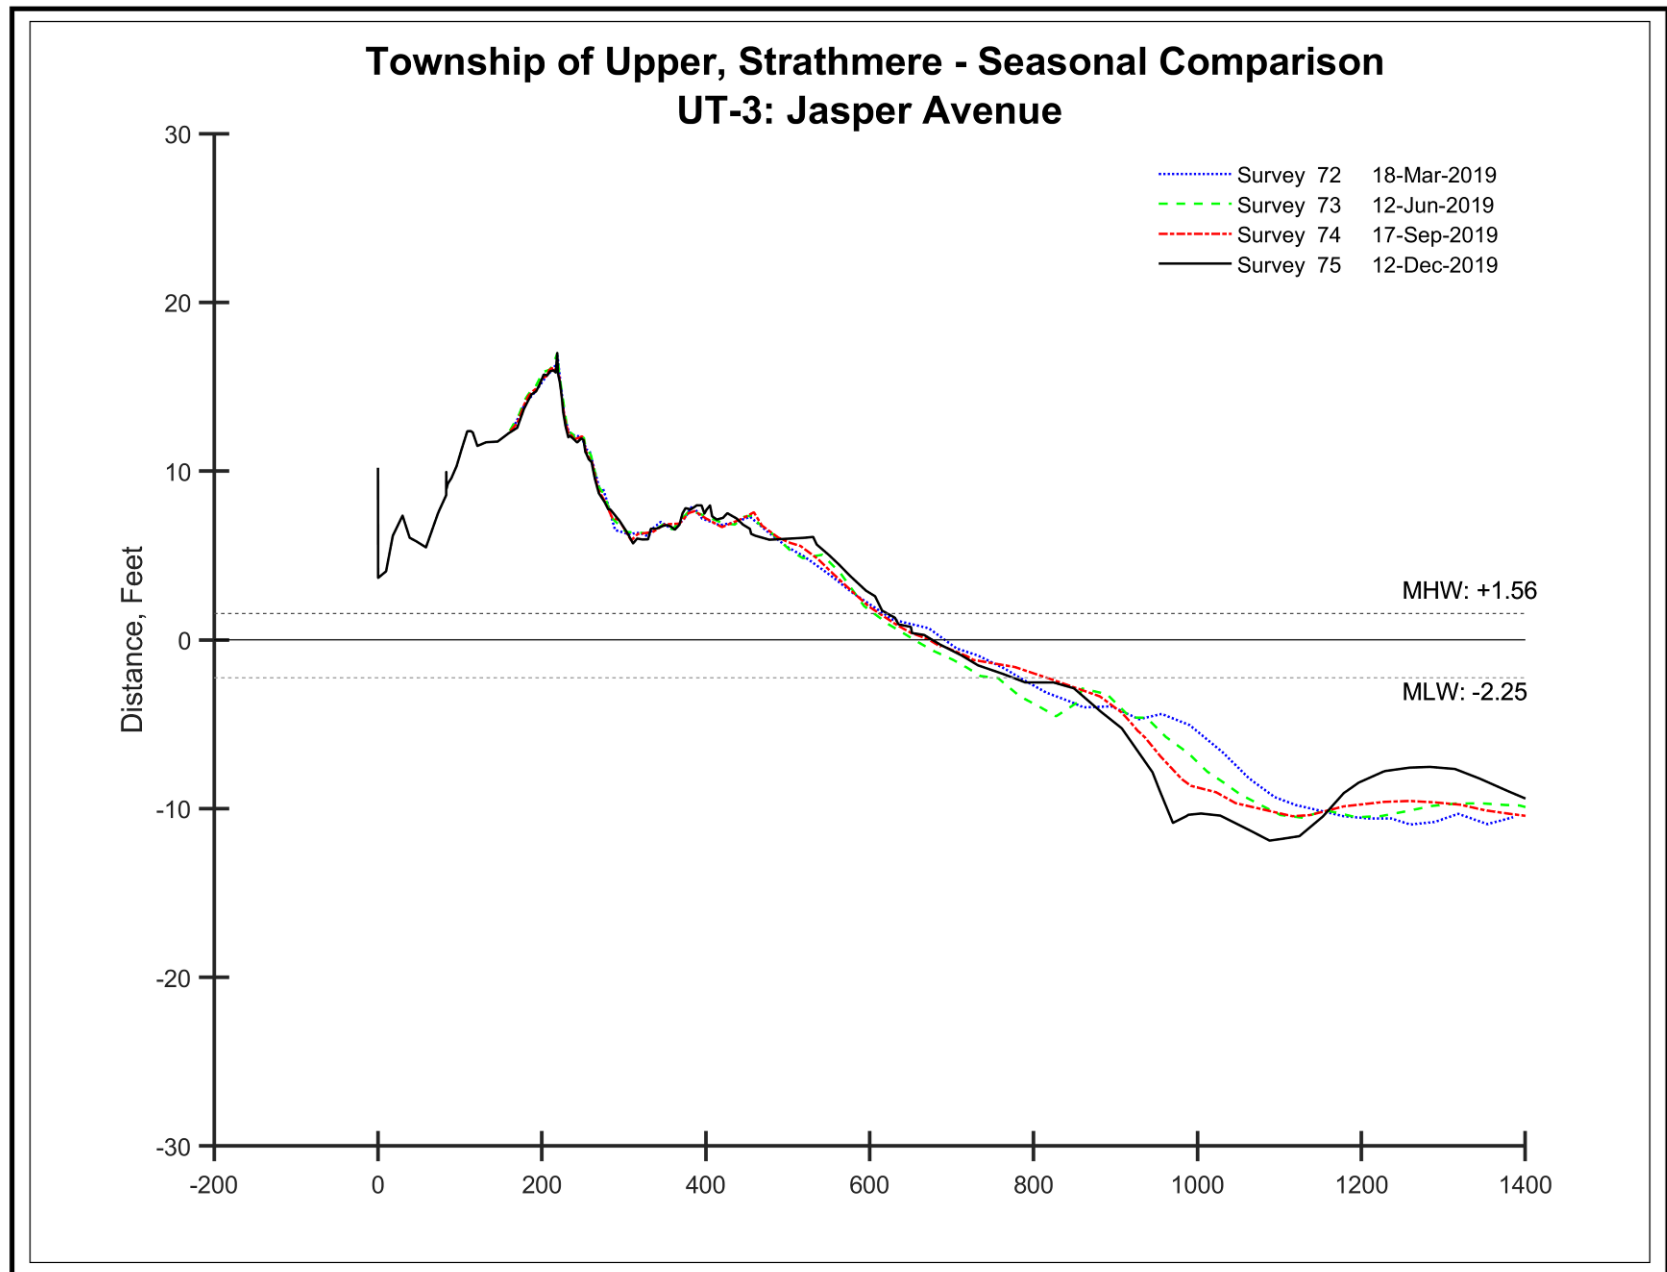
Figure 10. At Jasper Avenue the dunes and back beach areas did not change much over the past year. The beach added sand on the berm by December, while a substantially deeper trough offshore paired with a massive bar situated between 1,200 and 1,400 feet from the reference position was the primary cause for the sand volume changes reported above. Just the trough produced 34.16 yds³/ft. in sand loss quantity, while the bar gained 20.48 yds³/ft.

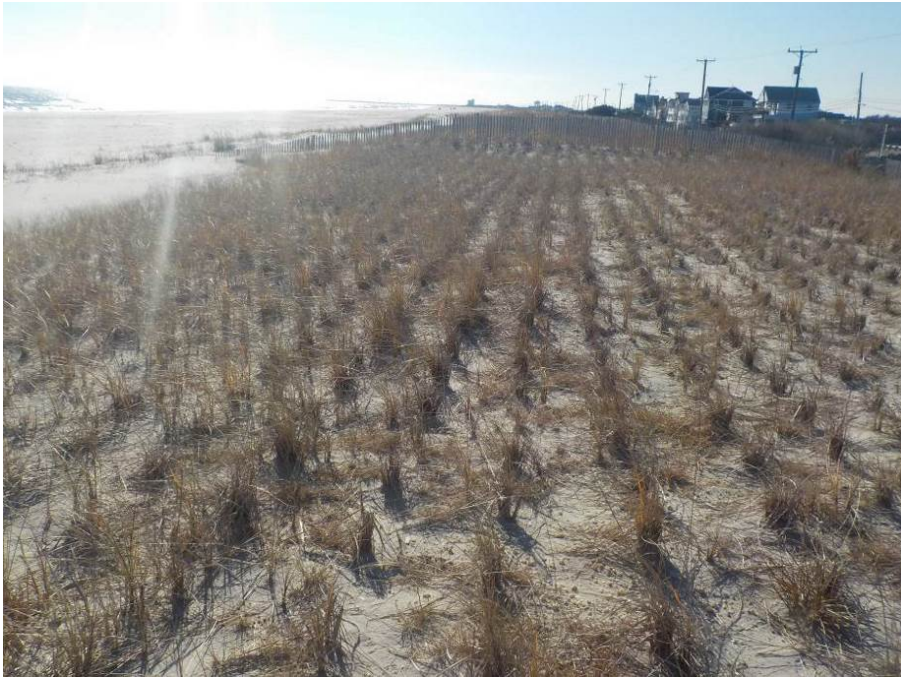
11a. December 1, 2017

Figure 14a is a view to the south from the instrument position on the foredune crest.

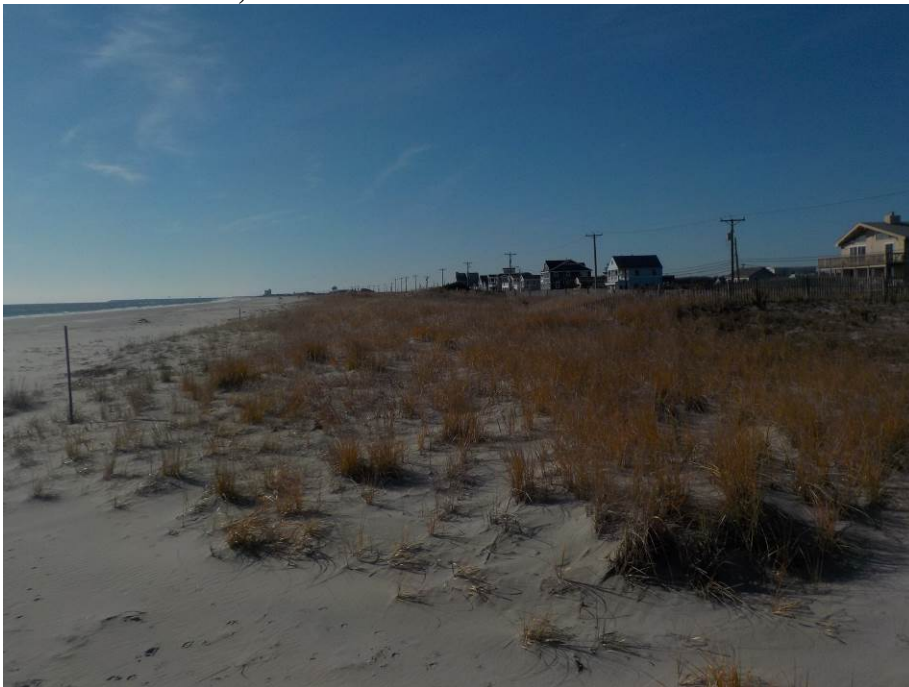
14c. December 12, 2019

Photograph 14c view from December a year later shows the grass becoming distributed more naturally as the planted plugs spread out.

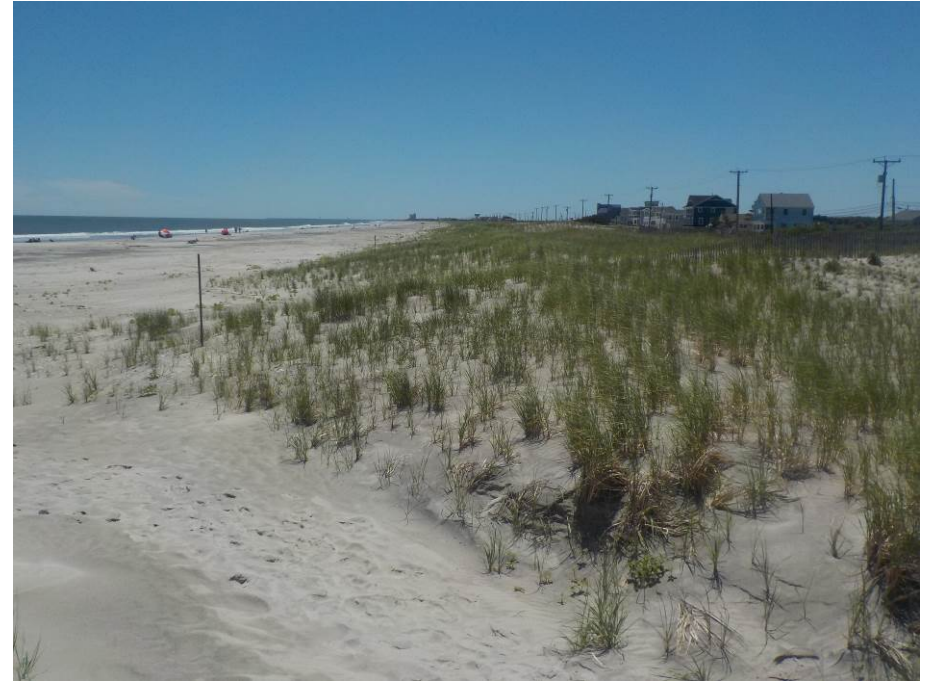
Figure 14b. June 12, 2019

Photograph 14b shows the dune toe in June with a substantial deposit of wind transported sand completely burying the line of fence. The plants are doing well as they expand seaward down the dune's seaward slope.

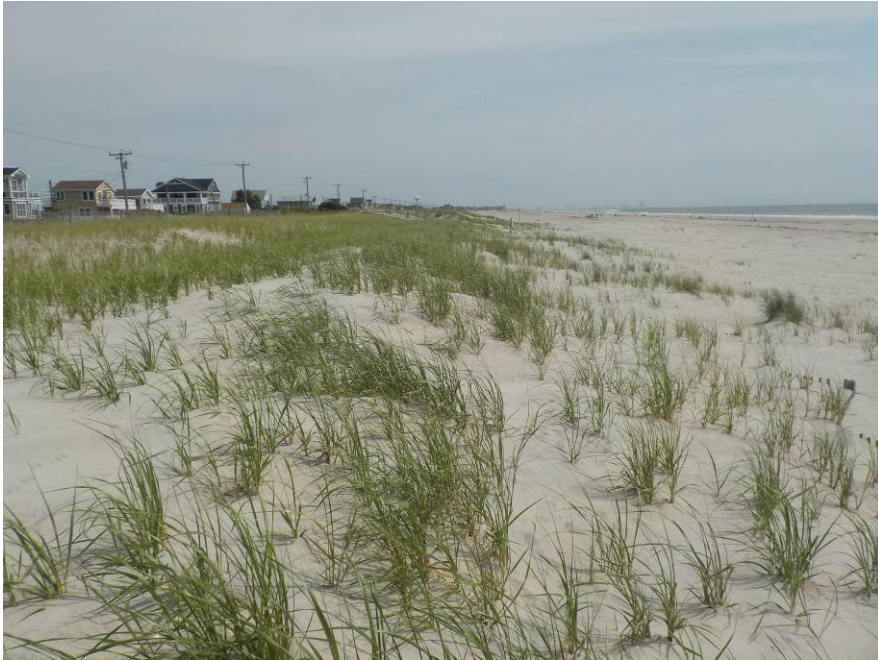
13a. June 8, 2018

Photograph 13a shows the dune growth as of the summer of 2018.

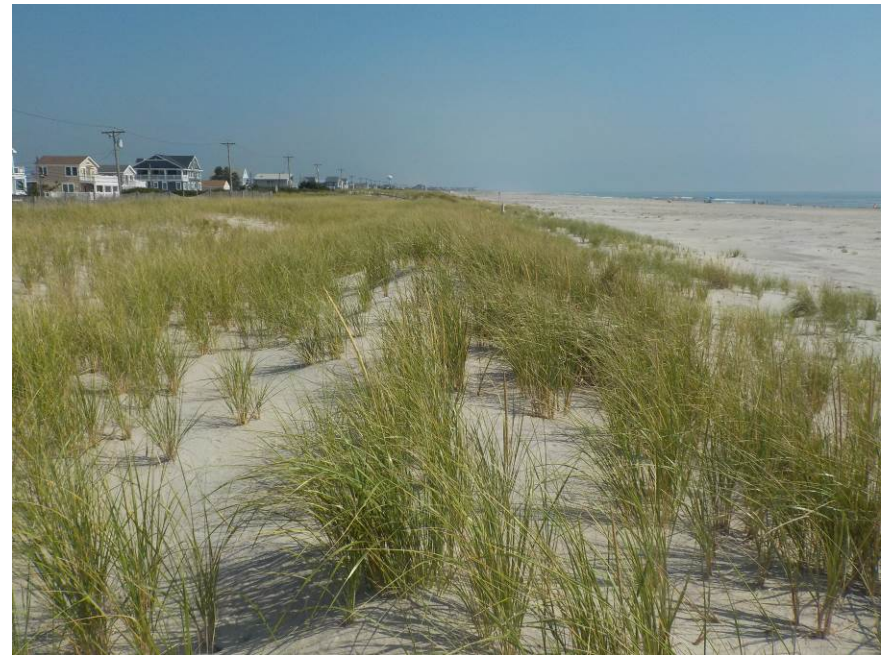
13b. June 11, 2019

Photograph 13b shows the dune with grass plants and the deposition of wind transported sand added a year later in June 2019. Luxuriant growth has enhanced the dune habitat.

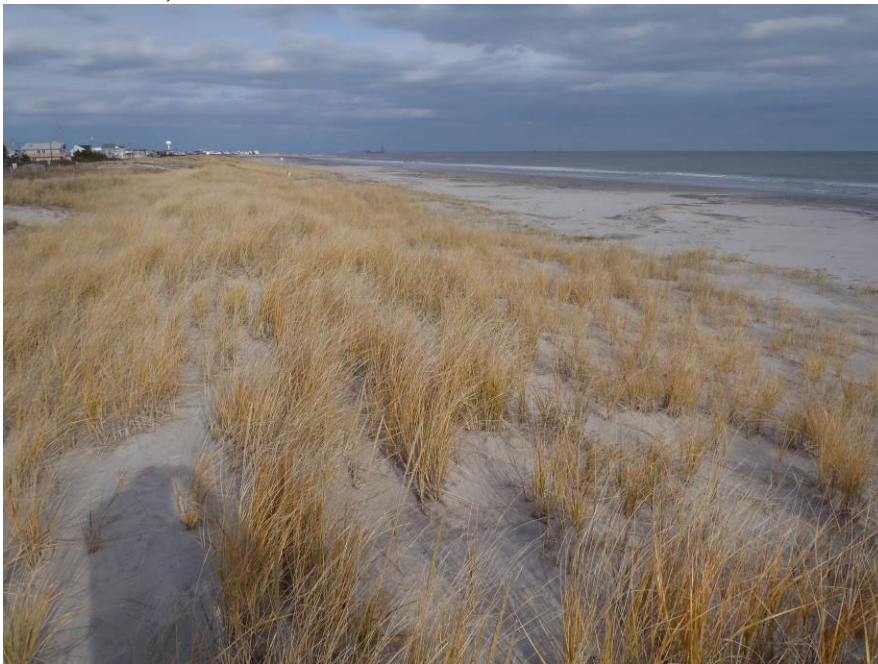
13c. December 12, 2019

Photograph 13c provides the winter view to the north across the dune and onto the beach. The decrease in beach berm width is evident in the picture.
