New Jersey Beach Profile Network

Cape May County

Great Egg Harbor Inlet to Stow Creek

> NJBPN Profile #'s 225 - 100

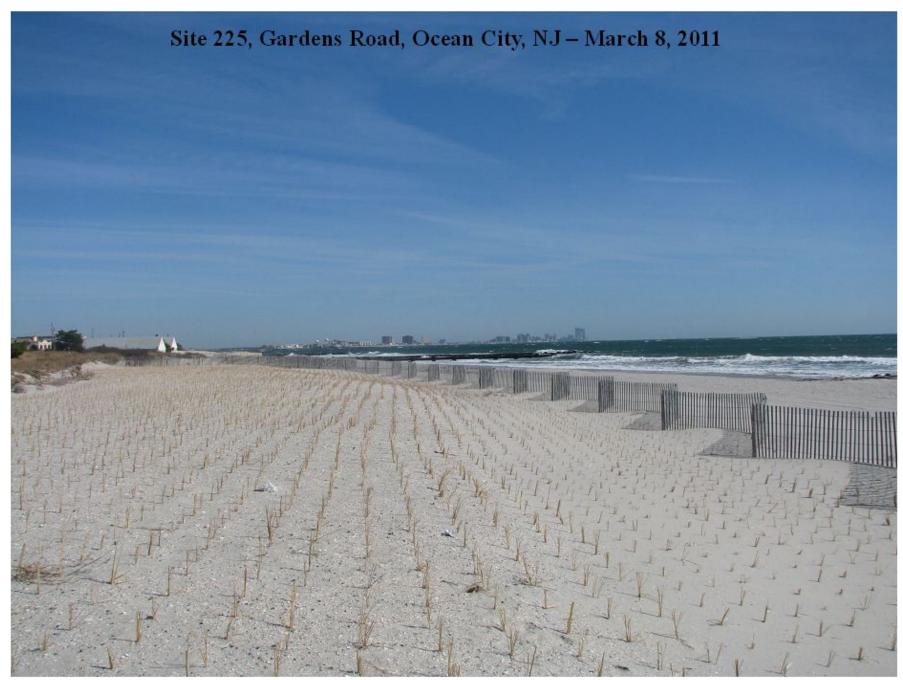
Figure 305. View of the seaward dune crest looking north along the Ocean City Beach.

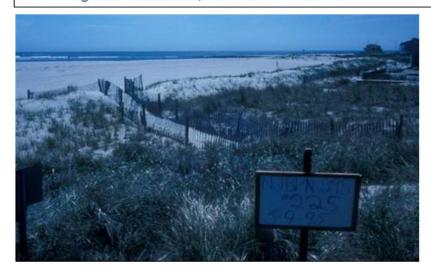
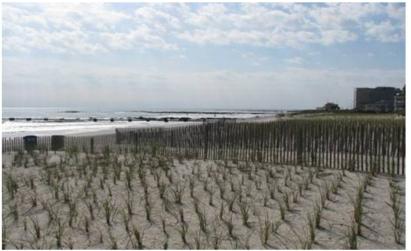
Figure 307: This site was established in 1994 to monitor shoreline changes near Great Egg Inlet. A Federal beach nourishment project was completed in 1995. The high volatility of the site has eroded the shoreline almost 300 feet since 1994. Photo on left taken May 9, 1995. View to the south.

Photo on right taken October 17, 2011. View to the south.

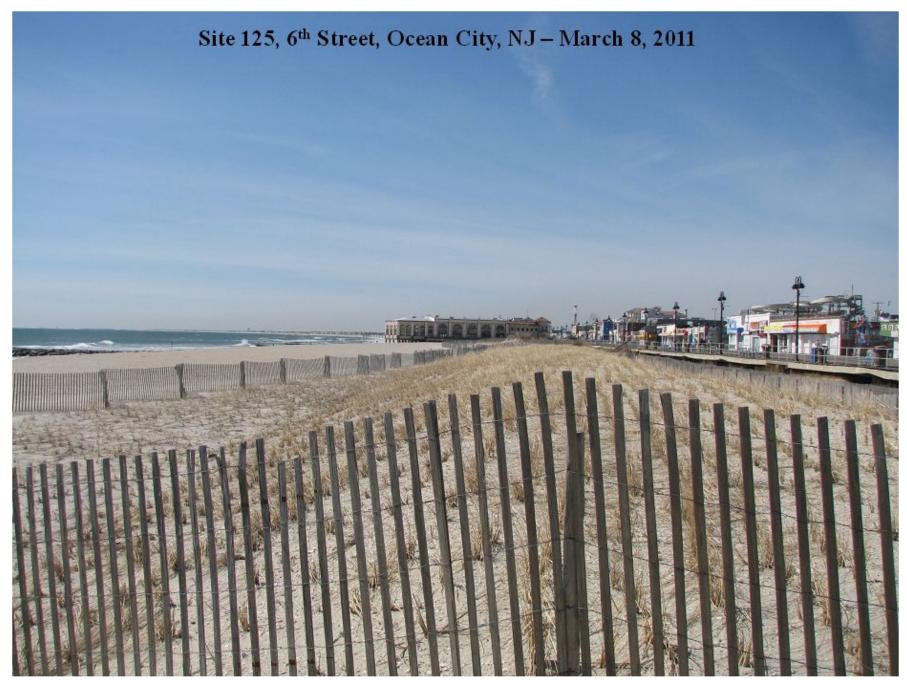
Figure 309. View of the dune crest and beach looking south along the ocean City beach.

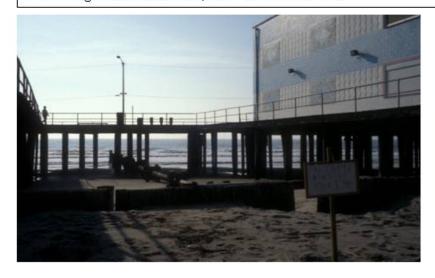
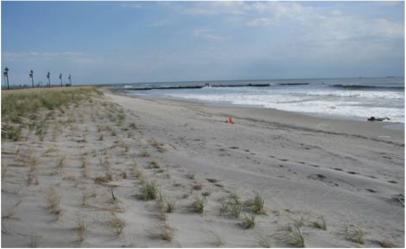
Figure 311: The naturally erosional shoreline at 6th Street initially received material in 1991 by the ACOE. Six additional maintenance fills have taken place since then, stabilizing the area. For the 25 years of study the cumulative sand volume gains amounted to 92.79 yds3/ft. Photo on left taken October 1, 1991. View to the east.

Photo on right taken October 17, 2011. View to the north.

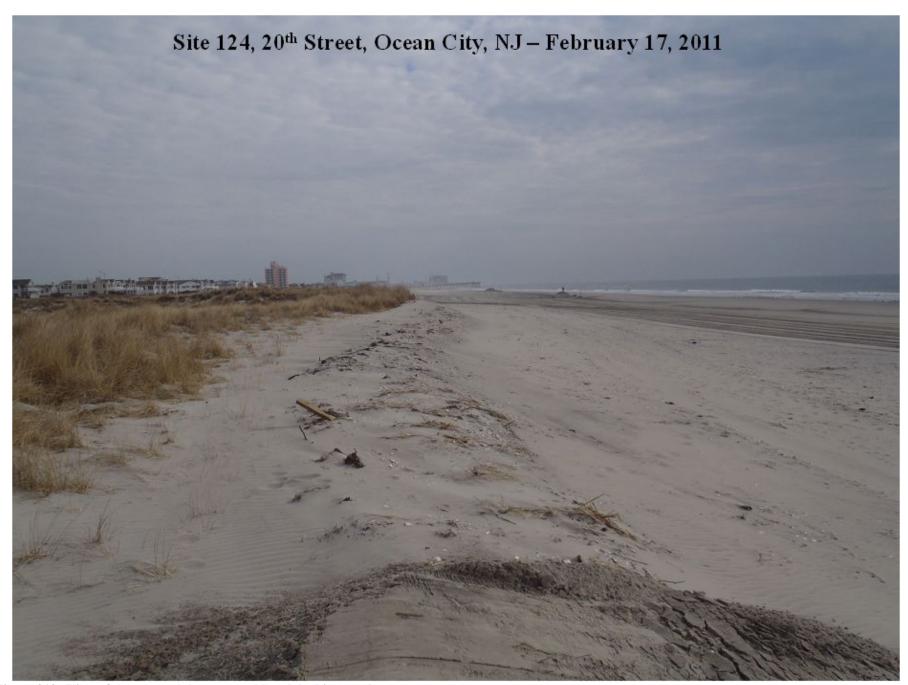
Figure 313. View of the seaward dune toe and beach looking north.

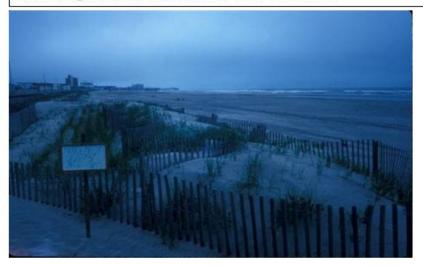
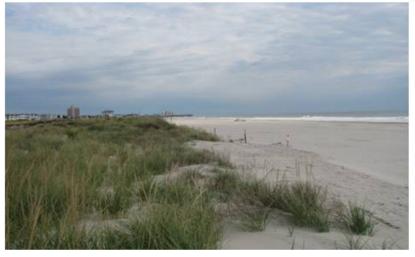
Figure 315: The initial beach replenishment project in 1991 added material to the retreating beach and dune. Since then, no additional sand has been directly placed here, but the profile configuration has remained stable from natural littoral transport of material from the north. Significant sand volume increases (142.15 yds³/ft) and shoreline advance (512 feet) have occurred over the 25 years of study. Photo on left taken in 1991. View to the north.

Photo on right taken October 17, 2011. View to the north.

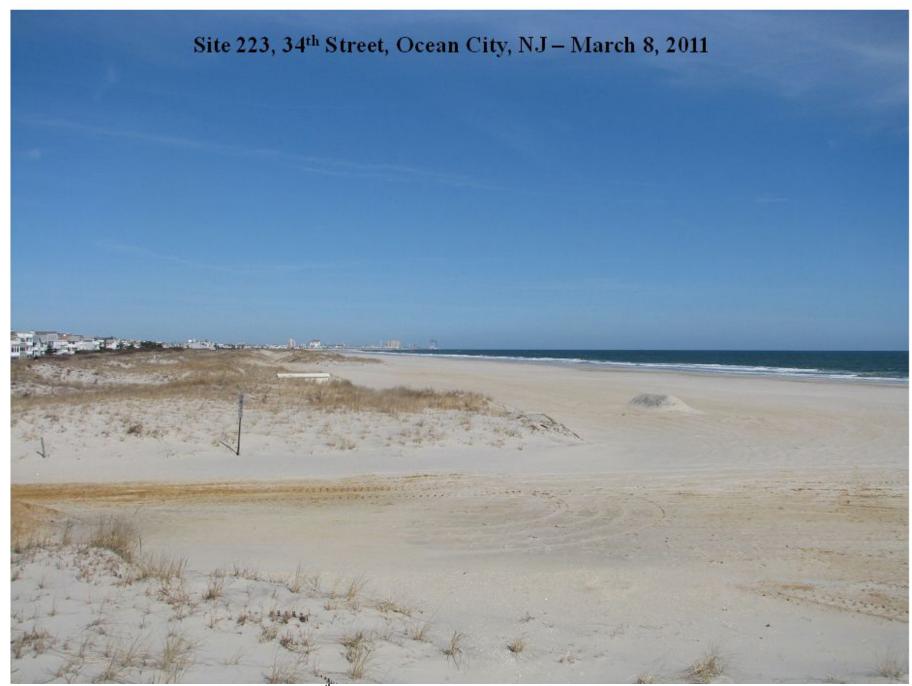
Figure 317. View looking north along the dune crest at 34th Street in early spring 2011.

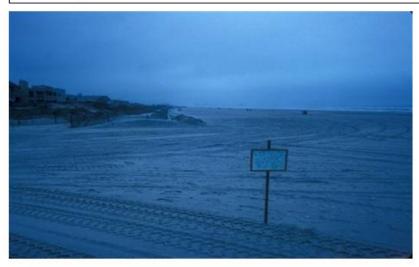
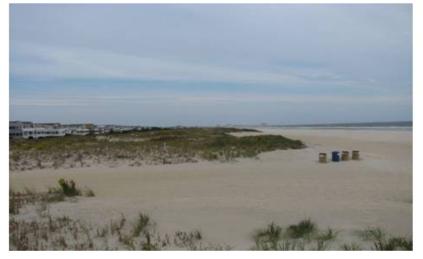
Figure 319: The location of the profile was moved 40 feet to the south to allow measurements of the dune growth and has altered the configuration of the profile. Currently the dune is represented in the October 2011 profile. Photo on left taken May 11, 1995 of former Site 123. View to the northeast. Photo on right taken October 11, 2011. View to the north.

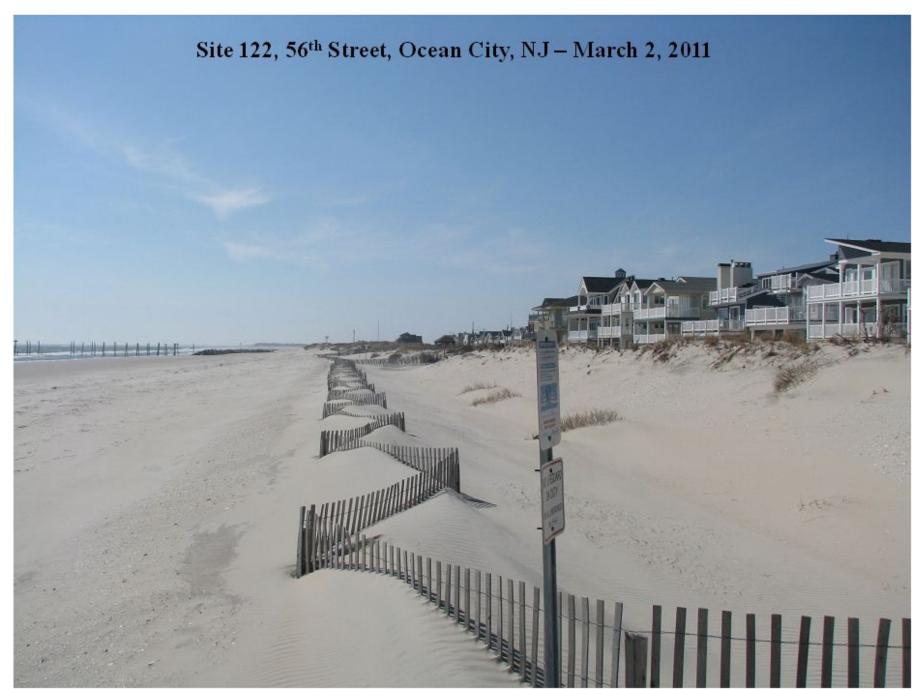
Figure 321. View along the seaward foredune toe looking south.

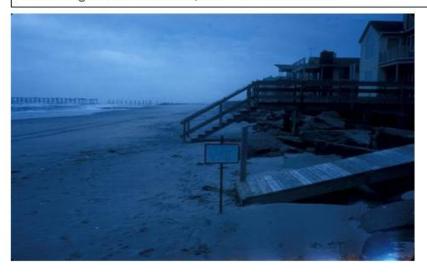
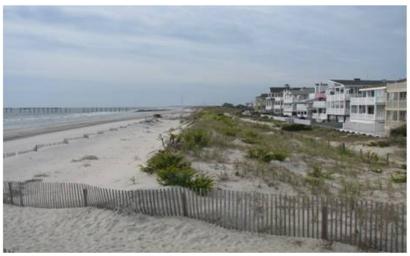
Figure 323: Replenishment work was done here in 1995, 2001 and 2010 maintaining a positive position of the primary dune, shoreline and the sand volume. A 37.84 yds³/ft sand volume gain has been recorded since 1986 along with a shoreline advance of 41 feet. Photo on left taken May 11, 1995. View to the south.

Photo on right taken October 11, 2011. View to the south.

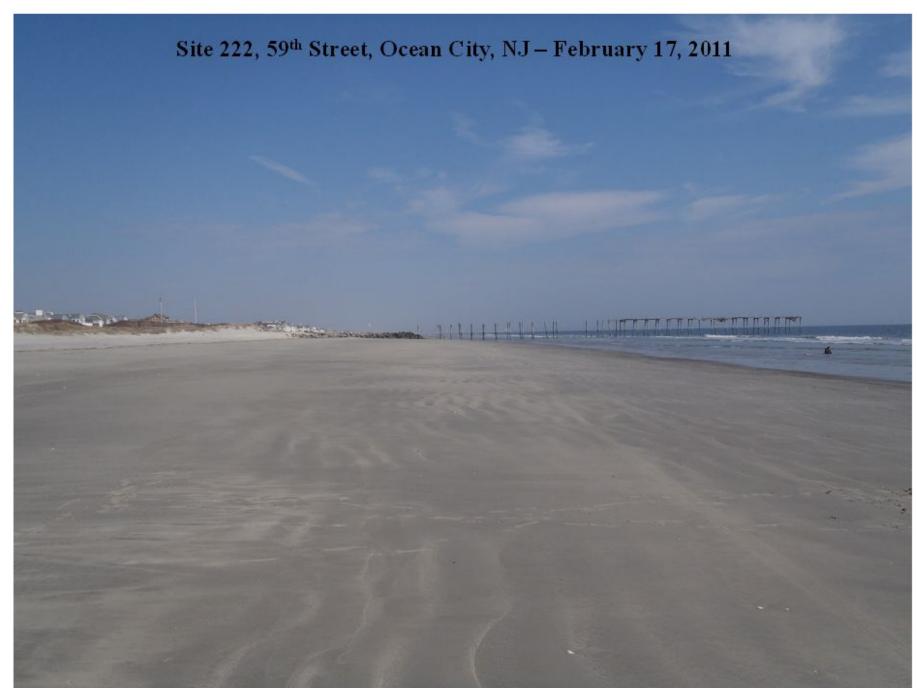
Figure 325. View to the north of the lower berm and beach along the State Park that occupies the southern segment of the Ocean City Beach.

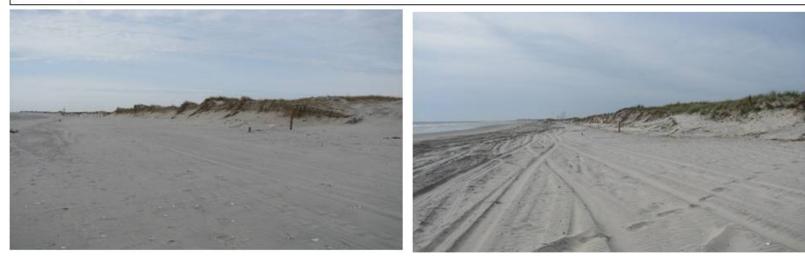
Figure 327: This site was established due to increased need of profile data for this section of the island. Offshore, nearshore, and recreational beach losses culminated in a 61 foot shoreline retreat since 2009.

Photo on left taken February 22, 2010. View to the south.

Photo on right taken October 11, 2011. View to the south.

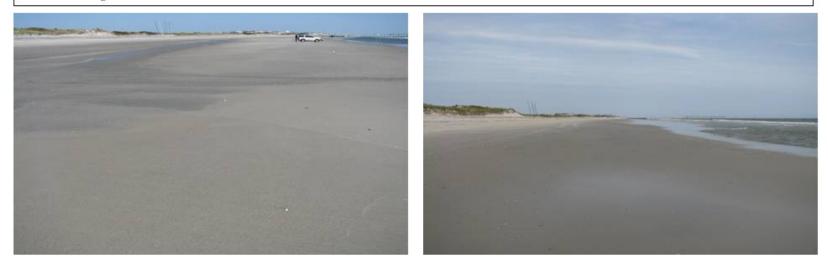
Figure 330: This site was established to monitor changes near Corson's Inlet. Losses offshore as well as at the beachface have retreated the shoreline over 100 feet since 2009.

Photo on the left taken October 7, 2010. View to the north.

Photo on the right taken October 11, 2011. View to the north.

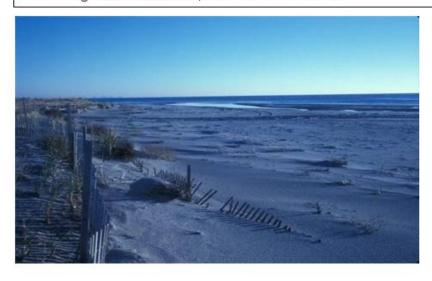
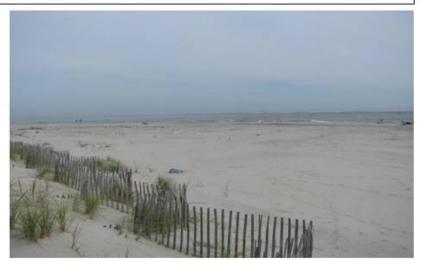
Figure 333: There have been three State/locally sponsored projects in Strathmere (1984, 2001, and 2009) that have enabled dune and beach growth for the 25 year period. Overall cumulative sand volume gains of 61.49 yds³/ft and a shoreline advance of 109 feet were recorded. Photo on left taken in 1988. View to the north.

Photo on right taken October 10, 2011. View to the north.

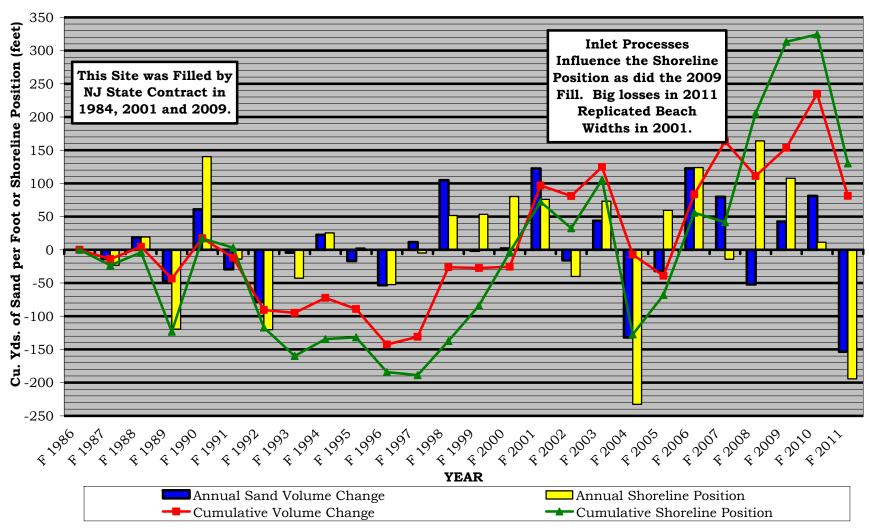
25-Year Coastal Changes at Site 121, Williams Road, Strathmere, Cape May Co.

Figure 334. Very large magnitude changes occur at the northern shoreline of Ludlam Island. There have been three State/locally sponsored projects in Strathmere (1984, 2001, and 2009 plus repair in 2012). A shoreline position variation of 500 feet is due to enormous sand volumes within the Corson's Inlet ebb-tidal shoals which periodically migrate onto the beach. The spikes in 2001 and 2009 were fill related, but the loss in 2011 was due to sand transfer toward the inlet.

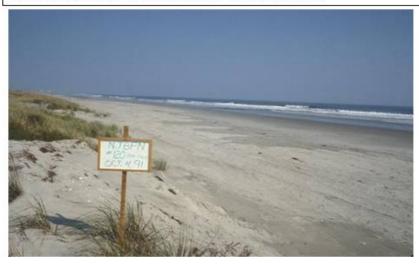
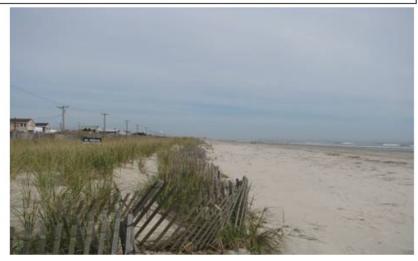
Figure 337: Historically, this site is known for its low elevation and narrow beach. The gradual decline in sand volume is evidence for a limited supply reflecting this low, narrow part of the barrier system. However, the 2009 replenishment sand has added 70 feet of shoreline as well as 32.95 yds³/ft of sand.

Photo on left taken October 4, 1991. View to the north.

Photo on right taken October 10, 2011. View to the north.

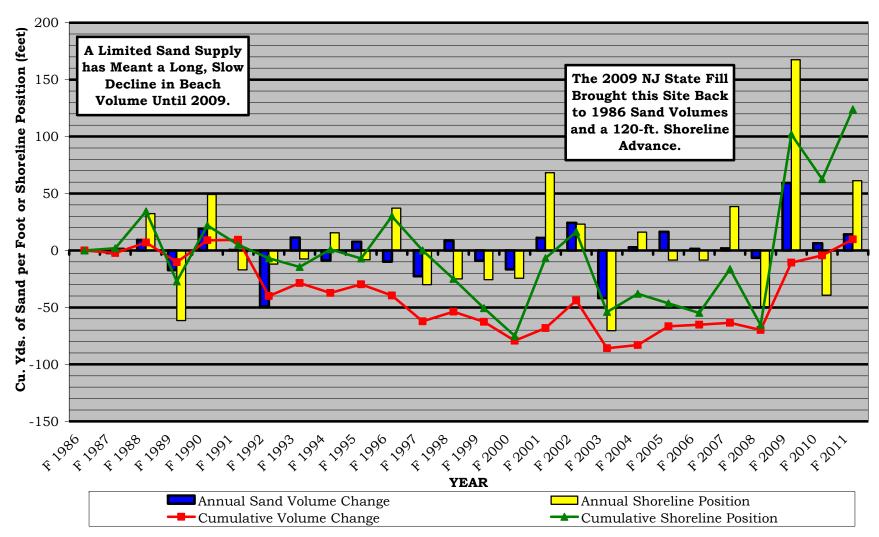
25-Year Coastal Changes at Site 120, 1st Street Sea Isle City, Cape May Co.

Figure 338. This site is located in the middle of Whale Beach, part of Ludlam Island known for its low elevation, narrow beach and minimal width. The gradual decline in sand volume is evidence for a limited supply reflecting this low, narrow part of the barrier system. The 2009 beach restoration plus the 2011 restoration of the storm losses in 2009 & 2010 have replaced the lost material seen following the 2008 survey.

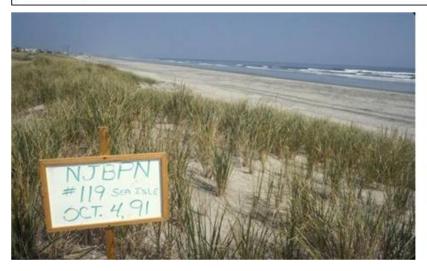
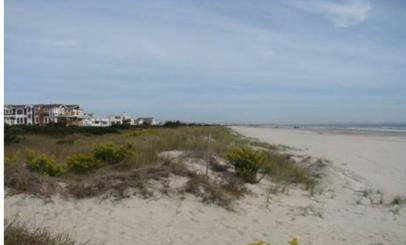
Figure 341: The replenishment project in 2009 has elevated the recreational beach and dune, adding 71.92 yds³/ft of sand along the profile. The shoreline also advanced 170 feet since 1986.

Photo on left taken October 4, 1991. View to the north.

Photo on right taken October 10, 2011. View to the north.

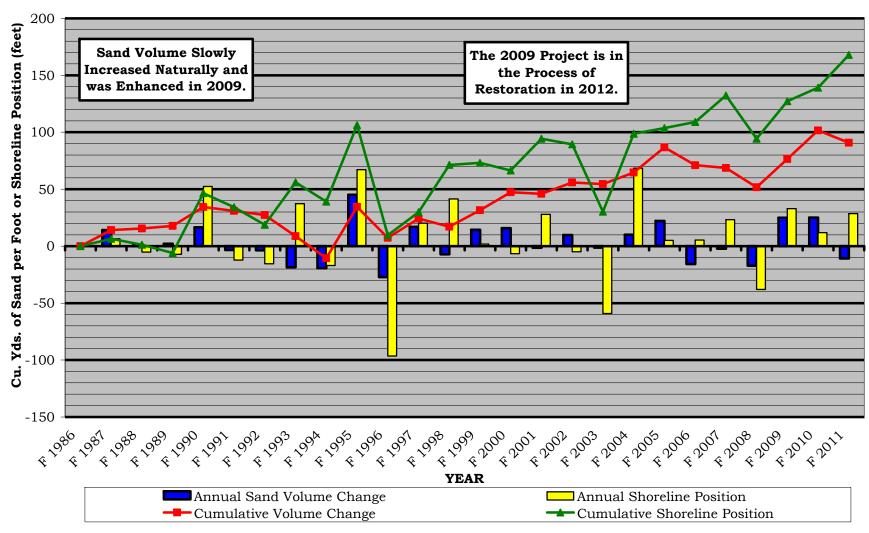
25-Year Coastal Changes at Site 119, 25th Street Sea Isle City, Cape May Co.

Figure 342. Sand was initially added here in 2009 with repair fill underway in starting late in 2011, so the net change at this site was a slow increase in sand volume with an advance seaward for the shoreline position.

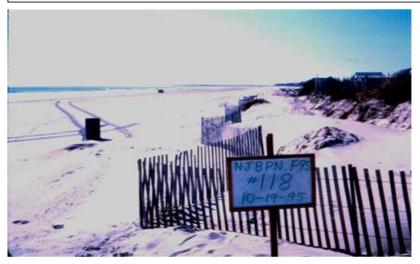
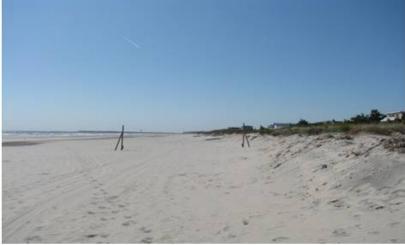
Figure 345: Sand placement in late 2009 advanced the shoreline 106 feet virtually restoring the original 1986 profile configuration. The dune growth since 1986 is also documented in the profile above.

Photo on left taken October 19, 1995. View to the south.

Photo on right taken October 7, 2011. View to the south.

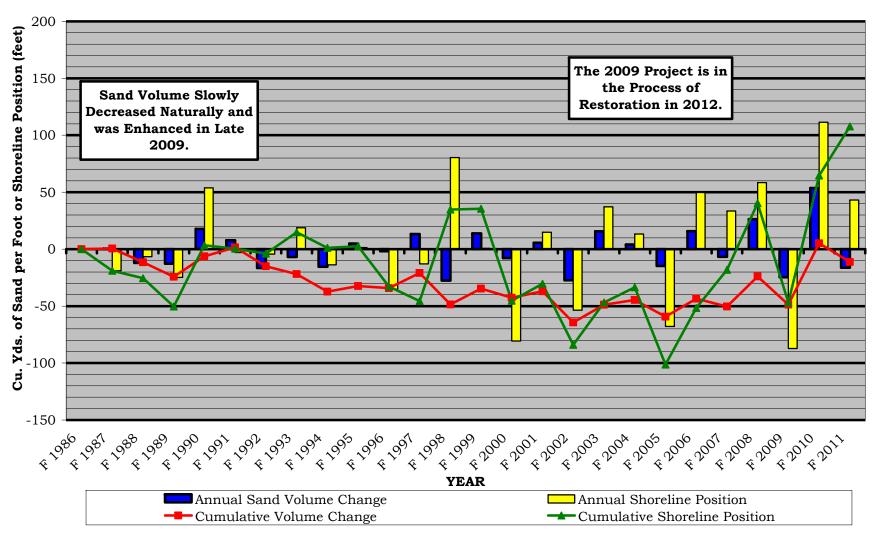
25-Year Coastal Changes at Site 118, 57th Street Sea Isle City, Cape May Co.

Figure 346. The mid-community beaches of Sea Isle City have been in slow decline for years. Sand was placed here in 2009 and the City funded additional material during the storm repair project that concluded in 2012. The 50 yds³/ft. loss in sand volume was restored to the 1986 conditions, with a bonus of a 100-foot shoreline advance.

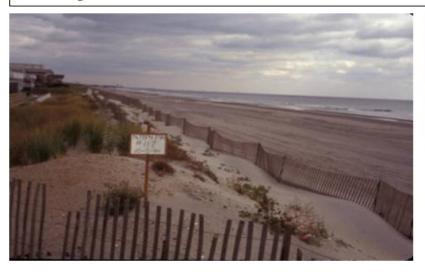
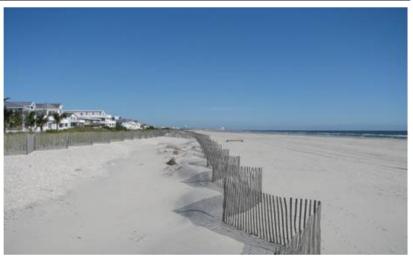
Figure 349: Sea Isle City received the latest beach replenishment sand in late 2009 significantly increasing the recreational beach elevation. Over the 25 year period the shoreline advanced 184 feet.

Photo on left taken October 5, 1994. View to the north.

Photo on right taken October 7, 2011. View to the north.

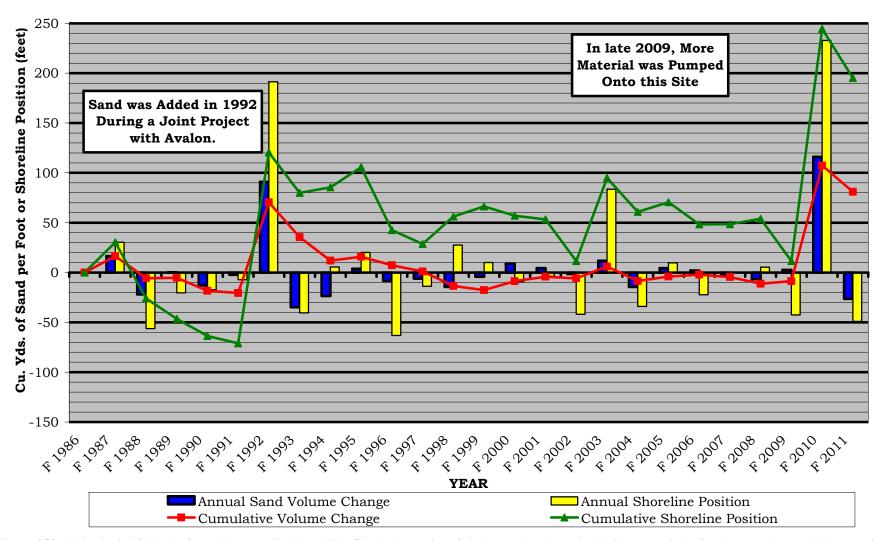
25-Year Coastal Changes at Site 117, 80th Street Sea Isle City, Cape May Co.

Figure 350. This site is 13 blocks from Townsend's Inlet. The City had a series of timber and rock groins built successively further south toward the terminal structure at 93rd Street with acts as a low profile jetty to the inlet channel over many years of time. In addition sand has been pumped here since 1978. It and a 1982 project preceded this undertaking, but the impact of a 1992 and the 2009 project show dramatically. The site is currently ahead of 1986 beach conditions.

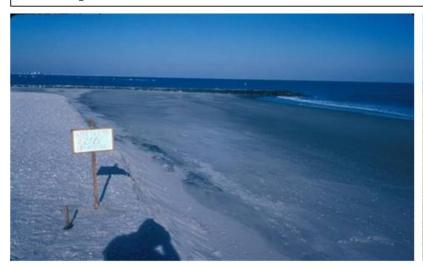
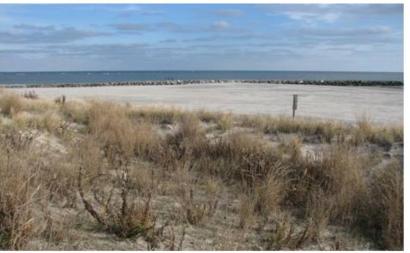
Figure 353: Beach replenishment projects have dominated the area at 9th Street. The sand added and the extension of the jetty immediately to the north of the profile has culminated in a shoreline advance of 254 feet and sand volume gains amounting to 325.52 yds³/ft. Photo on left taken in 1996. View to the north.

Photo on right taken December 9, 2011. View to the northeast.

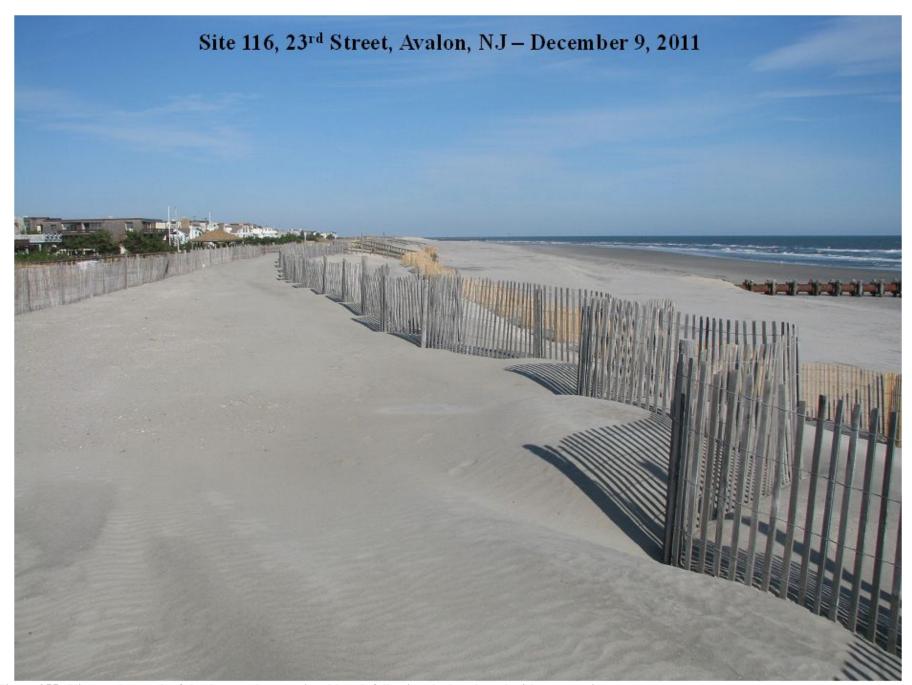
Figure 354. This is another of the inlet-associated cross sections added in 1994. Townsend's Inlet has had a significant impact on the stability of Avalon's northern shoreline. The initial beach project happened in 1987 with subsequent additions almost every two years. The Federally-sponsored work commenced in 2003 as the big spike shows. The municipality augmented the Federal beach work multiple times with a variety of sand supplies (back-passing, quarry sand and direct inlet dredging).

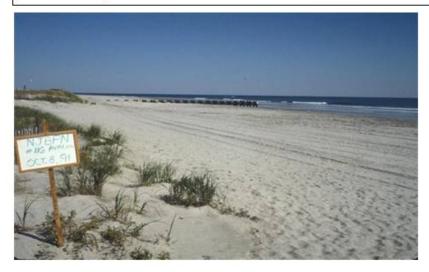
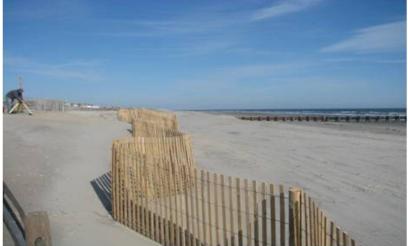
Figure 357: The site at 23rd Street has received direct sand placement from numerous beach replenishment projects going back as far as 1987. Currently the dune is shown to have increased in the last 25 years in both elevation and width along with a shoreline advance of 117 feet. Photo on the left taken October 8, 1991. View to the north.

Photo on the right taken December 9, 2011. View to the north.

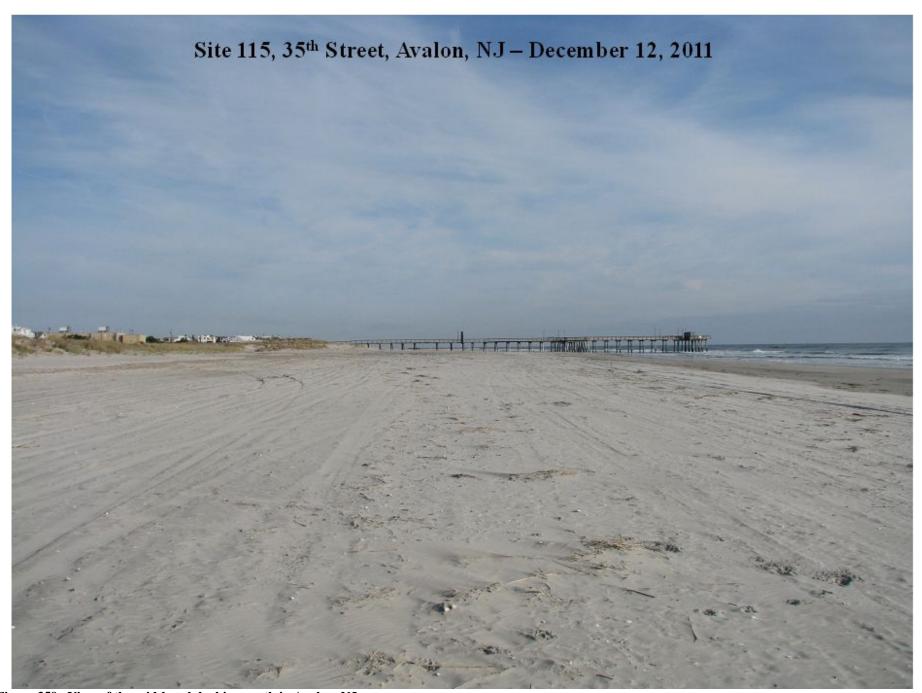
Figure 358. Positioned in the middle of the Avalon beach restoration zone, this site shows the complete history of sand placement since 1987. Not every project saw sand placed directly on this beach, but sand moved to the site readily. The big events were the initial 1987 work and the 2002 Federal initial construction. Decline is evident following 2002 until the Borough intervened in 2010.

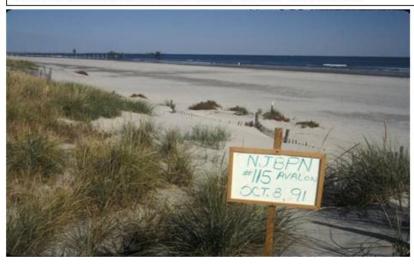
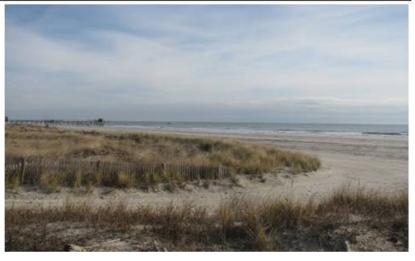
Figure 361: Cumulative sand volume gains over the 25 years of study amounted to 36.92 yds³/ft, concentrated in the primary dune growth, recreational beach, and nearshore regions. The transport of sand from the northern beachfill projects over the years has supplied ample material for stability along the profile.

Photo on left taken October 8, 1991. View to the northeast.

Photo on right taken December 9, 2011. View to the northeast.

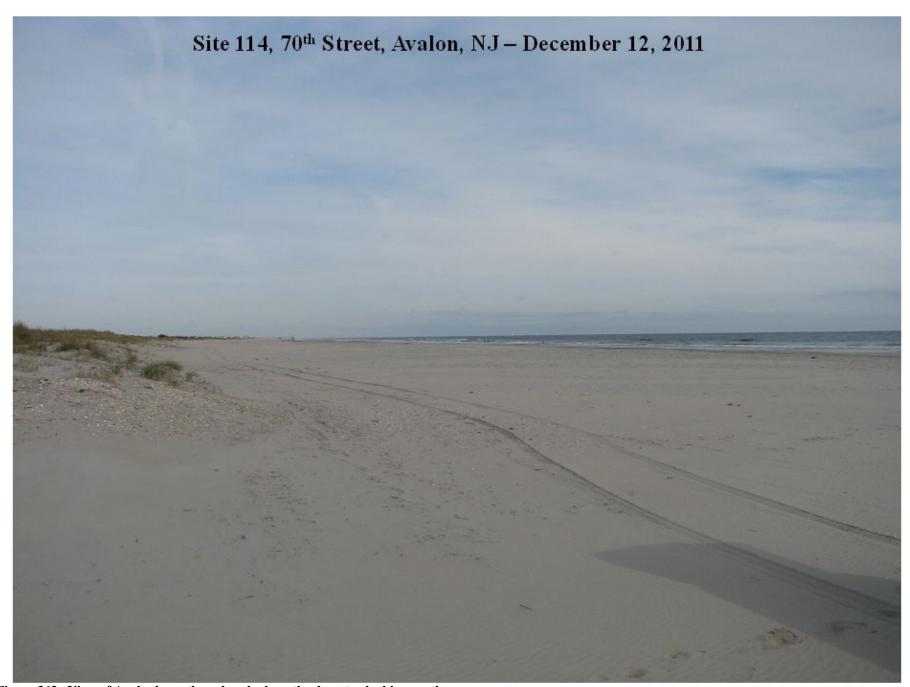
Figure 362. This site lies south of all beach nourishment work in Avalon. Sand moved to the site in quantity in 1995 and 1996 with another pulse in 2011. Derived from the project shoreline, the site has been in positive territory since 2003.

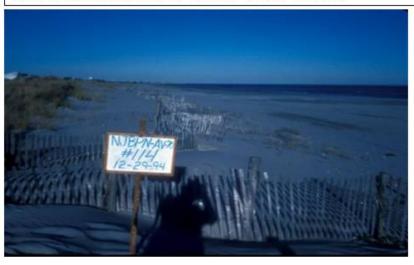
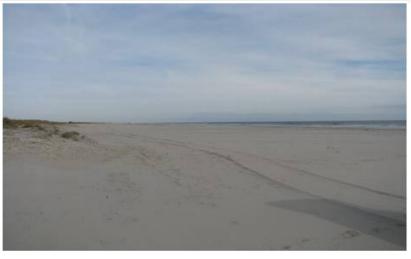
Figure 365: The creation of a seaward dune ridge is depicted in the cross section above. This site marked the tapered end of the beach replenishment projects. Considerable beach elevation increases continued to the offshore portions as well since 1986. The shoreline advanced nearly 200 feet over this time period.

Photo on left taken December 29, 1994. View to the north.

Photo on right taken December 12, 2011. View to the north.

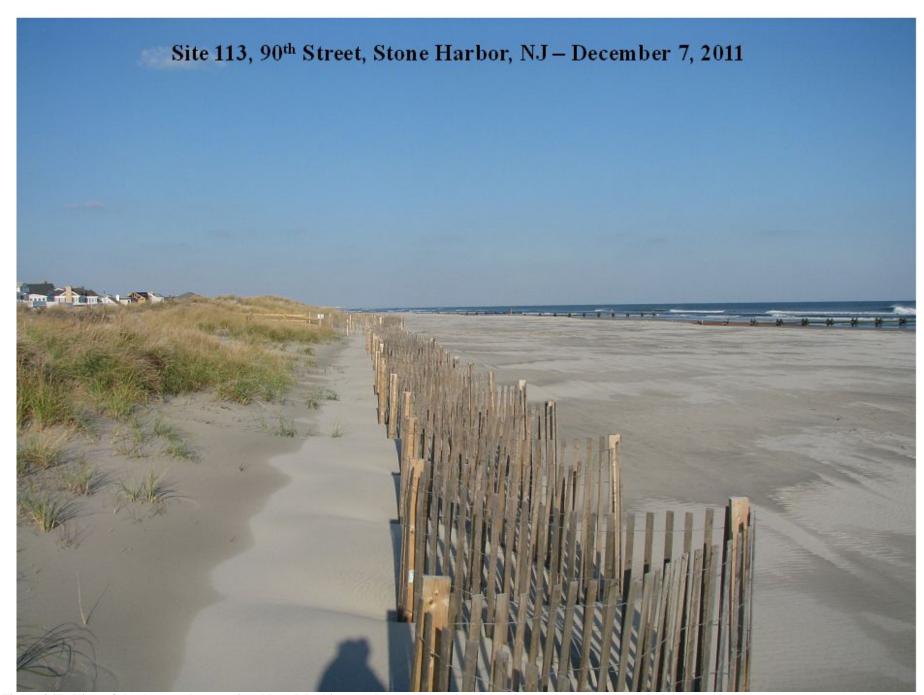
Figure 366. Sand has moved toward the center of Seven-Mile-Island since monitoring began, accelerating as the sand nourishment projects accumulated. A steady increase in sand volume and a shoreline advance seaward commenced in 1998 and have seldom reversed in even a minor instance. The dunes and back beach have all benefited greatly.

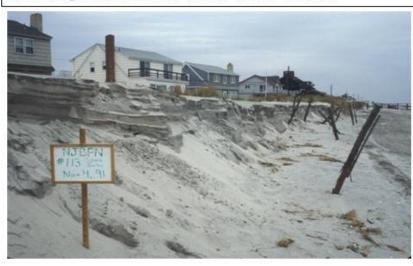
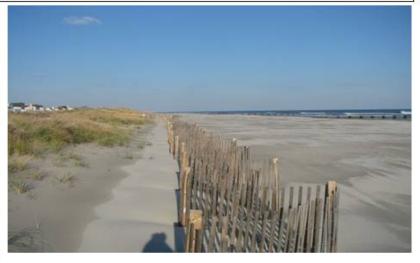
25-Year Coastal Changes at Site 113, 90th Street, Stone Harbor, Cape May Co.

Photo on left taken November 4, 1991. View to the north.

Photo on right taken December 7, 2011. View to the north.

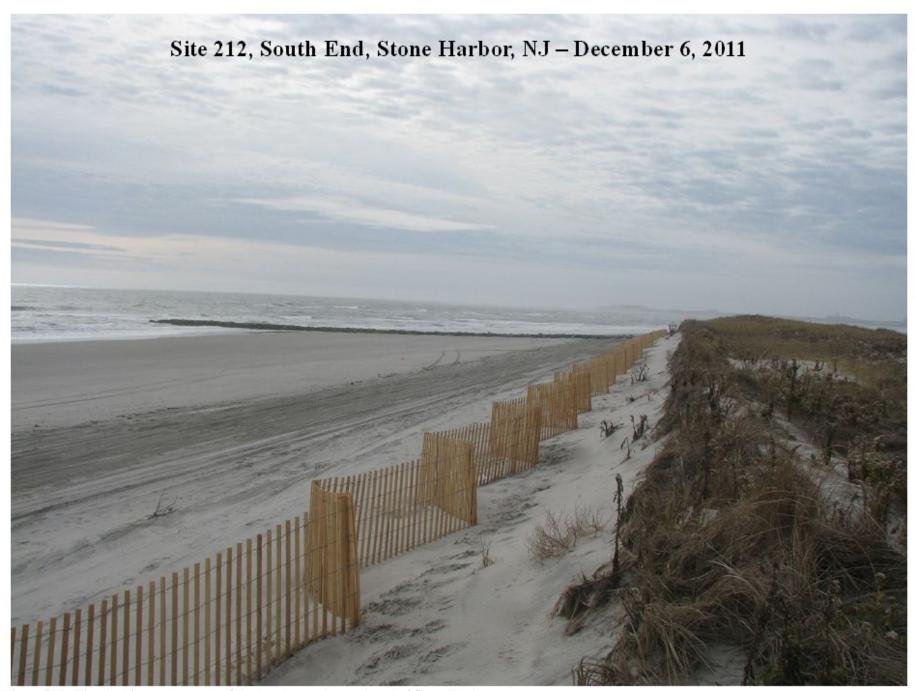
Figure 371. View looking to the south of the beaches at the south end of Stone Harbor.

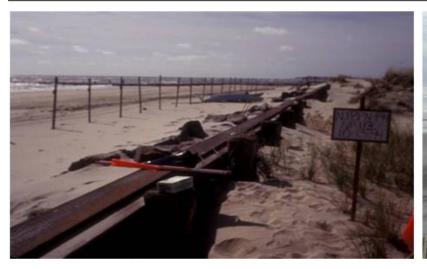
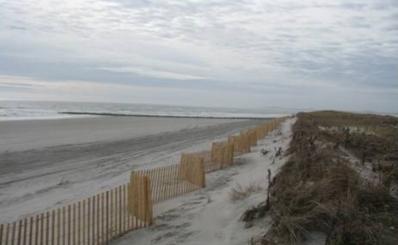
17-Year Coastal Changes at Site 212, South End, Stone Harbor, Cape May Co.

Figure 373: Numerous beach replenishment projects (largest in 2003) over the last decade has provided this profile site in Stone Harbor with significant primary and backdune growth. Currently, there exists an offshore bar that should build onto the existing beachface in the near future. Cumulative sand volume gains for the study period amounted to 118.26 yds³/ft.

Photo on left taken October 13, 1994. View to the south.

Photo on right taken December 6, 2011. View to the south.

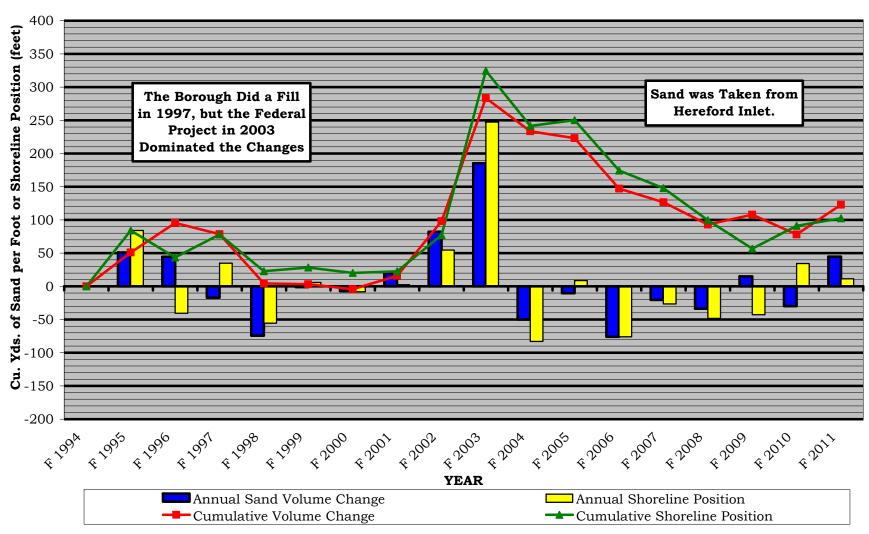
Figure 374. This is another of the inlet-associated cross sections added in 1994. However, this replaces a survey site initially established on the natural southern spit extending into Hereford Inlet. This spit disintegrated in 1990 leaving the entire spit as intertidal and shallow sub-tidal shoals. This location is at the southern end of the developed shoreline and in spite of the total recovery of the uninhabited southern spit, responds to beach work with erosion between efforts. The Federal project produced major changes that decayed over time. Recent recovery occurred in 2010 and 2011.

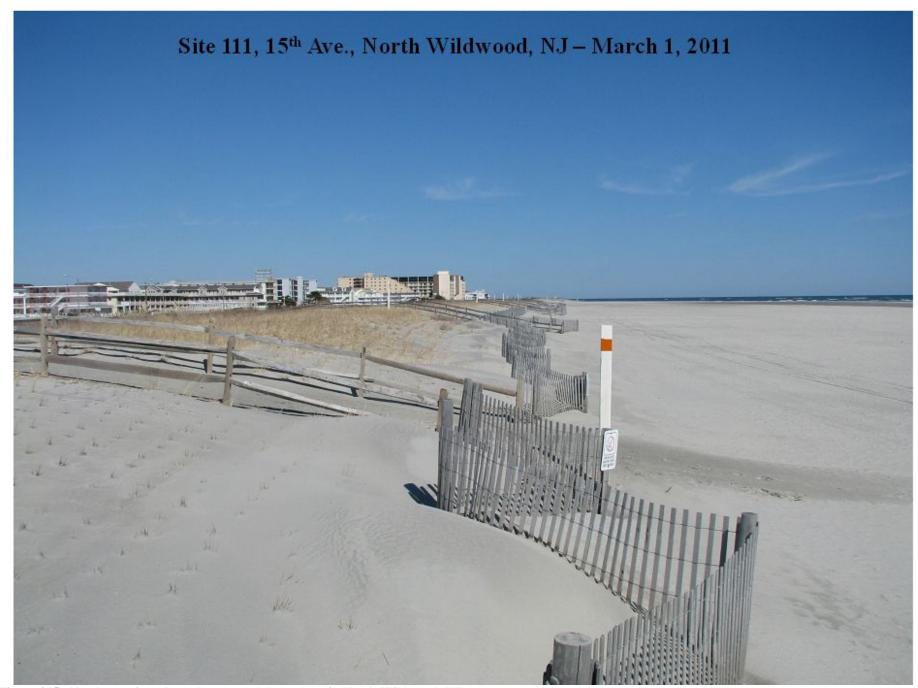
Figure 375. Northeast view along the seaward dune slope in North Wildwood, NJ.

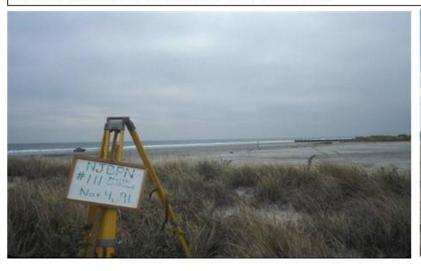
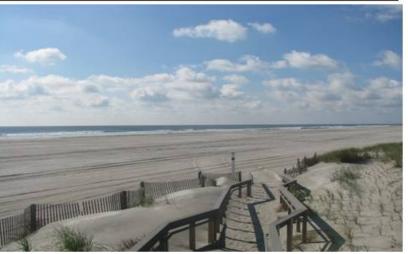
25-Year Coastal Changes at Site 111, 15th Avenue, North Wildwood, Cape May Co.

Figure 377: Erosional processes have been at work on the beachface as depicted in the profile above. Shoreline retreat of 681 feet has been recorded since 1986 as well as volume losses totaling -249.84 yds³/ft. The dune at this site has grown in width and elevation over the years and currently remains in tact.

Photo on left taken November 4, 1991. View to the south.

Photo on right taken October 4, 2011. View to the south.

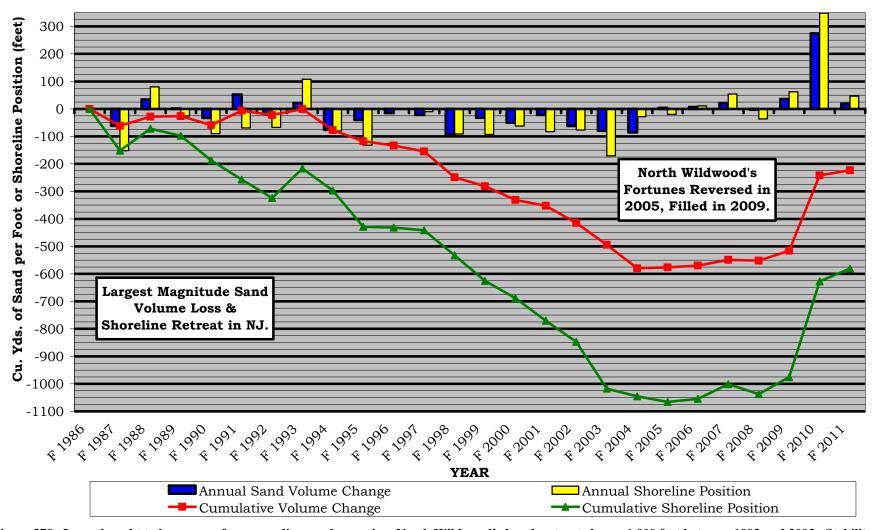
Figure 378. Long thought to be a zone of never-ending sand accretion, North Wildwood's beach retreated over 1,000 feet between 1993 and 2003. Stability at the eroded site continued for 5 years until a 2009 State/local project brought conditions partially back to those present in 1986. The sand volume shed both to the south and into Hereford Inlet as a spit attached to North Wildwood exceeds any beach nourishment amount by 200 yds³/ft.

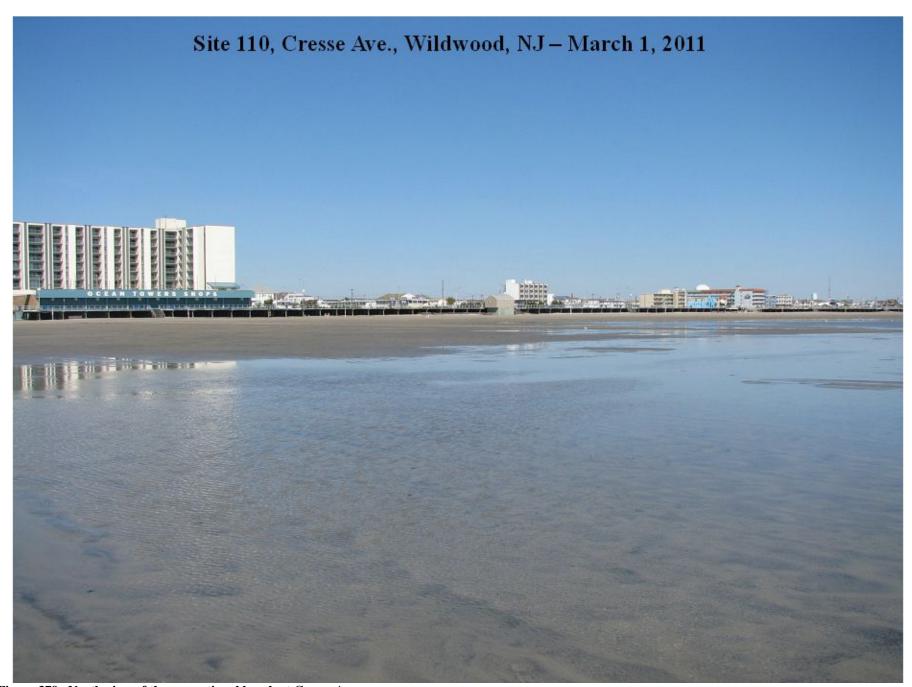
Figure 379. North view of the recreational beach at Cresse Ave.

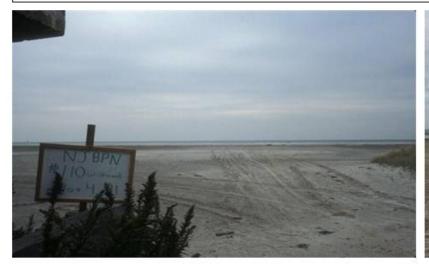
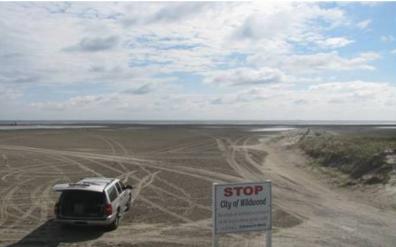
25-Year Coastal Changes at Site 110, Cresse Avenue, Wildwood, Cape May Co.

Figure 381: Cresse Avenue above displays tremendous recreational beach growth (shoreline advance of 711 feet) as material from the north has been transported on site. For the study period, cumulative volume gains of 141.54 yds³/ft were recorded. Photo on left taken November 4, 1991. View to the east.

Photo on right taken October 4, 2011. View to the east.

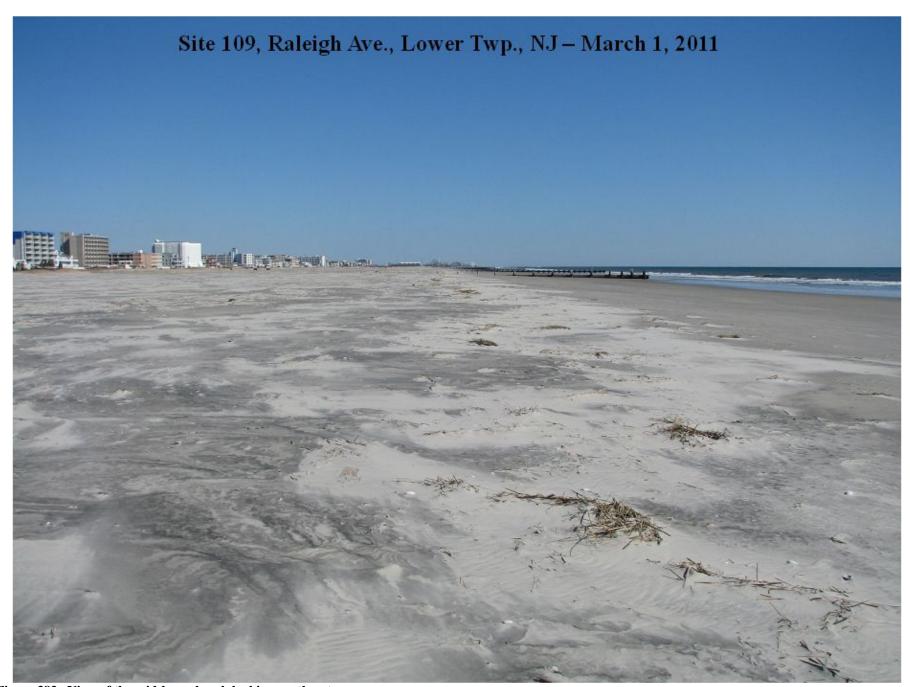
Figure 383. View of the mid-berm beach looking northeast.

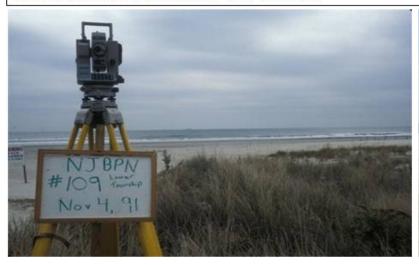
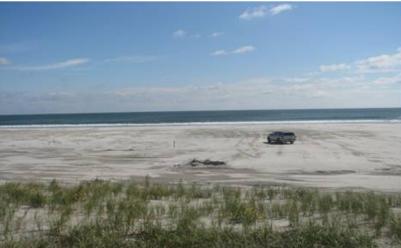
25-Year Coastal Changes at Site 109, Raleigh Avenue, Lower Township, Cape May Co.

Figure 385: The profile at Raleigh Avenue has not received material directly from renourishment projects. However, sand from the Wildwood region, coupled with dune fence placement has contributed to significant dune and beach growth. The shoreline advanced 164 feet since 1986 and volume gains amounted to 99.97 yds³/ft.

Photo on left taken November 4, 1991. View to the east.

Photo on right taken October 4, 2011. View to the east.

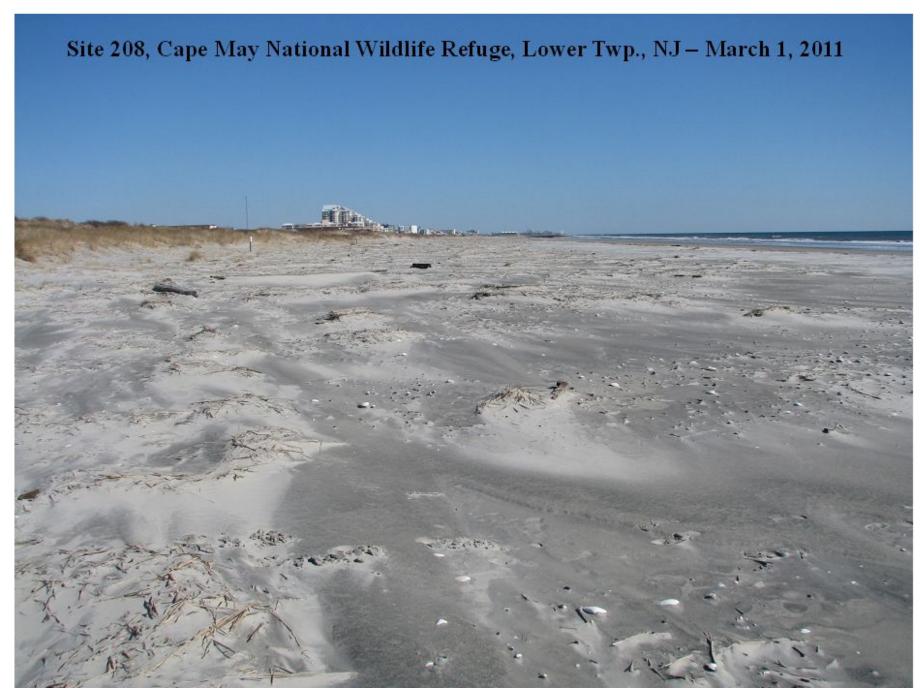
Figure 387. View of the unmaintained beach at the wildlife refuge looking northeast.

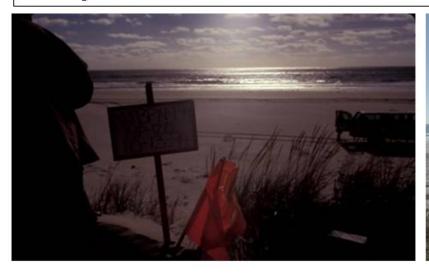
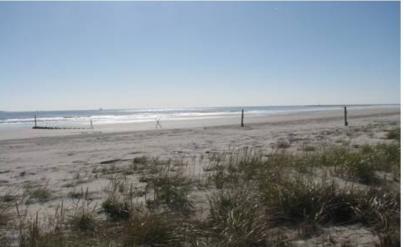
17-Year Coastal Changes at Site 208, Cape May National Wildlife Refuge, Lower Township, Cape May Co.

Figure 389: The profile above shows the primary dune elevation has increased over 7 feet as well as widened significantly since 1986. Cumulative volume gains of 137.79 yds³/ft were recorded as the beachface and nearshore portions of this profile were also enhanced. Photo on left taken October 13, 1994. View to the east.

Photo on right taken November 7, 2011. View to the southeast.

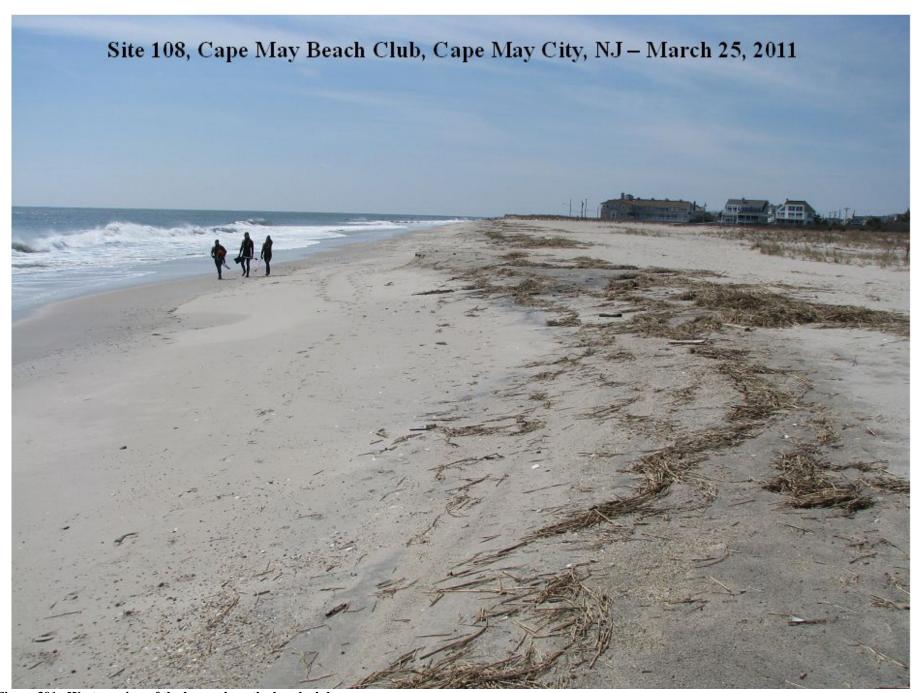
Figure 391. Western view of the berm along the beach club.

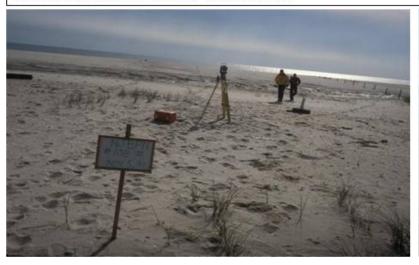
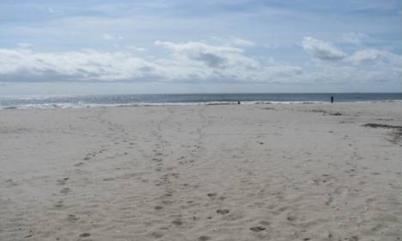
25-Year Coastal Changes at Site 108, Cape May Beach Club, Cape May City, Cape May Co.

Figure 393: The profile above displays elevation and position increases in the backdune, recreational beach, beachface, nearshore, and offshore. This profile site also received material from many beachfill projects over the years, advancing the shoreline 332 feet, and recording 121.43 yds³/ft of sand gain.

Photo taken November 5, 1991. View to the southeast.

Photo taken September 19, 2011. View to the east.
