New Jersey Beach Profile Network

Cape May County

Great Egg Harbor Inlet to Stow Creek

> NJBPN Profile #'s 225 - 100

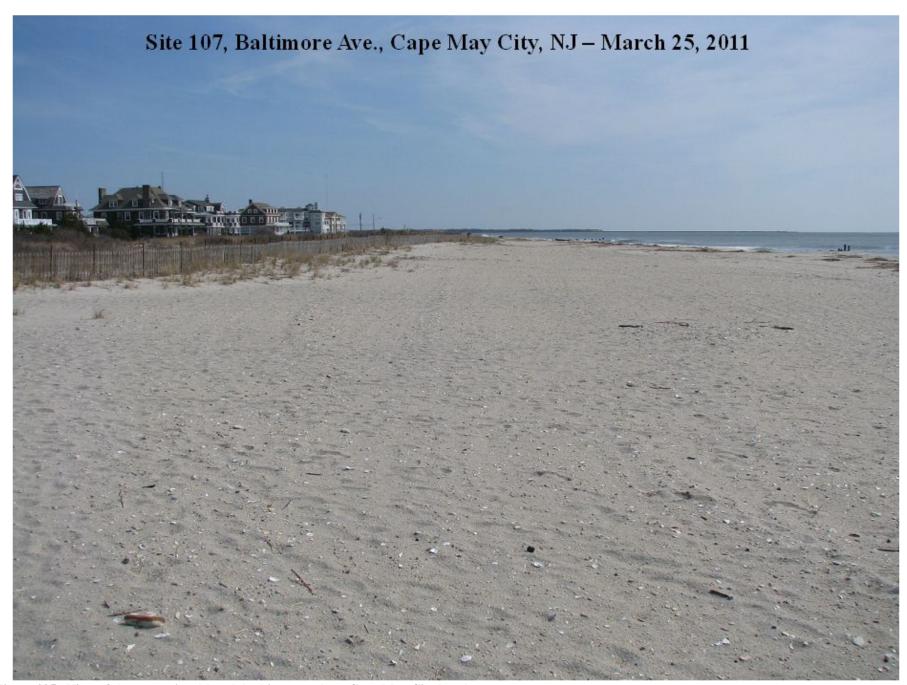
Figure 395. View of the recreational beach looking east along Cape May City beach.

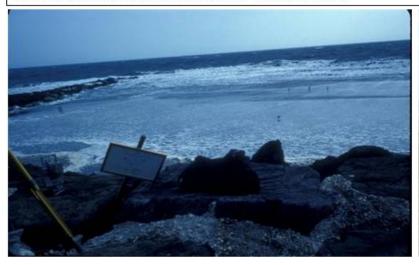
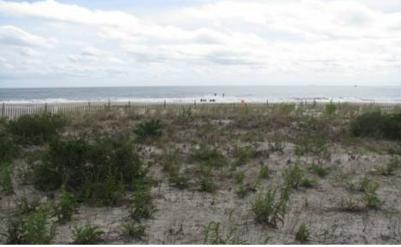
25-Year Coastal Changes at Site 107, Baltimore Avenue, Cape May City, Cape May Co.

Figure 397: The site of multiple beach replenishment projects over the last two decades, site 107 above shows significant position and elevation increases throughout virtually the entire profile. Over the 25 years of study, the shoreline advanced 37 feet and cumulative volume gains of 45.14 yds³/ft were recorded.

Photo on left taken October 4, 1990. View to the south.

Photo on right taken September 19, 2011. View to the south.

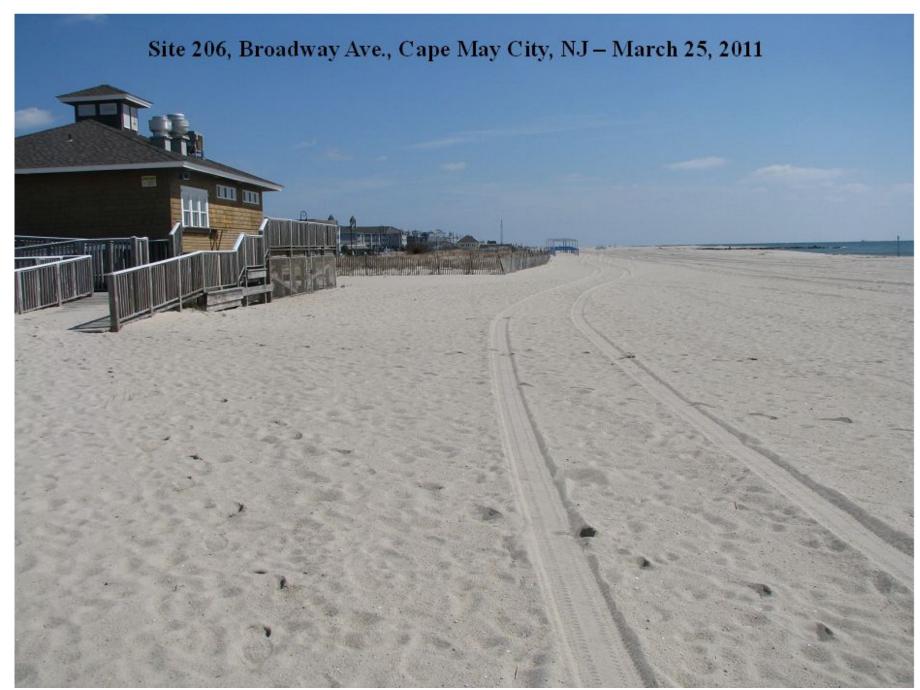
Figure 399. View of the recreational beach looking east along the Cape May City beach.

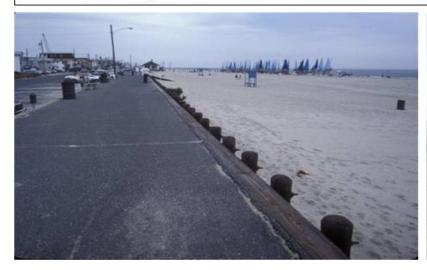
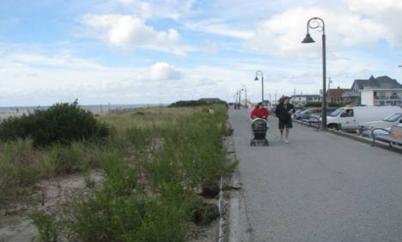
25-Year Coastal Changes at Site 206, Broadway Avenue, Cape May City, Cape May Co.

Figure 401: The profile above displays a shifting of offshore material onto the beachface and recreational beach. This site is the benefactor of multiple beach replenishment projects that began in the early 1990's. A gain of 31.77 yds³/ft of sand was recorded for the time period. Photo on left. View to the east.

Photo on right taken September 19, 2011. View to the west.

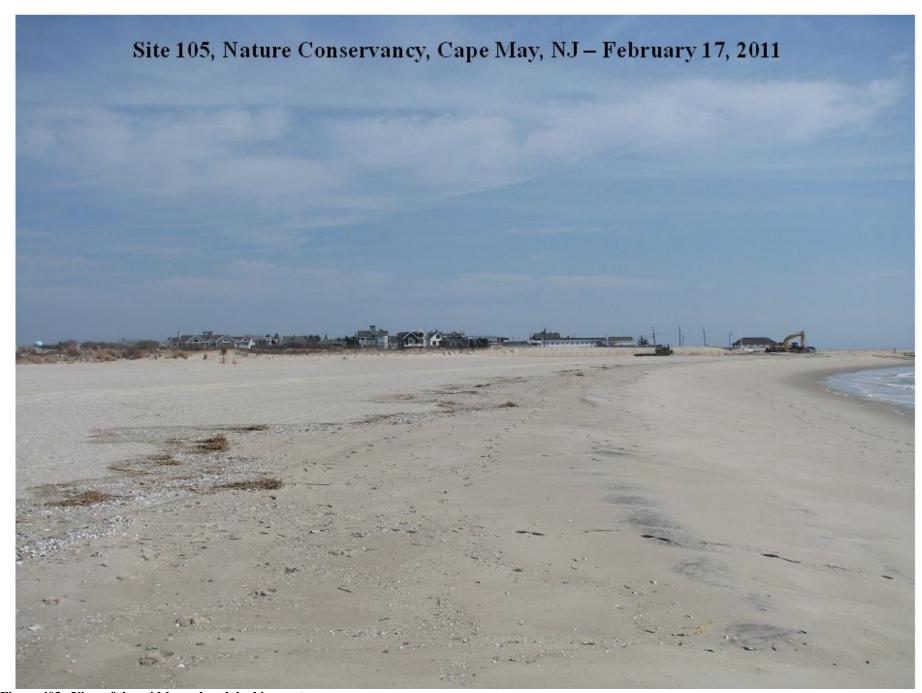
Figure 403. View of the mid-berm beach looking east.

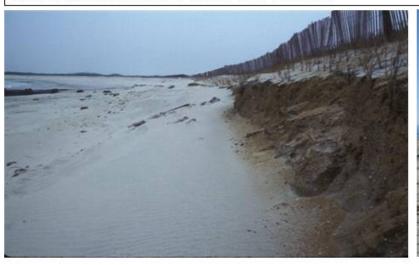
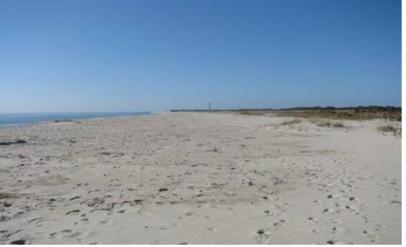
25-Year Coastal Changes at Site 105, Nature Conservancy, Cape May Co.

Figure 405: The profile above clearly displays the significant dune growth, in both position and elevation, that has occurred at the nature conservancy. Littoral currents are responsible for transporting material supplied by multiple beachfill events in the area. The shoreline advanced 512 feet and sand volume gains amounted to 81.24 yds³/ft over the 25 years of study.

Photo on left. View to the west.

Photo on right taken November 7, 2011. View to the west.

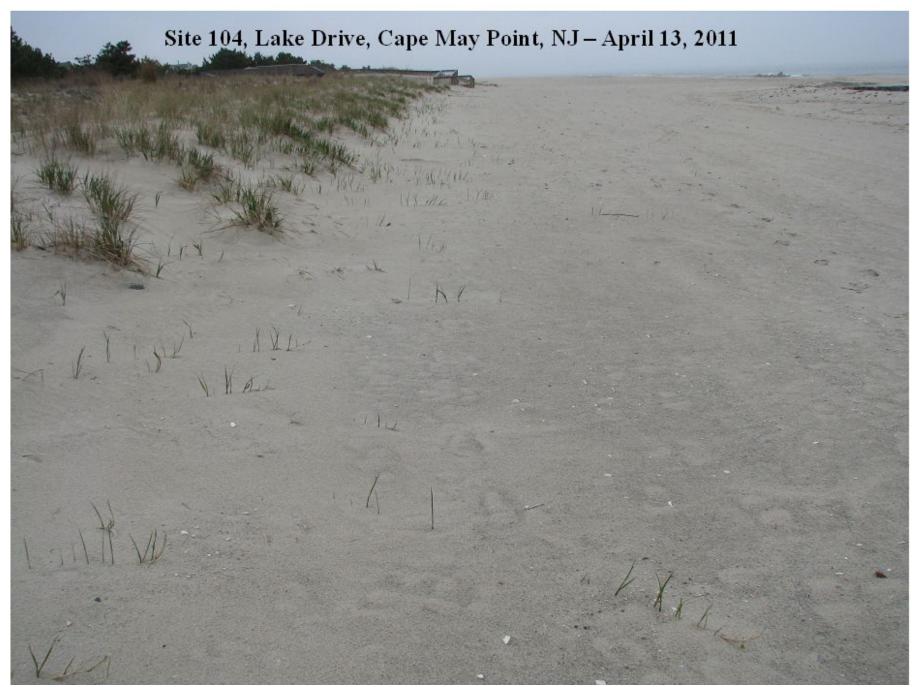
Figure 407. View of the seaward dune toe looking east along Cape May Point beach.

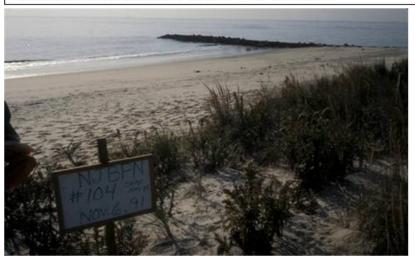
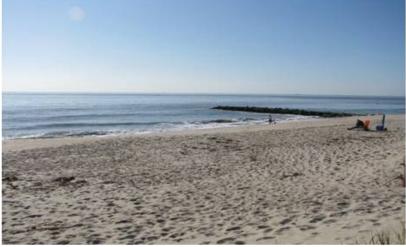
25-Year Coastal Changes at Site 104, Lake Drive, Cape May Point, Cape May Co.

Figure 409: The Lake Drive profile above clearly shows the dune reconfiguration that took place in 2005. Material from adjacent cells has been moved here by mechanical devices since the projects completion, increasing the berm elevation and width, as well as supplying material for the significant fore dune growth.

Photo on left taken November 6, 1991. View to the west.

Photo on right taken November 7, 2011. View to the west.

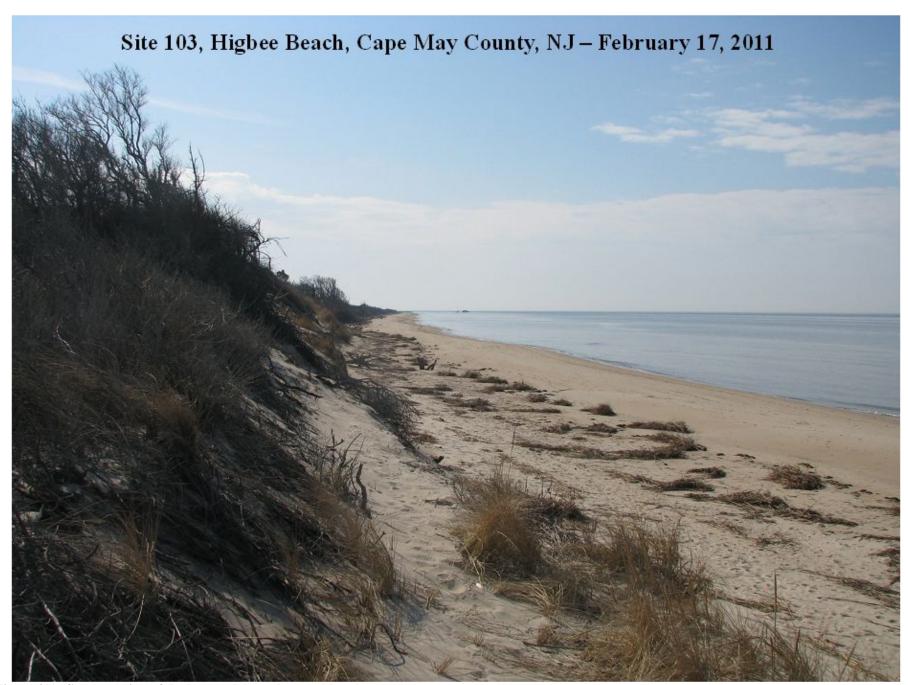
Figure 411. Southern view of the bayward dune slope and beach.

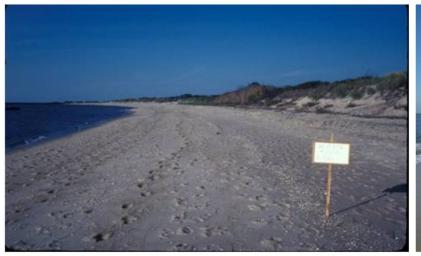
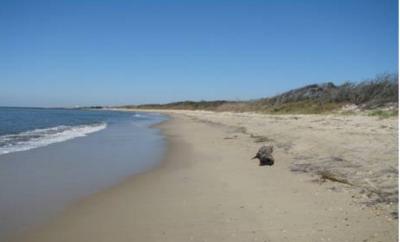
25-Year Coastal Changes at Site 103, Higbee Beach, Cape May Co.

Figure 413: The profile above shows the site at Higbee Beach has undergone continual erosion in the dune, beachface, nearshore, and bay floor regions of the profile. For the study period the shoreline has retreated 25 feet and cumulative losses totaled 22.28 yds³/ft of sand. Photo on the left. View to the north.

Photo on right taken November 2, 2011. View to the north.

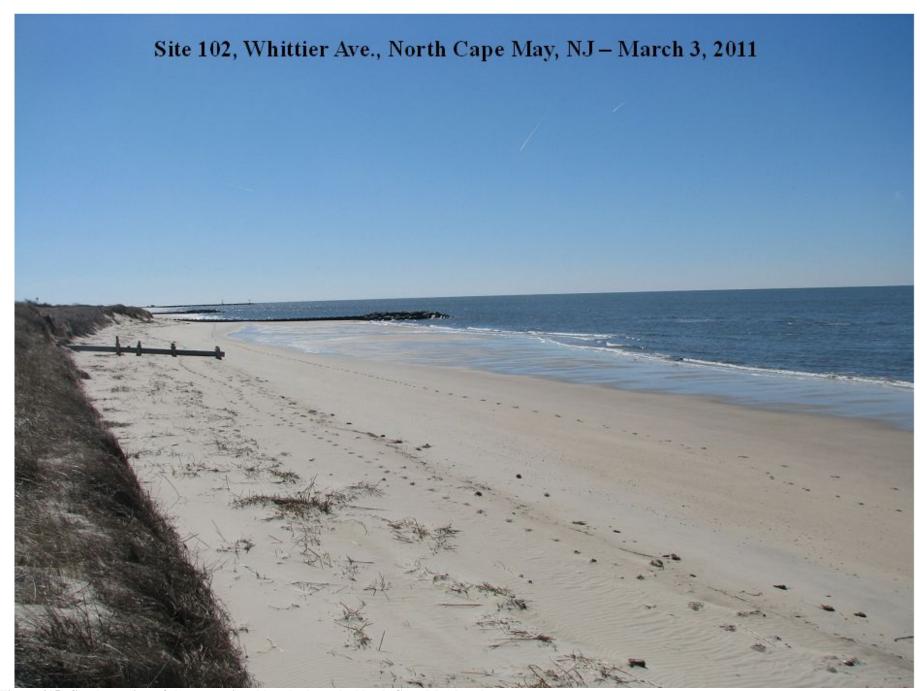
Figure 415. Southern view of the recreational beach along the North Cape May beach.

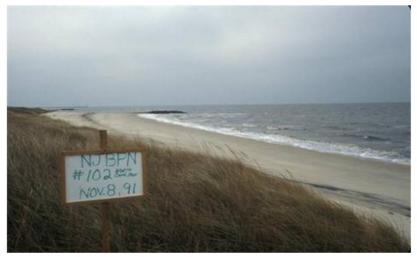
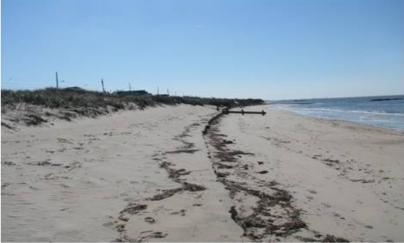
25-Year Coastal Changes at Site 102, Whittier Avenue North Cape May, Cape May Co.

Figure 417: The profile above displayed a modest dune width and elevation increase over the 25 year study. The bay floor elevation portion of the profile decreased marginally by 2011. During this time, the shoreline also advanced 41 feet and added 10.35 yds³/ft of material. Photo on left taken November 8, 1991. View to the south.

Photo on right taken November 2, 2011. View to the south.

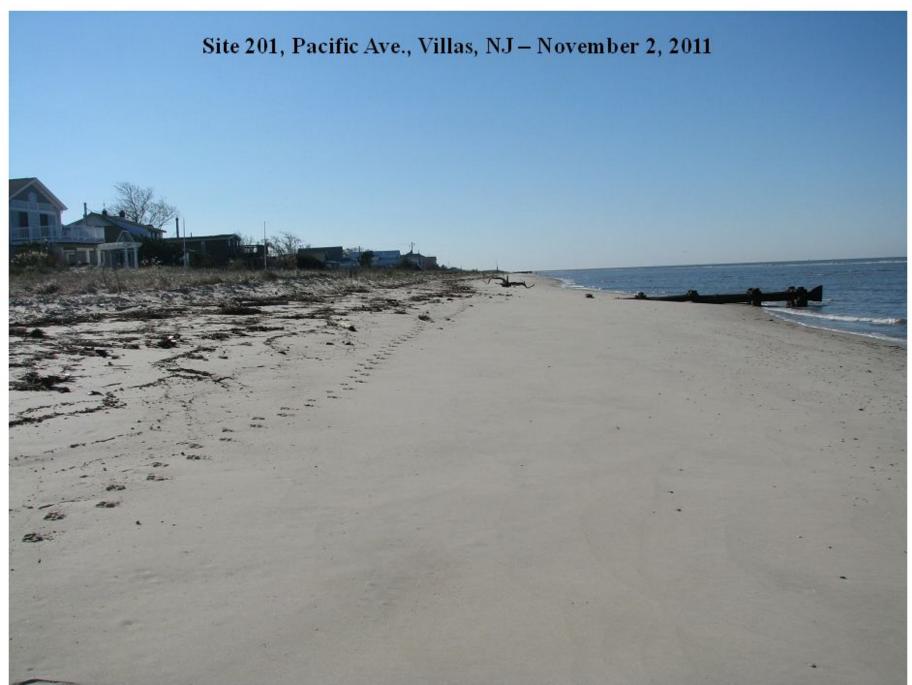
Figure 419. View to the south of the mid-berm beach along the Villas, NJ.

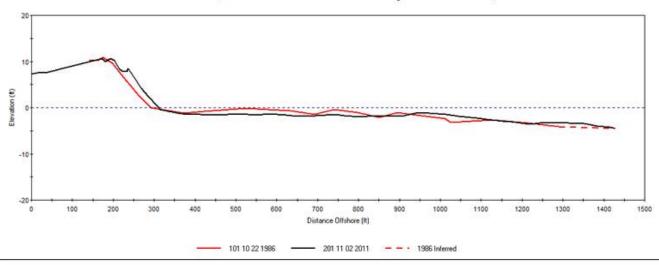
Figure 421: The profile above shows a relatively stable offshore region with sand accretion observed on the seaward dune slope and beach face since 1986. The shoreline advanced 24 feet for the study period. This profile location was moved 100 feet to the south in 2011 due to the continued difficulty in accessing the site.

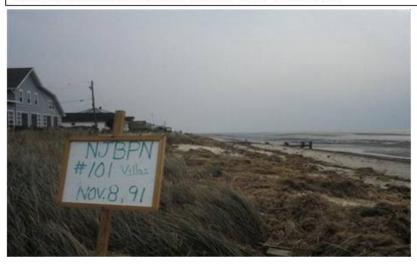
25-Year Coastal Changes at Site 101, Pacific Avenue Villas, Cape May Co.

Photo on left taken November 8, 1991. View to the south.

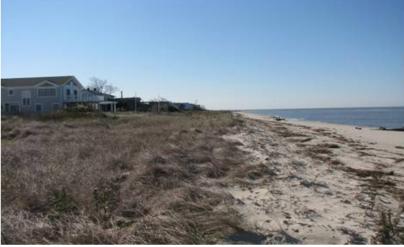
Figure 422. Further north along the Delaware Bay shoreline, the beach becomes lower and consists of sand deposited on older marsh deposits covering the Cape May Formation. The sand volume changed very little here, but shoreline retreat spiked in 1988, then remained modestly negative from there.

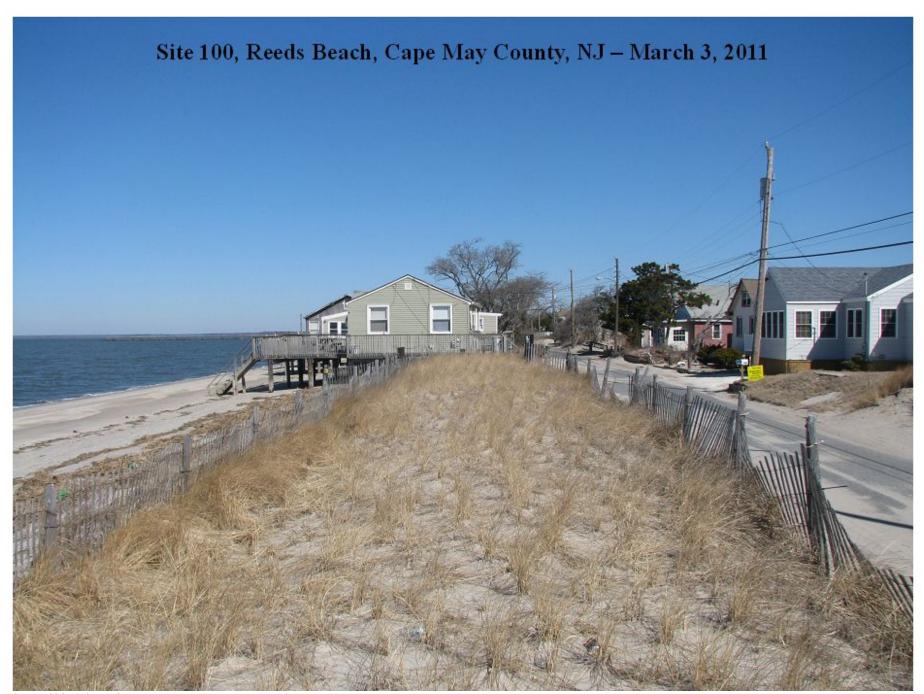
Figure 423. View of the bayward dune crest looking north.
