Monmouth County

Raritan Bay and Sandy Hook to Manasquan Inlet

NJBPN Profile #'s 187 - 256

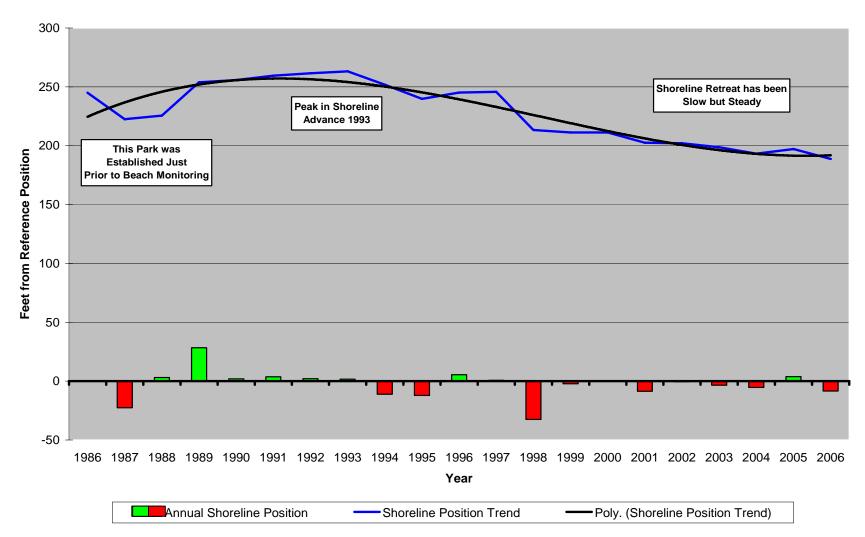
Shoreline Trends at Cliffwood Beach Park, NJ

Figure 5 – **Site 187.** The Monmouth County Cliffwood Beach Park was established just prior to the establishment of the beach surveying project in 1986. Selected because the site represented an opportunity to track changes at a natural beach with a dune located on Raritan Bay, the location has seen the dune system grow over the years, while undergoing a long-term shoreline retreat from the peak seaward position observed in 1993. Since then the shoreline has been forced back from a 263-foot distance from the reference position to a 188-foot distance.

The loss in beach width has made up most of the 75-foot retreat. The Raritan Bay fetch limits the maximum size of the waves generated by either northeast storms or northwest winds to less than 5 second periods and 4 feet in height. The energy in these types of waves is insufficient to have any impact on the sea bottom offshore from the beach. All the surveys from the past 20 years have not diverged in any significant fashion from the depths ranging from 0 to 4 feet of water within 1,000 feet of the shoreline. There are never any offshore bars and little sediment appears to have moved onto the site or left for other locations along the shoreline. The shoreline retreat appears to be due to sand moved into the dunes and perhaps a spreading of the park beach alignment toward the west into an embayment.

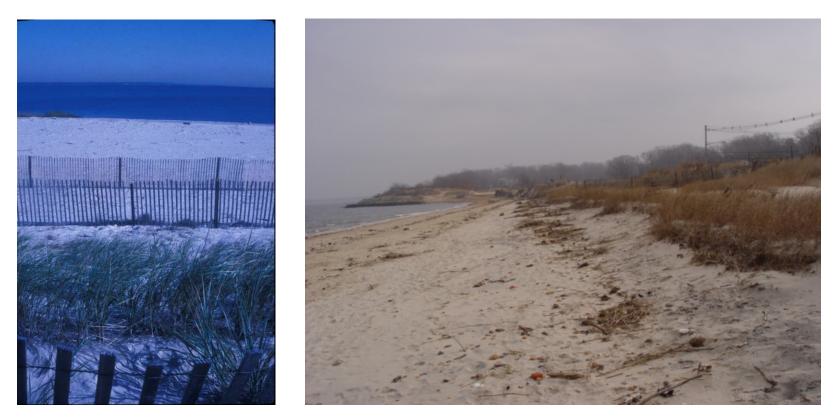
20-Year Comparison Photographs – Site 187, Cliffword Beach Park

The Cliffwood Beach shoreline developed a well vegetated dune around the fencing visible in the 1987 photograph (left) and is an excellent example of a bay beach where wave energies are relatively low. Northeast and northwest winds generate up to 4-foot waves, but they do not possess the power of oceanic waves. A combination of storm surge and waves will produce dune erosion, but recovery is usually fairly rapid. The cross sectional plot below shows the initial survey plotted against the same line in 2006. Over the past 20 years, the dune has continued to grow much larger expanding seaward from the toe of the original dune. Sand moved from the beach into the dunes and the shoreline retreated because new sand is not available from any source offshore or nearby.

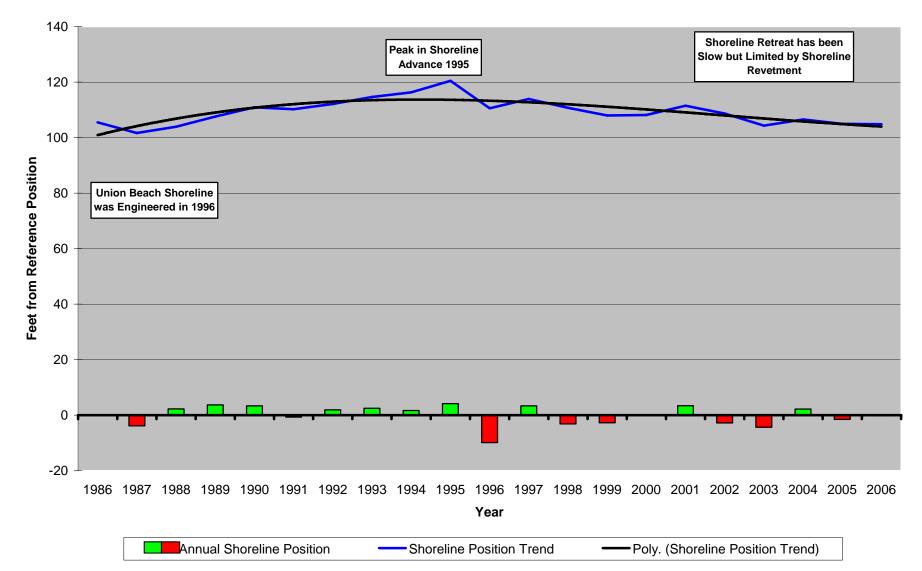
Shoreline Trends at Union Beach, NJ

Figure 7 – **Site 186.** Union Beach is basically an engineered shoreline with a rock revetment constructed during the 1990's and a small wet to dry beach at the base of the rocks. There is no dune and prior to the rock wall construction by the State, there were sections of the

shoreline where erosion had created a bluff in the older sediments of Monmouth County. Shoreline changes have been rather small with no changes to the submerged part of the profile in the bay. Since 1995 the trend has been slightly negative with very little distance to cover to the base of the rocks.

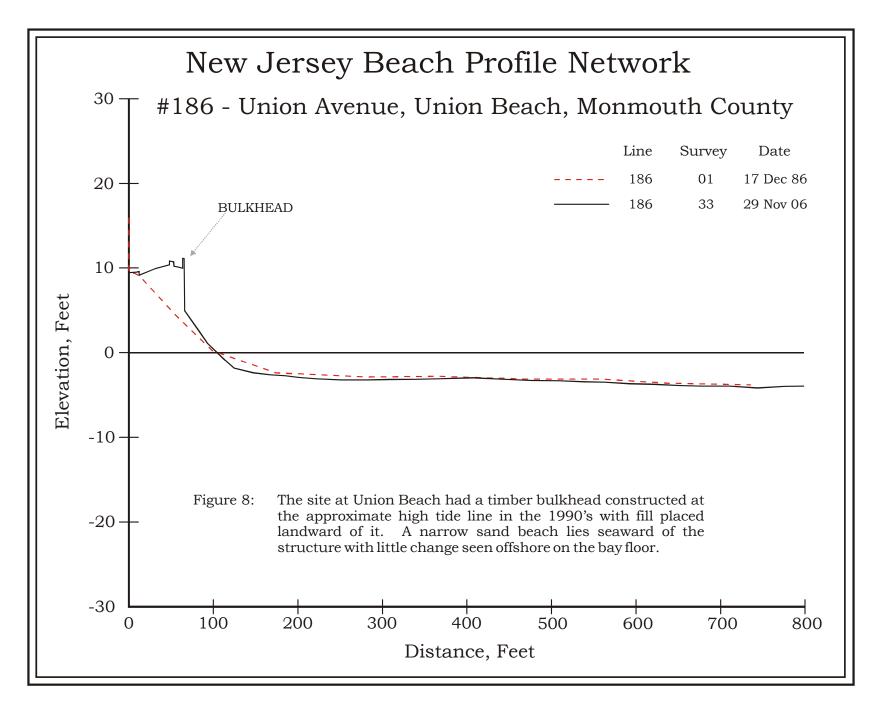
20-Year Comparison Photographs – Site 186, Union Beach

Engineering a stable shoreline produced the majority of the change at this site over 20 years. The left photograph was taken in 1988 showing the original narrow beach that ended at the sidewalk along the road at the shoreline. In the far distance stands the rod-man in about 3.5 feet of water some 600 feet out into the bay from the shoreline. The bulkhead and rock apron on the beach have precluded an alteration of the profile to the water's edge. Low wave energy on the bay has meant that little occurs below low tide. The site monitoring continued in the hope that sand might migrate parallel to the shoreline and bury the rocks.

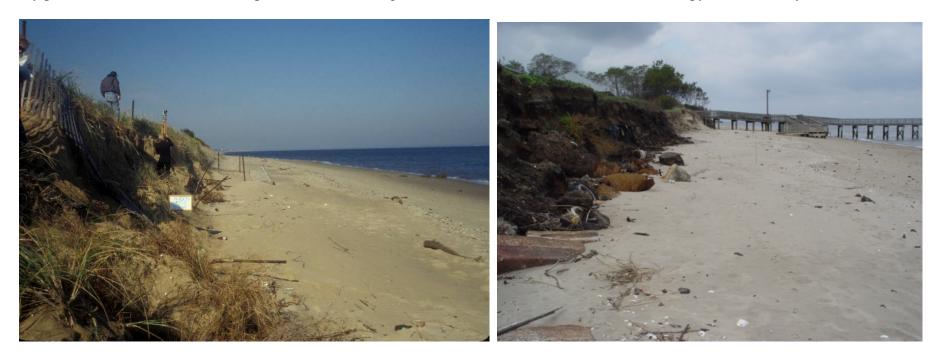
Figure 9 – **Site 185.** This is the easternmost cross section along the northern bay shoreline established in Monmouth County. This site experienced dune and bluff erosion from minor northeast storms that generated a scarp at the edge of the uplands leading down to the beach. The shoreline retreated about 72 feet in 20 years with the largest loss seen in 1989. There is a tiny dune perched on the edge of the bluff that is periodically restored by the county and as beach sand blows up the scarp cut into the older sediments. This dune vegetates and if left

untouched would resemble a seaward dune slope. A lack of adequate beach width inhibits dune/bluff stability at this site. The same Raritan Bay pattern of no offshore bar development and little change offshore in sea bed elevation occurs at the Spy House locality.

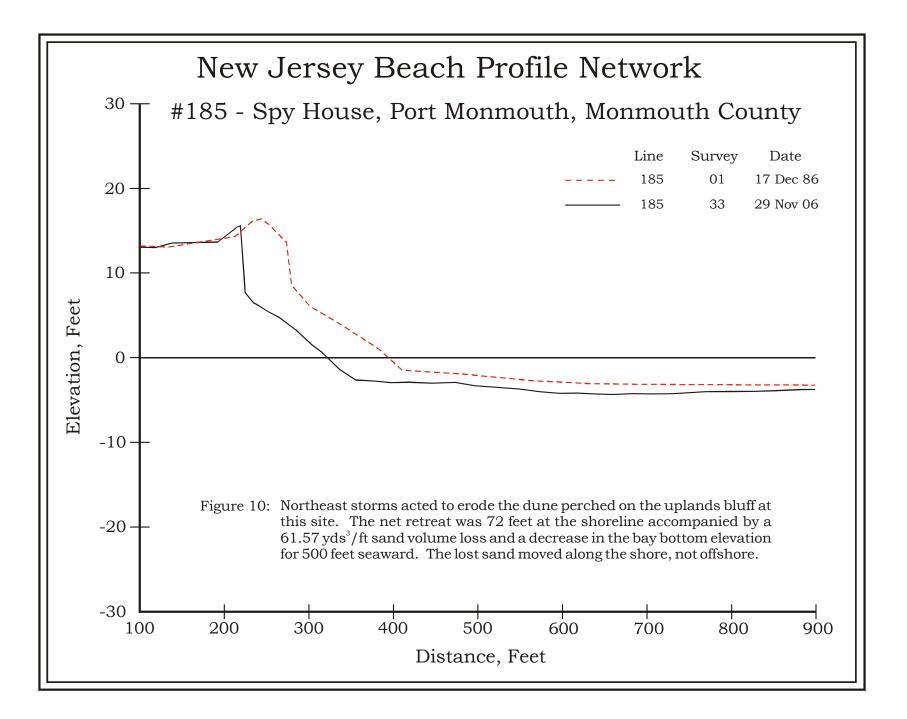
20-Year Comparison Photographs – Site 185, Spy House Museum, Port Monmouth

At the Spy House site, the bluff has been eroding for years as northeast storms generate waves across Raritan Bay. The material in the bluff has a component that is not suitable for beaches, but gets cleaned up from time to time. Offshore the bay floor is flat and not subject to much change. As seen below, the bluff has retreated over 80 feet in the 20 year study period with a nearly uniform pattern mimicking the bluff retreat on the beach and within the zone of wave influence. The pictures above show the similarity and contrast between 1989 (left) and 2006 (right).

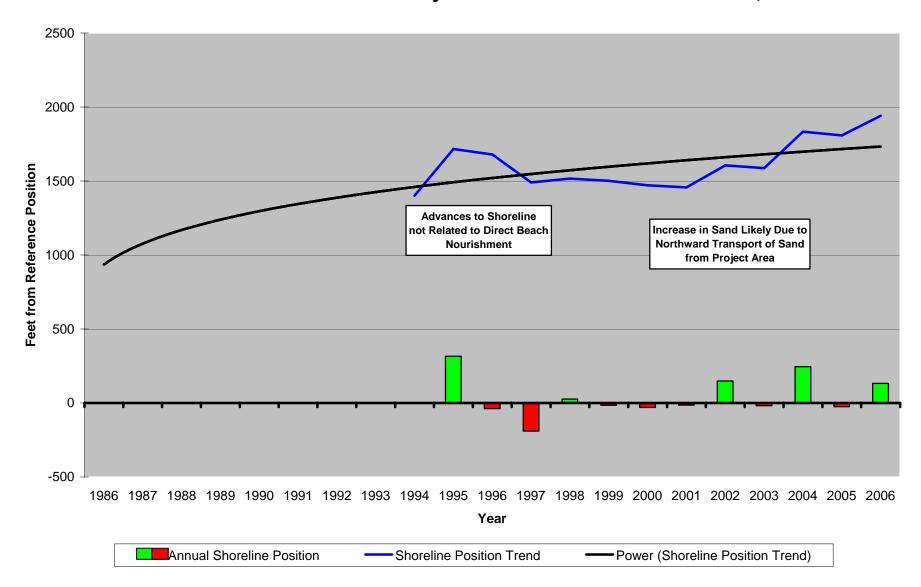
Shoreline Trends at the Gateway National R.A. Gunnison Beach, NJ

Figure 11 – Site 285. This site was established in 1994 following expansion of the program. Two new sites were placed on the Sandy Hook National Seashore to follow changes anticipated as the Monmouth County shore protection project got started. Initially, the northern site saw a substantial advance in the shoreline position (317 feet in 1995) that was not related to the start up of beach nourishment. The shoreline position retreated in 1997 by 190 feet, and then remained stable for four years. Accretion in 2002, 2004 and 2006 produced an advance totaling 540 feet leaving a very wide dry beach with massive offshore bars moving slowly north appearing like small sand spits as they attached to the beach. This beach is over 1,400 feet wide between the seaward toe of the dune and the berm crest.

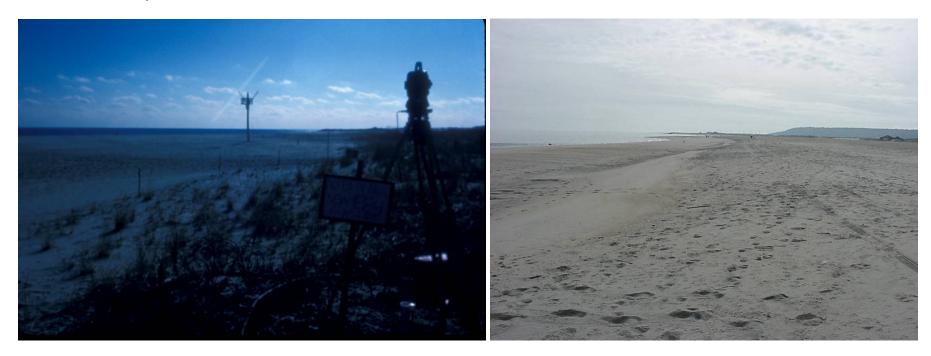
Figure 13 – Site 284. This profile was positioned about half way between the park entrance site (#184) and Gunnison Beach (#285). This location shows a shoreline retreat between 1994 and 1997 that indicates that the ACOE project sand did not immediately appear along this shoreline. By 1998, an advance of over 100 feet is most likely related to the arrival of sand moved north from Sea Bright. The advances in 2001, 2004, and 2005 continued the trend in 2002 sand was placed directly during 2006 for a net shoreline advance totaling 120 feet. This

site was influenced by earlier efforts at shoreline stabilization conducted by a partnership between the US Park Service and the NY District Corps of Engineers pumping sand from Raritan Bay onto the shoreline south of this site. Erosion had threatened several times to breach the base of the spit cutting Sandy Hook off from the peninsula or wiping out the access highway due to severe overwash into the Navesink/Shrewsbury River tidal channel.

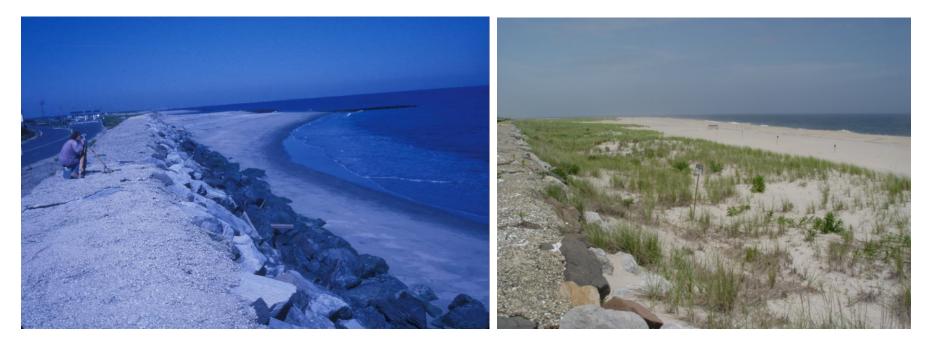
Shoreline Trends at Highland Beach, Gateway Entrance, NJ

Figure 15 – **Site 184.** This profile was an example of how the Sea Bright seawall provided the only protection from storm damage along the northern 13 miles of Monmouth County prior to beach nourishment. There was no dry beach and surveys went from the rocks of the seawall

into the water limiting shoreline changes. Dramatic changes occurred in 1995 as sand began to accumulate along the rocks. By 1996 the shoreline had advanced seaward by 253 feet as hundreds of cubic yards of sand were pumped onto the profile shoreline from a source offshore. The profile location saw subsequent erosion as sand moved north over the next few years bringing the shoreline landward by 108 feet. An ACOE funded maintenance fill in 2002 restored the shoreline position to 403 feet distant from the reference position (+123 feet). Losses over the past four years have been relatively minor. The initial sand loss rate may be lower in the recent past due to low storm frequency or the fact that the loss previously has made for wider beaches to the north and therefore, lower open end loss rates. Northeast storm wave directions should transport sand south along the shoreline. Since northeast winds are limited by the presence of Long Island, NY to the north and east, the southerly waves dominate the sand transport direction generally producing sand transport to the north.

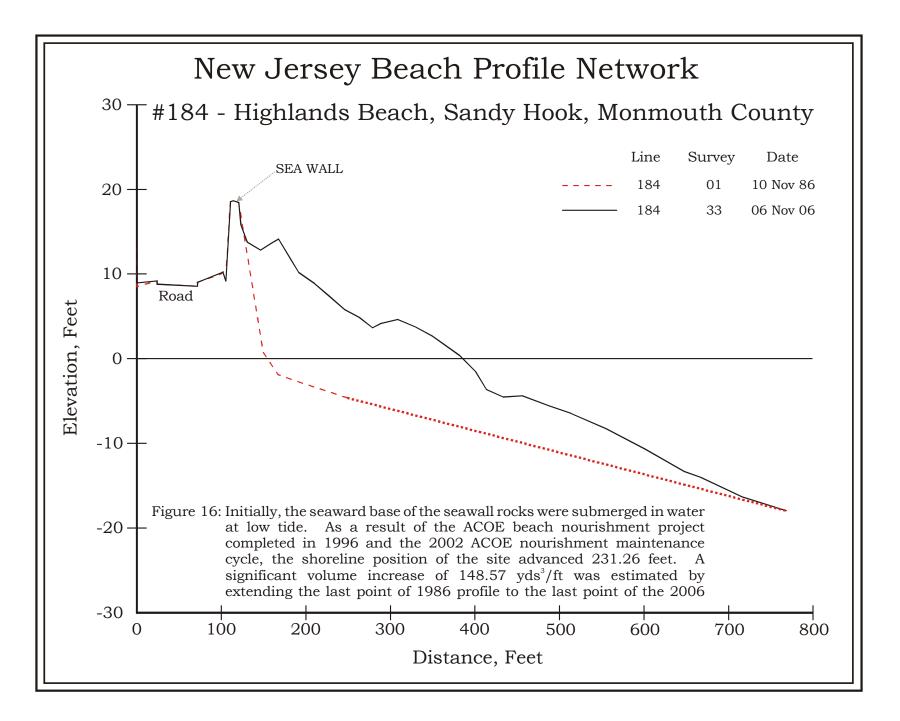
20-Year Comparison Photographs – Site 184, Highlands Beach, Near Entrance of Gateway National Seashores, Sandy Hook The extreme difference made by the sand volume placed along this shoreline shows in the next series of sites along the Sea Bright shoreline. Located near the north end of the rock seawall, this location did have a narrow wet beach in 1986 (shown in the 1987 photograph on the left). Now in 2006 (photo of right) the beach remains reasonably wide with a natural dune system developing on the dry beach. No effort was expended in designing a dune, so growth is dependent on natural plant succession and spreading.

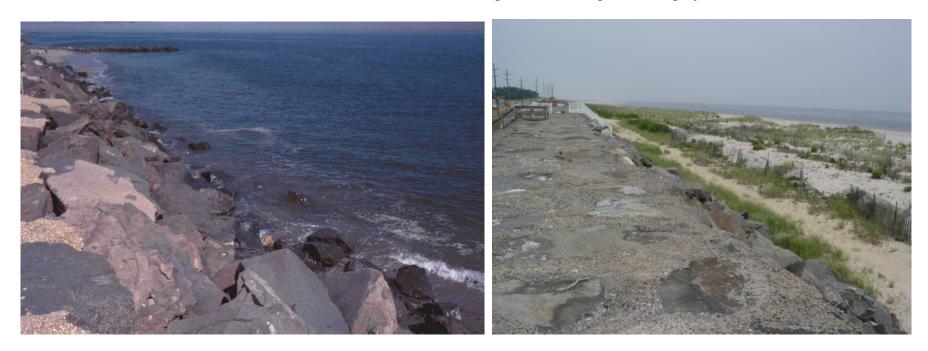
Figure 17 – Site 183. Slightly further south along the Sea Bright seawall, there was no beach and the rocks were reached by the waves at all but the lowest tides. Between 1986 and 1995 the shoreline varied slightly over 9 years, then the NY District Corps of Engineers added enough sand to produce a 365-foot advance in the shoreline position. Modest incremental retreats followed causing 173 feet of landward

movement by 2001. The maintenance fill pushed the shoreline seaward again by over a hundred feet. Minor fluctuations between gains and losses since have left this shoreline with a net advance of 237 feet over that present in 1995 prior to the project.

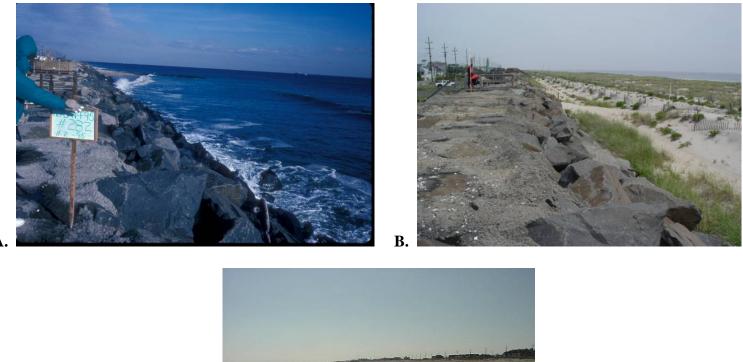
Figure 19 – **Site 282.** The early years are not represented because this site was established just prior to the commencement of the Monmouth County beach nourishment project. The fill produced an advance in the shoreline of 375 feet that continued to grow wider by another 85 feet

by 2006 without additional sand placement. Acquired by the State of New Jersey as public use beachfront, the location has a dune and a substantial beach for recreational purposes.

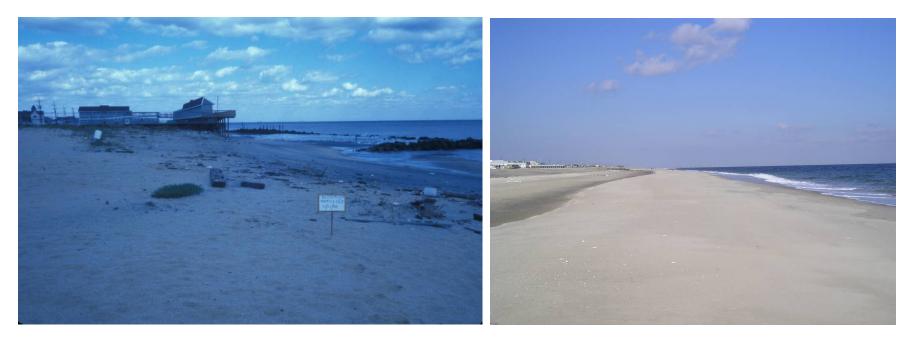
Figure 21 – **Site 182.** This profile is located between groins and as a result a beach did exist prior to the beach nourishment. The shoreline position shifted within a narrow range prior to 1995 and a trend of very minor shoreline retreat appears to be consistent following both the initial fill and the 2002 maintenance nourishment effort. The beach is heavily used recreationally during the season.

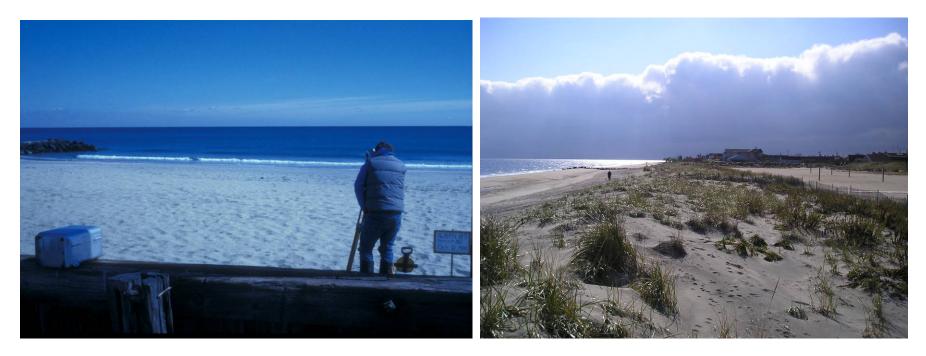
Figure 23 – **Site 181.** The Sea Bright municipal beach was significantly enhanced by the Federal project, but a beach was present for recreational use prior to the fill. Loss rates following both the initial work and the maintenance effort appear to be similar.

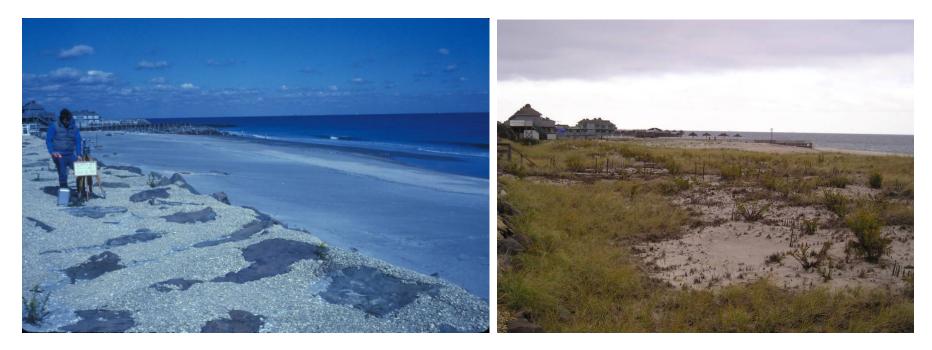
Figure 25 – **Site 180.** Further south along the Sea Bright shoreline the beach was very narrow in 1986 with sand banked up against the rocks and a beachface slope that began immediately seaward to the zero elevation line at a distance of 200 feet from the reference. Storms in 1991 and 1992 reduced this distance by 50 feet prior to the initial beach replenishment.

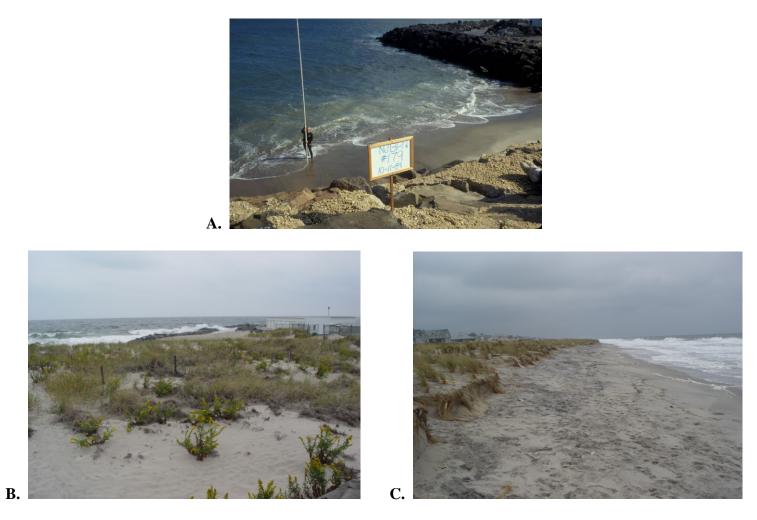
Shoreline Trends at Cottage Road, Monmouth Beach, NJ

Figure 27 – **Site 179.** The Cottage Road site lies just north of a vintage beach club that was built seaward of the highway and protected by moving the seawall seaward around the structure. This geometry appears to enhance the erosion rate at this beach. The trend shows a substantially greater rate of retreat in the shoreline than at other Sea Bright sites. The dredge added sand in 1997 and 1999 as it was involved

in working other portions of the project. The maintenance fill in 2002 reversed the loss, but the rate of retreat continued. From 1986 to 1994 there was no beach of any kind at the base of the seawall rocks. Water depth at the rock wall's toe would vary yearly, but on the best of survey dates, the crew left the rocks directly into the water.

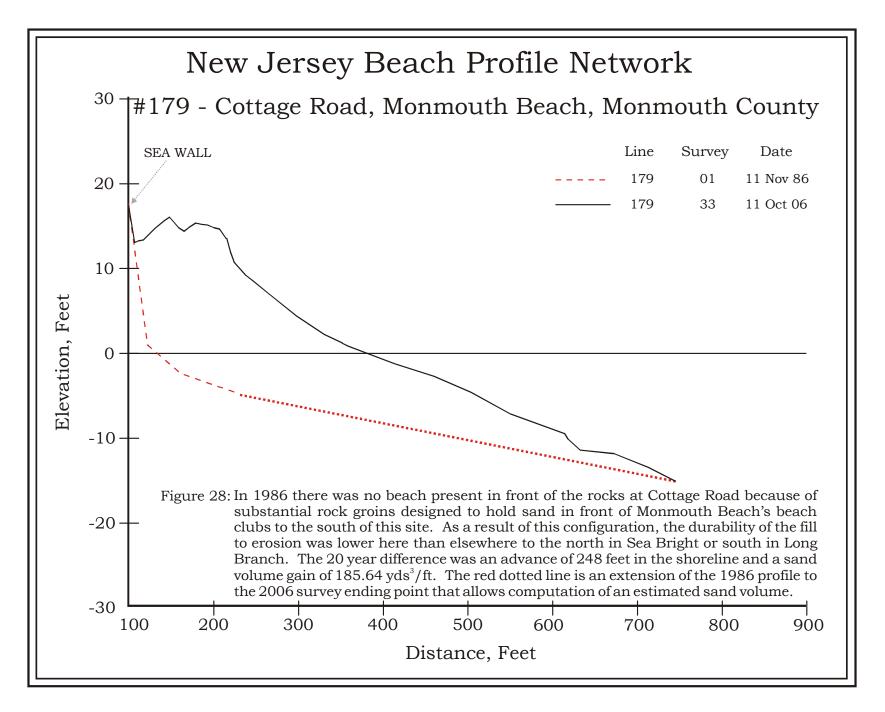
20-Year Comparison Photographs – Site 179, Cottage Road, Monmouth Beach

The left photograph (B) shows the geometry of the seawall from the survey site instrument position. The bottom right picture (C) shows the scarp present Oct. 11, 2006 indicating that shoreline retreat was impacting the dunes on a mildly rough day. However, compared to the situation present prior to the project, this beach is infinitely superior to any observed between 1986 and 1994. The top photo shows the conditions of the beach in 1989 (A).

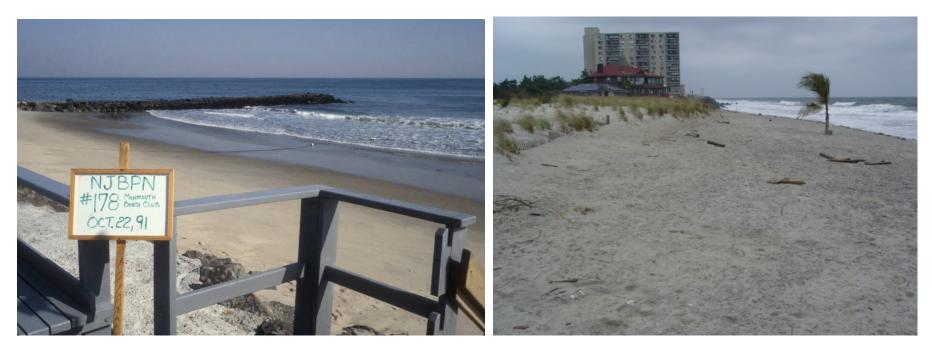
Shoreline Trends at the Beach Club, Monmouth Beach, NJ

Figure 29 – **Site 178.** This profile, located at one of the Monmouth Beach clubs, also declined in sand volume more rapidly after the federal fill project than it did elsewhere between Long Branch and Sandy Hook. The rate of loss was less than that seen at Cottage Road to the north.

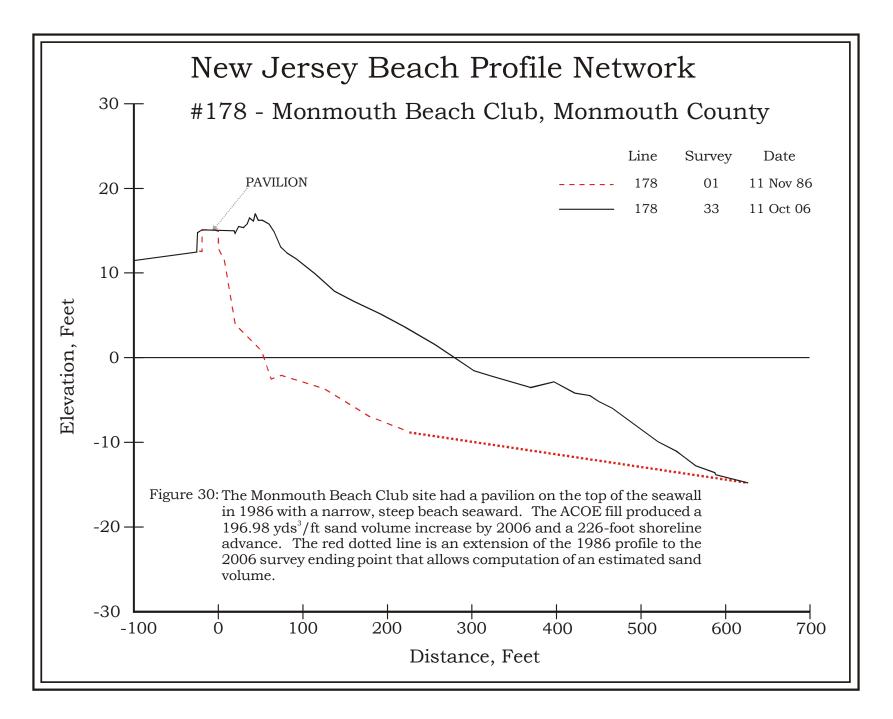
20-Year Comparison Photographs – Site 178, Monmouth Beach Club, Monmouth Beach

The dune seen in the 2006 photograph (right) did not exist in 1986 because the dry beach area was pushed directly to the bulkhead protecting the buildings. The beach sloped steeply seaward from the pavilion to the water. In the fall of 2006 that distance was 226 feet further seaward. The photo on the left depicts the conditions of this beach in 1991.

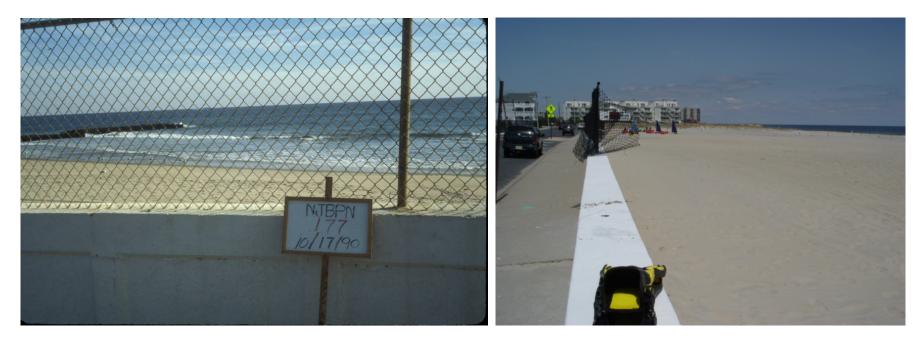
Figure 31 – **Site 177.** South of the seawall, this beach has remained relatively constant in width since the 1997 initial sand placement. There was no 2002 maintenance effort in Long Branch, so the retreat rate is not influenced by additional sand volumes since 1997.

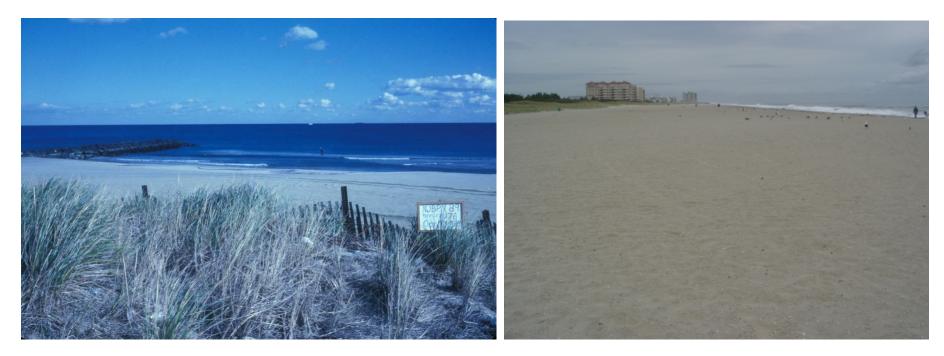
Figure 33 – **Site 176.** This Park location was assembled from multiple commercial and single family lots east of Ocean Avenue. It has become an extremely popular county recreational site since it opened. The beach nourishment project added 300 feet of width to the

shoreline with only 100 feet of retreat since 1998. There was no maintenance project done here in 2002 so the retention quantity exceeds that anticipated by the New York District engineers and far exceeded that expected by the project's detractors.

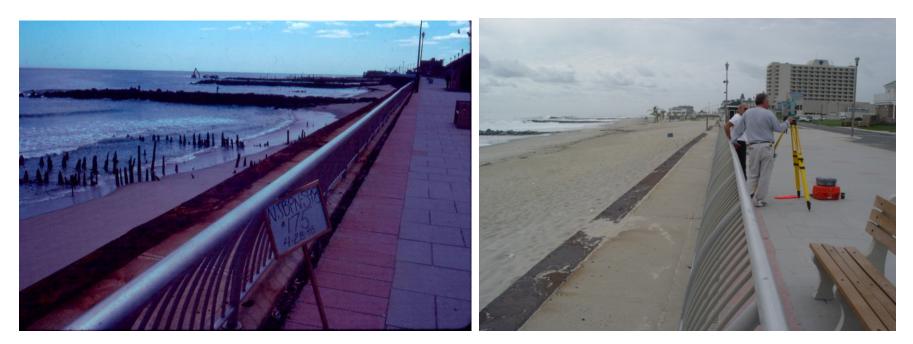
Shoreline Trends at North Broadway Avenue, Long Branch, NJ

Figure 35 – **Site 175.** The major segment of the Long Branch shoreline is represented by cross sections #175 (this site), 174 and 173 where the uplands bluff was protected by a vertical steel bulkhead dating from the mid-twentieth century. Later the southern half was reinforced

with a rock seawall in front of the steel wall due to its deterioration. The Federal project had advanced beyond N. Broadway by fall 1998 creating a 207-foot advance in the shoreline position. Since then it has been relatively stable retreating by about 50 feet over eight years.

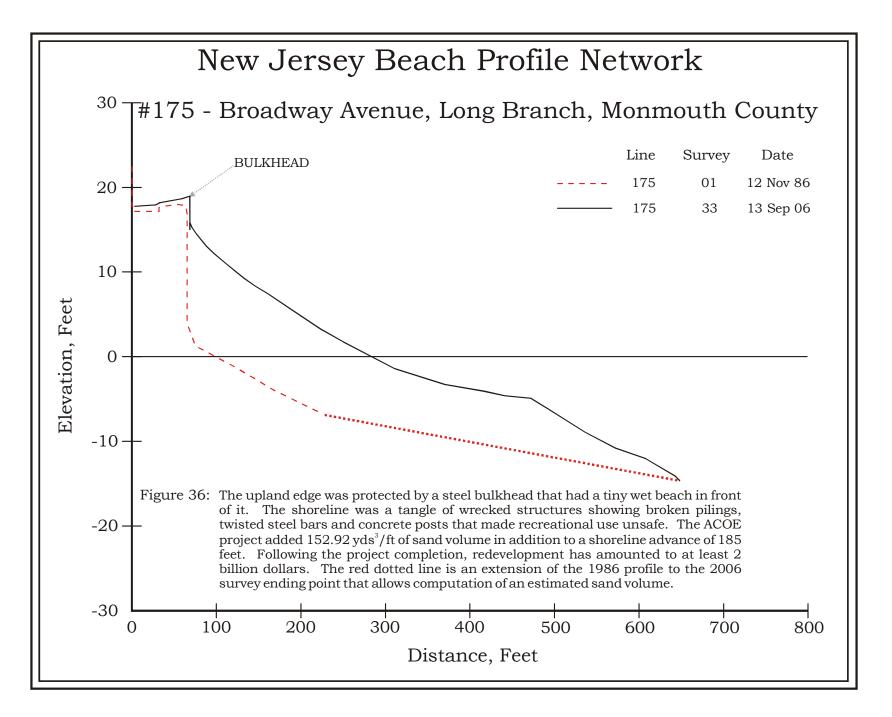
20-Year Comparison Photographs – Site 175, North Broadway Avenue, Long Branch

The Long Branch shoreline was in shambles prior to the Federal Shore Protection Project. While redevelopment started in the mid-1980's the rate of major project initiation was slow until following sand placement. After the project developers flocked to the area pouring hundreds of millions of dollars into massive residential and shopping-related projects. The 2006 photograph shows that sand has filled the zone directly in front of the old steel bulkhead nearly to its top elevation of 20 feet. In 1986 it was 14 feet from the top of the bulkhead to the sand below. The sand volume remaining since 1998 is 152.95 yds³/ft, which has formed a 125 foot wide recreational beach seaward of the bulkhead.

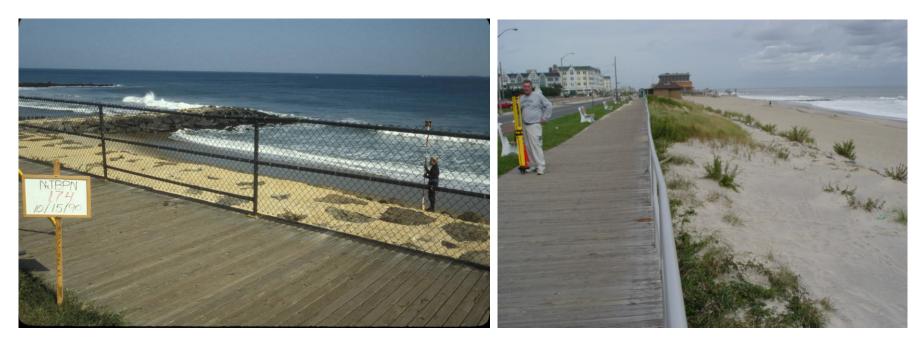
Figure 37 – **Site 174.** This profile in the middle of the Long Branch oceanfront begins to show an increased rate of shoreline retreat. The process is directly related to the fact that the initial project ended at the Long Branch southern boundary due to issues of real estate easements

to the beach. New Jersey was required to obtain easements in perpetuity on any privately-owned shoreline where there was ownership of the dune or dry beach. This was nearly universal in the municipalities of Elberon, Deal, Allenhurst and Loch Arbor so a major gap was left in sand placement along the Monmouth County shoreline.

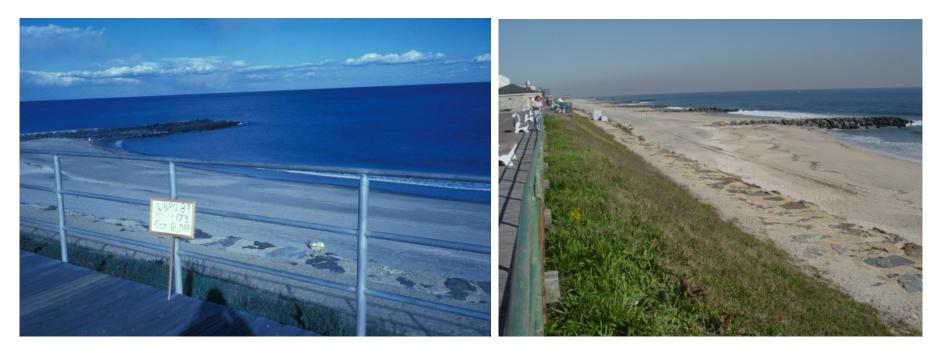
Figure 39 – **Site 173.** West End Avenue was essentially the southern limit of sand placement due to real estate issues blocking sand placement further south. The commencement of loss was immediate and continued at a constant pace until 2003 when a mild reversal

occurred. In 2006 the rate of loss returned to that seen earlier. In the final analysis the 1997 shoreline position was slightly seaward of the 2006 shoreline position (214 feet vs. 194 feet from the reference location).

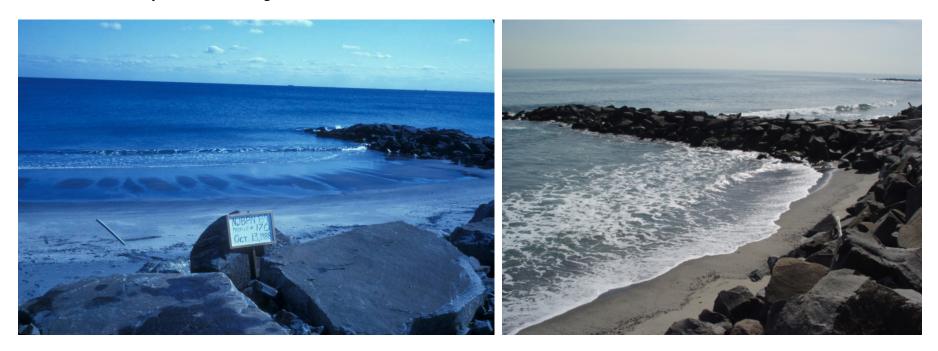
Figure 43 – **Site 170.** Located along the Deal shoreline, the site is typical of the bluff where timber and rock shore protection structures abound. Normally, there is no dry beach and frequently the transition from the rocks of the seawall to the sand surface is done in water even

at low tide. The data was variable from year to year with a trend toward shoreline retreat that appeared to reverse after 1999. There is a major fluctuation between 2005 and 2006 that will be interesting to investigate in the future for evidence of gains either from the south or north as sand is slowly distributed along the beach.

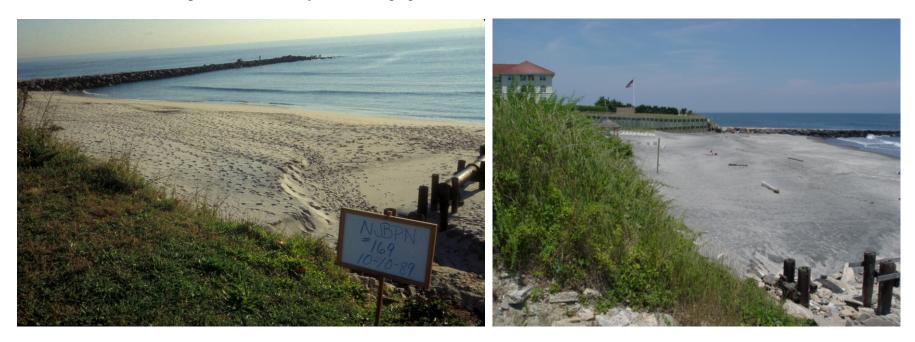
20-Year Comparison Photographs – Site 169, Darlington Avenue, Deal

The beach extends to the base of the bluff where waste concrete mixed with the sand covers the upland stratigraphy comprising the bluff. The profile changed little over the 20-year surveying interval with no significant episodes of storm erosion to the bluff other than 1992. The pictures above show the contrast between 1989(left) and 2006(right).

Figure 45 – **Site 169.** The Darlington Avenue site had more sand within the groin compartment than most other Deal shoreline segments. This is because the bluff was less protected from direct wave erosion, which over time introduces new sand to the system as the bluff

intermittently erodes and due to the presence of a large groin a block to the north at Roseld Avenue that traps sand from moving north. The variation in shoreline positions here has been less than that seen to the north, but the trend showing retreat that reverses following 1996 is similar. In spite of the similar shoreline retreat in 2006, the 20-year trend shows little net change to the beach over that time as sand moves around within the beach compartment formed by the two large groins.

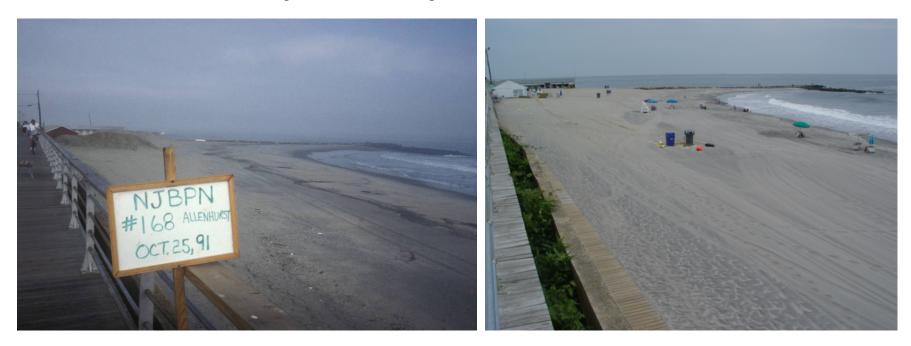
20-Year Comparison Photographs – Site 168, Corlies Avenue, Allenhurst

The Allenhurst beach is entirely protected by an aging concrete wall at the edge of the bluff. Sand slowly appears to have migrated north around the Deal Lake groin and the flume exit that formed the northern boundary of Asbury Park. The tiny 2-block oceanfront shoreline of Loch Arbor separates Asbury Park from Allenhurst. The comparison cross section below shows that the beach, and especially the offshore region have gained substantially over the past 20 years, probably related to sand loss moving to the north from the southern segment of the ACOE project that ended in nearby Asbury Park. This site is poised to see substantial shoreline advances when this offshore sand eventually moves onshore. The pictures above show the contrast between 1991(left) and 2006(right).

Figure 47 – Site 168. Positioned less than a mile north of Asbury Park where the ACOE project commenced south to the Manasquan Inlet, this Allenhurst site also shows a post-construction positive trend in shoreline position since 2000. The big spike in 1989 was due to the

municipality trucking in 180,000 cubic yards of sand placed directly onto this locally important recreational beach. The shoreline advanced almost 200 feet seaward, and then proceeded to retreat until 1993 where it stabilized. The net 50-foot increase seaward in shoreline position from this small project suffered a partial retreat in 2006. By 2006 the beach width was slightly wider but the elevation was higher providing more recreational area above the shoreline position as seen in the photos below.

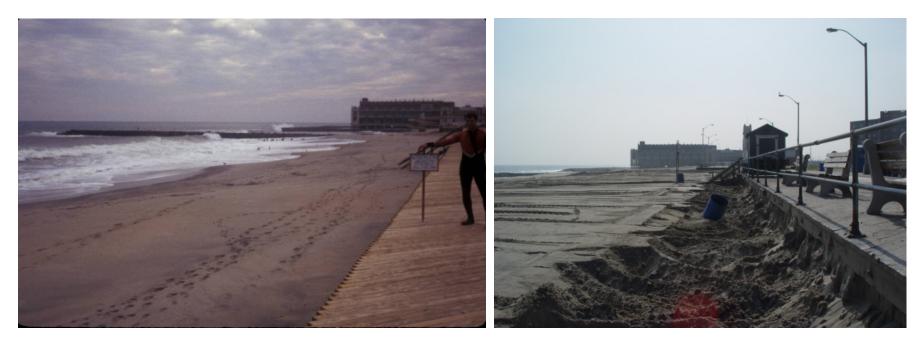
Figure 49 – **Site 267.** Located two blocks from Deal Lake in Asbury Park, the effects of the 1999 ACOE shore protection project are clear. In spite of the gains seen in Allenhurst offshore, the sand volume as shown by the shoreline position has remained fairly constant since 1999. No new sand has been added here since 1999.

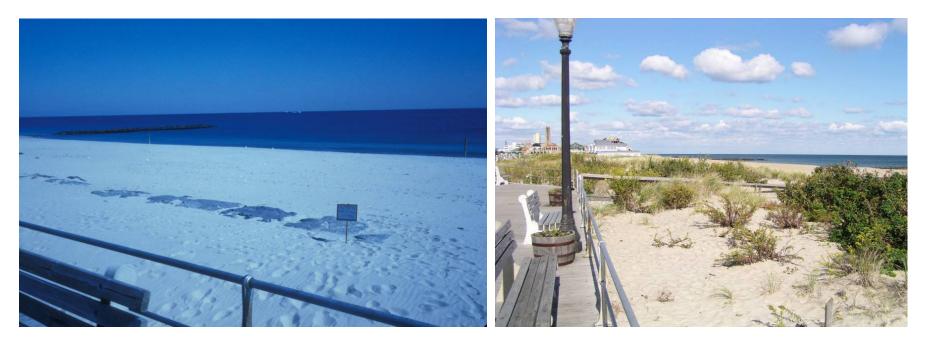
20-Year Comparison Photographs – Site 166, Ocean Pathway, Ocean Grove

The Ocean Grove site bisects the Pilgrim Pathway pavilion seaward of the boardwalk. The beach was fenced initially and planted, but never deliberately maintained for dune growth, so vegetation is somewhat random and in a naturally seeded state on the beach. There was a dry beach here in 1986, but with a far narrower width. Above is the comparison photographs between 1988(left) and 2006(right).

Figure 53 – **Site 166.** The extended period of slow shoreline retreat ended in 1999 with a better than 300-foot advance in the position with the fill project construction. Retreat occurred in 5 of the next 7 years to generate approximately 50% retreat in the 300-foot advance. The net change at this site since 1986 was an advance of 120 feet.

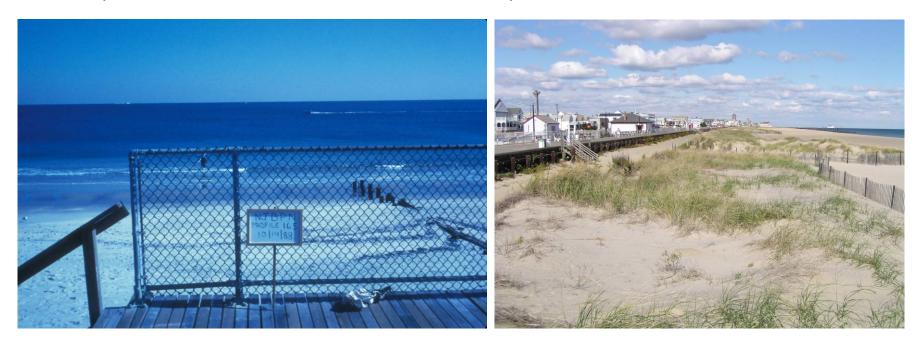
20-Year Comparison Photographs – Site 165, McCabe Avenue, Bradley Beach

The new promenade position is landward of the bulkhead that protects the bluff from erosion. The community keeps a 20-foot path clear of dune sand for emergency and maintenance access to the beach. The community has taken a more active role in maintaining the dunes, fencing the seaward toe and producing a meaningful barrier to storm onslaught. The photographs above contrast 1988 (left) and 2006 (right).

Figure 55 – **Sit e165.** The rate of shoreline retreat was greater in Bradley Beach than in Ocean Grove prior to the ACOE project. The 1992 storm forced the municipality to pull the boardwalk completely off the beach and move it onto the top edge of the bluff. This provided an

additional 40 feet of badly needed recreational beach area following the storm. The beachfill in 1999 added significant width to the beach and was followed by a further shoreline advances in 2000 with retreat in 4 of the 7 years since.

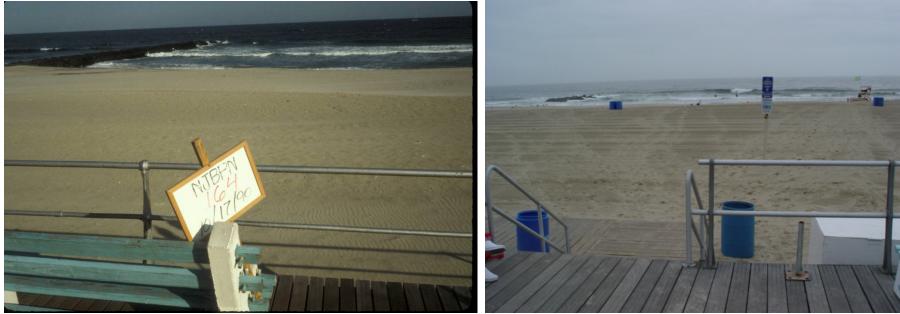
20-Year Comparison Photographs – Site 164, Sylvania Avenue, Avon-by-the-Sea

The Avon beaches are extensively used for summer recreation; therefore no dune system was created. The municipality does install a sand fence each winter to reduce the wind transport landward onto Ocean Avenue or the boardwalk. The net shoreline position advanced 123 feet seaward between 1986 and 2006 largely due to the ACOE project. An older bulkhead landward of the boardwalk protects Ocean Avenue and oceanfront properties.

Figure 57 – **Site 164.** Between 1986 and 1996 the shoreline was slowly retreating as sand left the Avon beachfront. This trend reversed in 1997 for two years prior to the ACOE project was completed in 1999. Sand continued to accumulate advancing the shoreline another 40 feet by 2000. The next 6 years saw one significant advance in 2005 and 5 years with minor retreat.

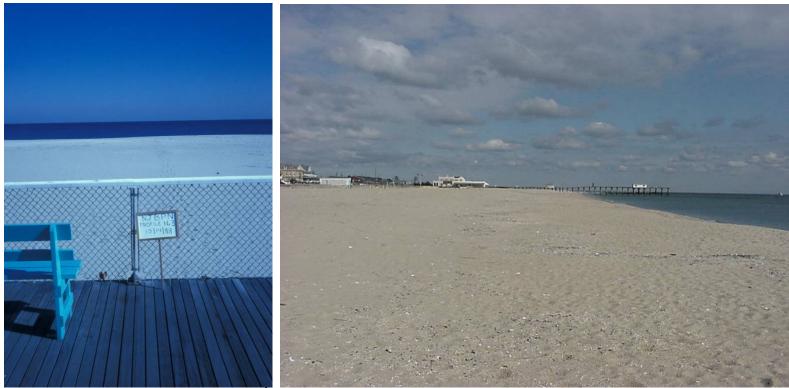
20-Year Comparison Photographs – Site 163, 5th Avenue, Belmar

The 2006 photograph (right) shows the beach and the Belmar fishing pier located just south of the Shark River Inlet south jetty. These structures are barriers to sand transport parallel to the shoreline and largely responsible for the pattern in the shoreline position data shown above. The comparison plot shown below between the beach in 1986 and the survey from 2006 shows the least difference of all the sites in NJ. The shoreline advanced exactly 0.67 feet in 20 years. No significant dune was ever developed along this shoreline due to heavy recreational use. A very small dune has developed adjacent to the seaward side of the boardwalk but is not continuous across beach access stairs over which this profile crosses. A ridge is pushed up each winter as a barrier to wind transported sands.

Figure 59 – **Site 163.** Fifth Avenue in Belmar is in proximity to Shark River Inlet. The south inlet jetty has accumulated sand and formed a substantial wide recreational beach for decades and the ACOE project manager determined that no sand would be added to regional beaches in proximity to the jetty. As a result the data on shoreline change reflects significant shifts in the balance of littoral sand transport. In 1990, 1997, 2000, and 2004 the advances recorded were due to dominant littoral sand movement north toward the jetty. In 1991, 2001 and 2005 the dominance favored transport to the south away from the jetty, so the shoreline retreated. The largest advance came in 2004 because there was abundant new sand south of this site to move toward the jetty. Correlation of the data with northeast storms occurs in 1991 (Halloween Storm) and 2001 (El Nino year). In 2004, there were no storms of any significance, so sand moved north producing shoreline advance.

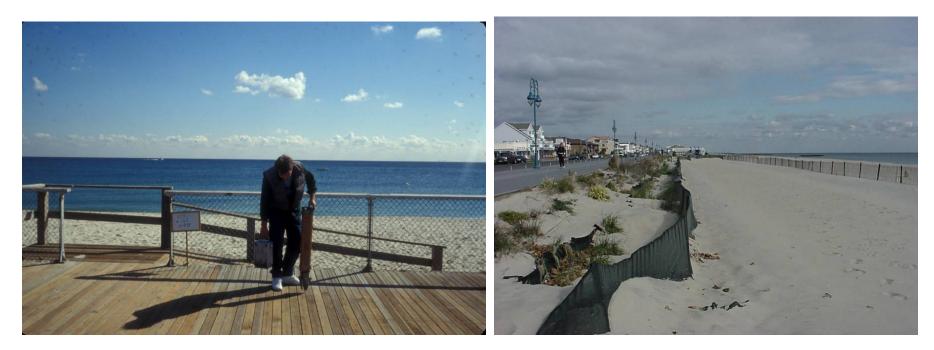
Figure 61 – Site 162. At the 18th Avenue beach, the ACOE project did provide a 150-foot advance to the shoreline position that was followed by small variable periods of retreat and advance over the next 9 years. The net change was modest with a retreat of 63 feet in the shoreline position.

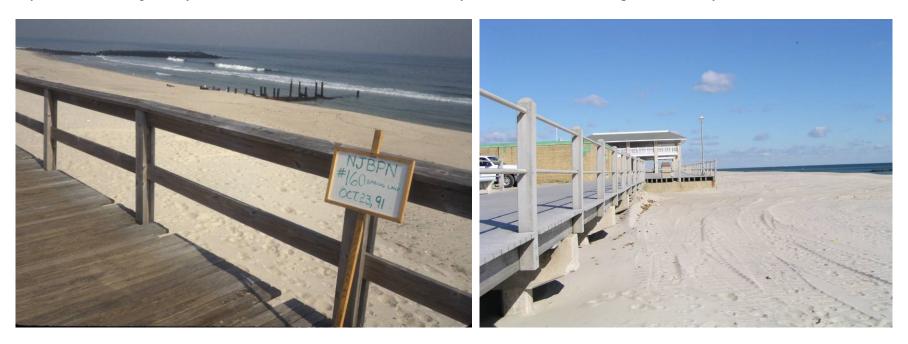
Shoreline Trends at Salem Avenue, Spring Lake, NJ

Figure 65 – **Site 160.** The Salem Avenue site demonstrated a very slow retreat in the shoreline between 1986 and 1996. The ACOE project produced a 120-foot advance that remained nearly constant until 2001 when a series of larger swings caused larger changes in the zero

elevation shoreline position. The 2006 retreat restored the shoreline position back to the conditions following construction of the beach for nearly a net zero change in 9 years. The shoreline has remained at or beyond the 1997 "as-built" position for 9 years.

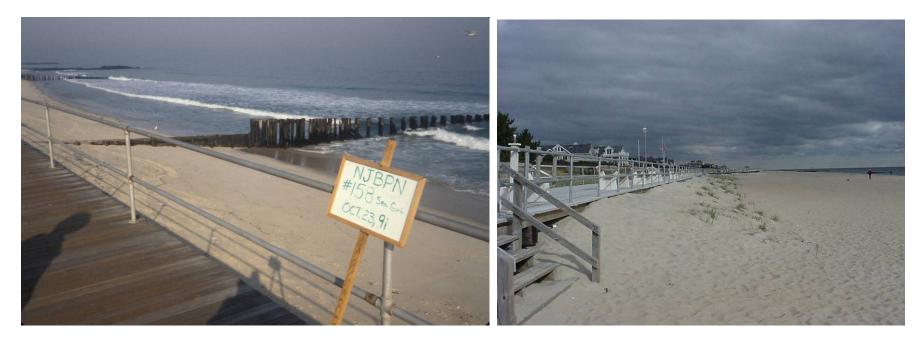
20-Year Comparison Photographs – Site 158, Trenton Avenue, Sea Girt

The change at this location is very dramatic because the December 1992 northeast storm produced serious bluff erosion damage that required a bulkhead to assure nervous residents that further loss would be avoided. The high tide was always landward of the boardwalk, but advanced 300 feet further seaward after the project. Prior to The ACOE project it was possible to walk under the boardwalk at this location. After completion sand has filled under the boardwalk and was blown landward raising the dune elevation by several feet from the toe up to the crest. The cross section below shows the 1997 boardwalk position relative to the beach elevation as compared to the post construction situation in 2006.

Figure 67 – **Site 158.** Toward the southern boundary of Sea Girt, the impact of the ACOE shore protection project showed a large shoreline advance. That advance did retreat 5 out of 9 years pulling the shoreline back about 150 feet.

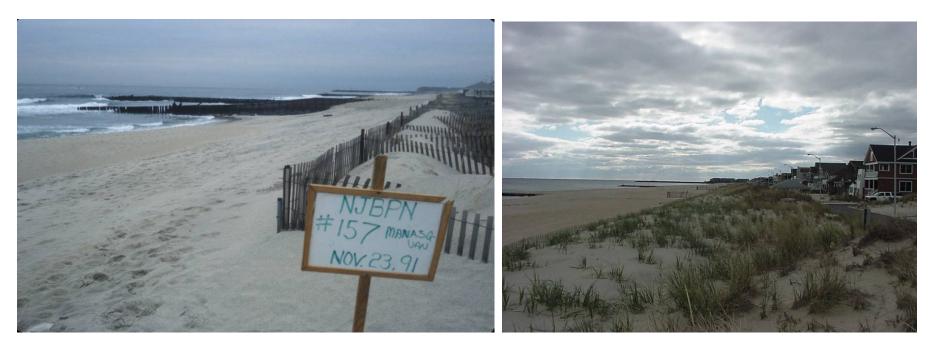
Shoreline Trends at Riddle Way, Manasquan, NJ

175-foot advance in the shoreline. The years 1998 and 2003 each caused a 50-foot retreat that was partially offset by advances in 2000, 2004 and 2005.

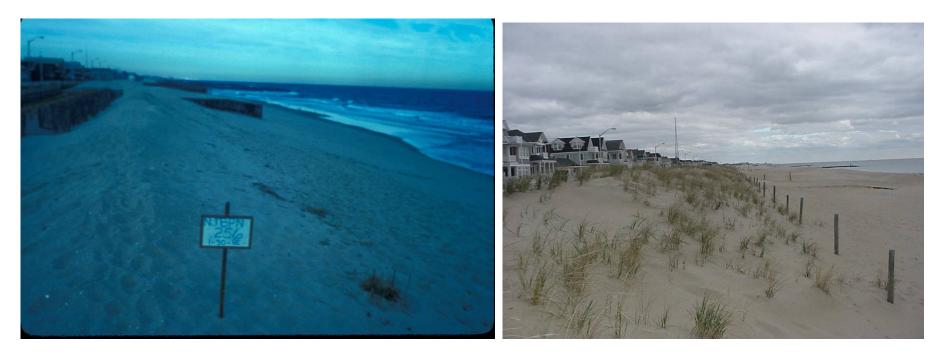
20-Year Comparison Photographs – Site 256, Pompano Avenue, Manasquan

The dune at this site has grown substantially since 1995. Unfortunately, some homeowners do not appreciate the greater storm protection they provide. The wider beaches now support both a larger dune footprint and provide ample recreational space. The photographs above show the contrast between 1995 (left) and 2006 (right).

Figure 71 – **Site 256.** This profile was added in 1994 to provide closer coverage of the shoreline and sand volume changes on the north side of Manasquan Inlet. The sand volume added was reduced at the inlet because the jetties were shorter than necessary to retain the normal

volume being added elsewhere. Despite the taper in width, sand readily moves into the Manasquan Inlet channel requiring more frequent dredging. For several years after completion the shoreline width fluctuated with little net change but in the last two years shoreline retreat has gradually accelerated.
