Monmouth County

Raritan Bay and Sandy Hook to Manasquan Inlet

NJBPN Profile #'s 187 - 256

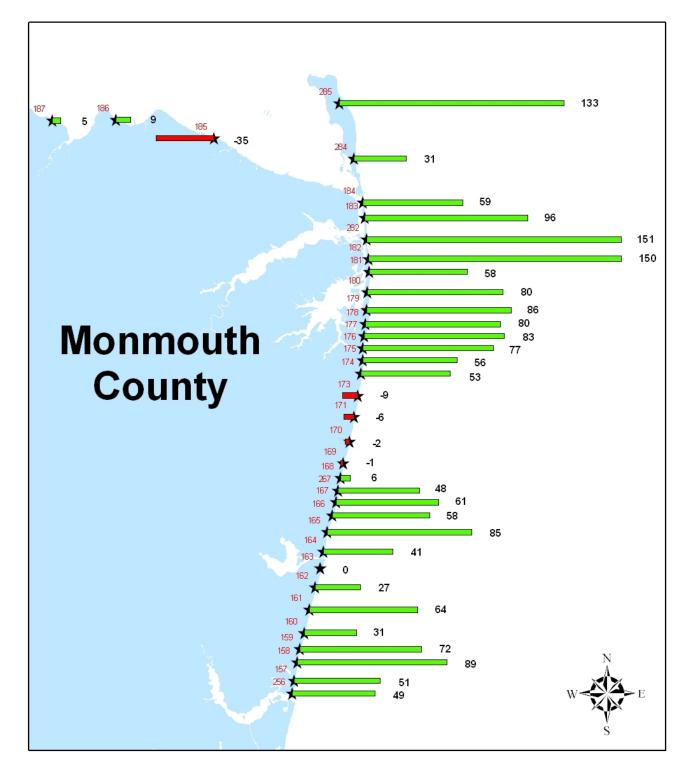
Summary Illustration 1: Monmouth County's shoreline received the most extensive restoration project thus far co-sponsored by the State and Federal governments with local participation to add sand to 21 miles of the county shoreline. This effort clearly shows in the large advances seen to the shoreline position in all but the segment between Elberon and Allenhurst, NJ. Some sand has moved into the area not nourished, but not enough to change conditions at the pre-existing erosional beach within the un-nourished reach.

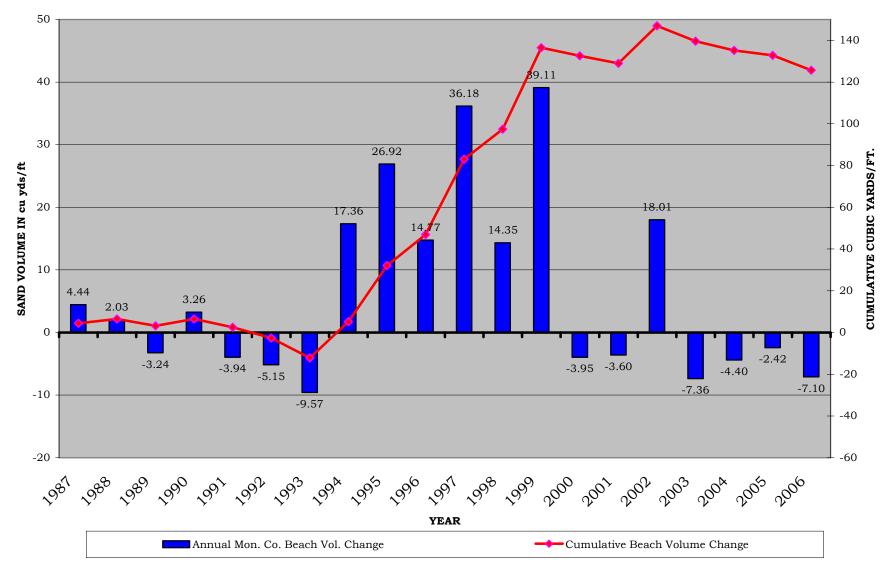
Summary Illustration 2: The average fall sand volume change for Monmouth County illustrates the commencement of the Federal beach restoration in 1994, continuing until 2000. The 2002 maintenance effort shows as added material as well (18.01 yds³/ft). Loss rates since 2002 have been relatively minor. By 2006, the cumulative trend shows a 125.69 yds³/ft average sand volume gain in Monmouth County.

As the graphics (pages 12 to 116) show, the general trend at all the Monmouth County sites receiving beach nourishment sand showed slow losses with many years of stability. The rate of loss calculated demonstrated that if nothing further were to be done, the beach at these sites would be back to pre-project condition in 65 years. Increased storm intensity or frequency would reduce this value, but the prediction was made by some that the vast majority of this sand would be gone in six months after the construction was completed. The most serious sites of loss were found in places where the project terminated due to impediments to sand placement involving public access and
